Root Cause Assessment – Fractured Girder Flanges

Transbay (Salesforce) Transit Center, San Francisco

December 13, 2018

Salesforce Transit Center Girder Repairs

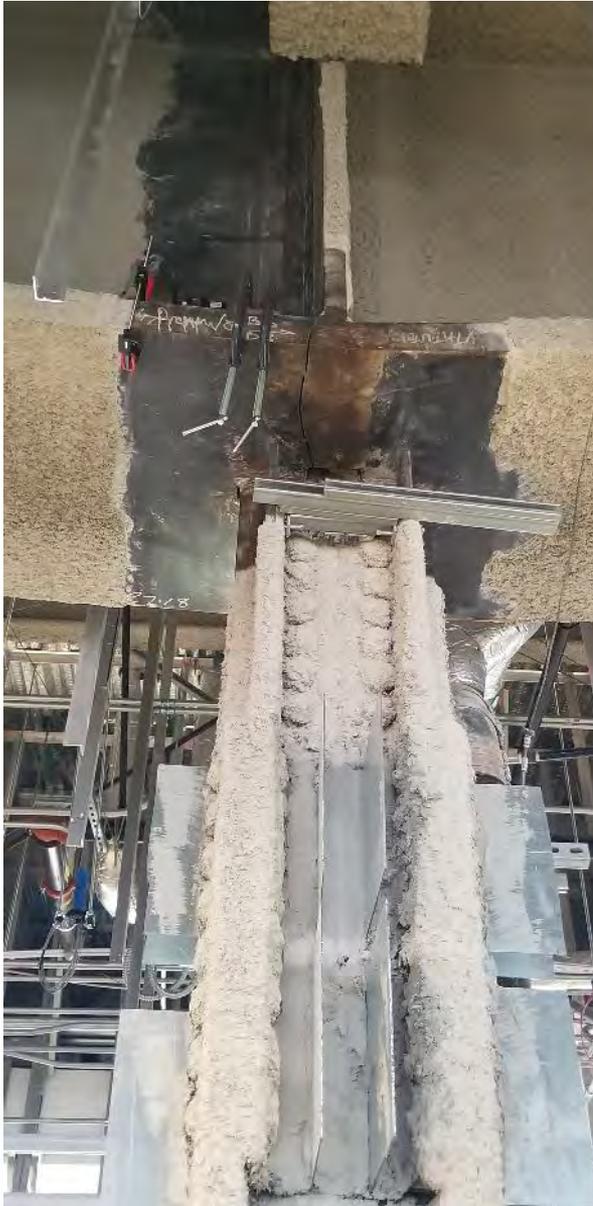
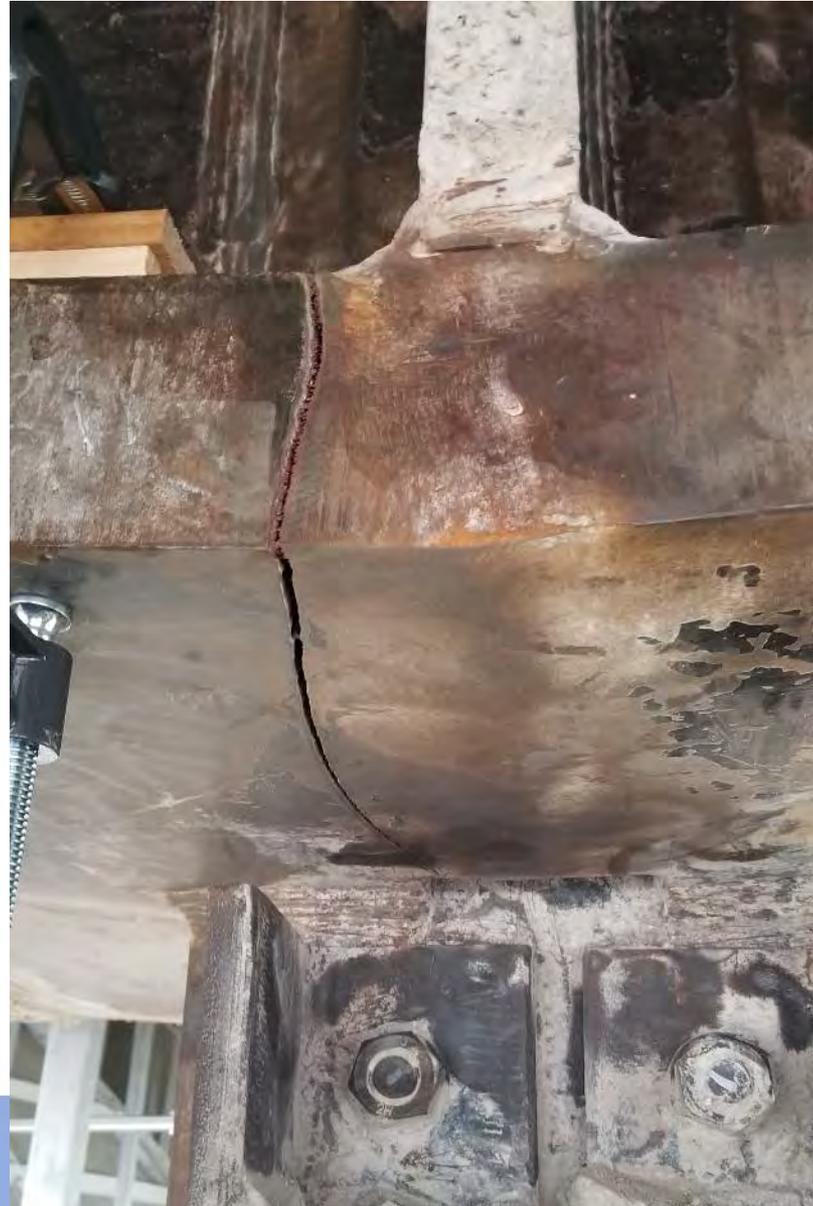
Fractured Fremont St Girder

- **August 12, 2018:** Transbay Transit Center opens to the public
- **September 25, 2018:** Cracks found in two girder flanges
- **October 1, 2018:** LPI retained to perform root cause assessment of girder fractures and the removal and testing of the fractured sections
- **October 23 through 29, 2018:** Girder samples removed by IPM under direction of TT and LPI - samples shipped to LPI's New York facilities
- **November 14-15, 2018:** Joint laboratory examination at LPI with all interested parties
- **December 2018:** Expected completion of all metallurgical and mechanical testing
- **January 2019:** Expected completion of root cause assessment

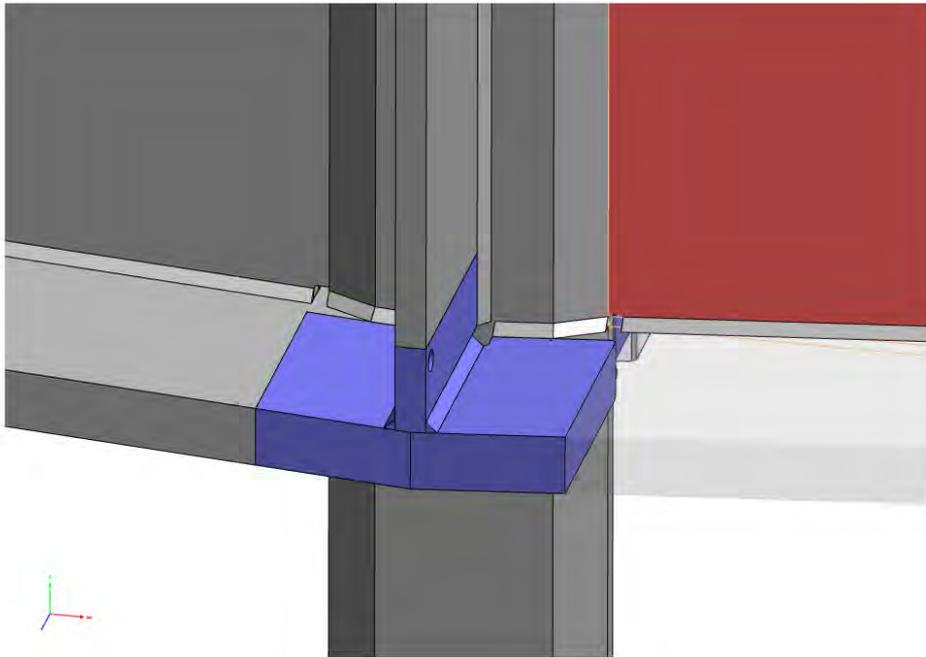
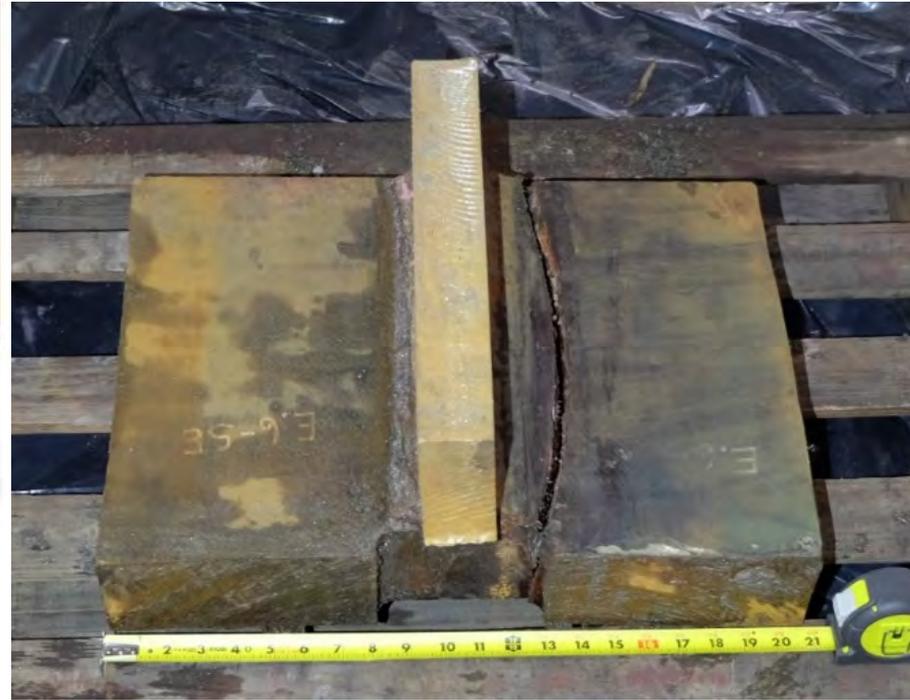
Typical Girder Sample

- Fremont St., south girder, E.6-SE-SW (cracked)

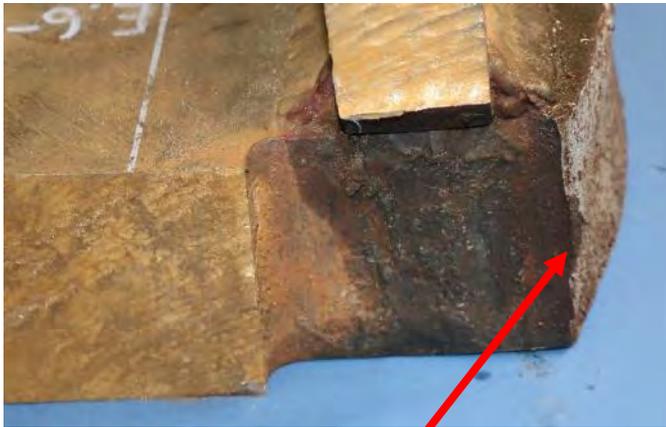
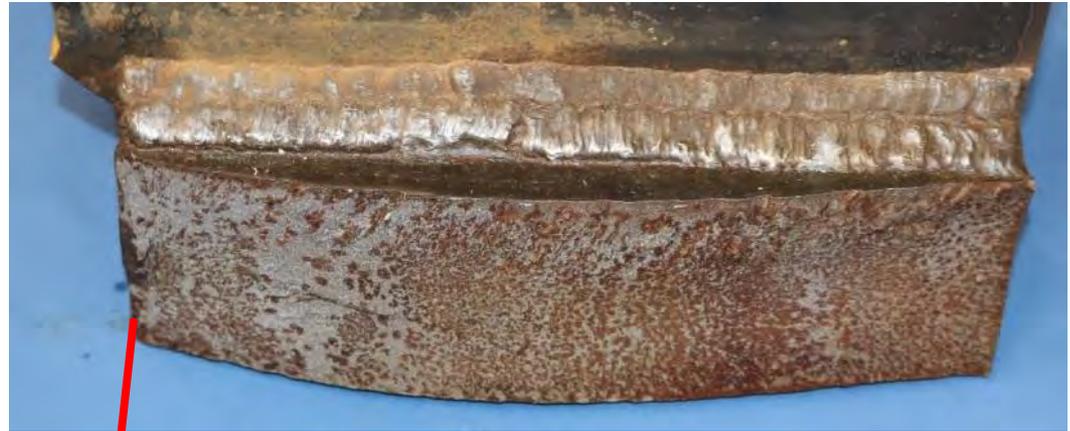
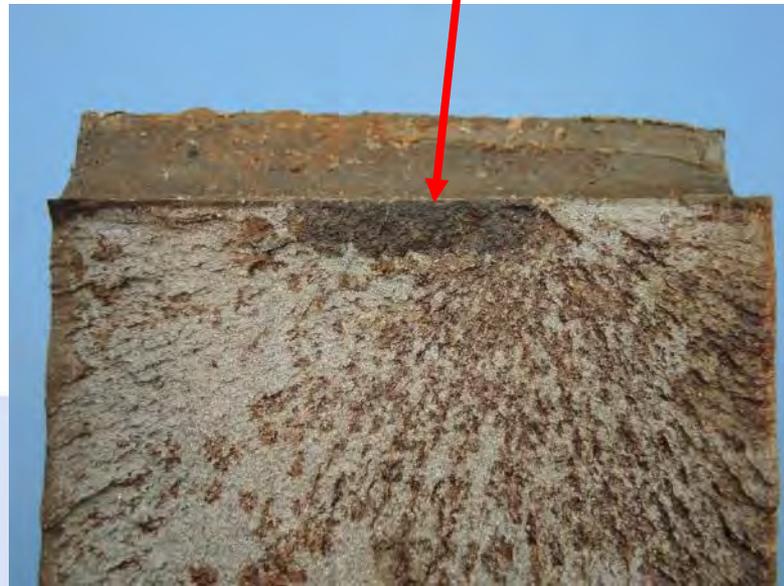
Fracture Origin in the Weld Access Hole of Girder Sample E.6-SW

Initiation sites for all girder fractures exhibited tenacious dark oxide (high temperature) with underlying low-energy (brittle) cleavage fracture. The remainder of the fracture surfaces also exhibited a cleavage fracture morphology.

- Initially, shallow (micro) surface cracks developed during thermal cutting of the weld access holes in the highly hardened and brittle martensitic surface layer.

- Thereafter, larger pop-in cracks formed in two of the four flanges, potentially during butt welding of the flange plates.
 - Black, tenacious, high temperature oxide was present on both the shallow surface cracks and the larger pop-in cracks, confirming that both crack types formed at elevated temperatures.

- The fracture origins were located in the mid-thickness of the flange where low fracture toughness, as confirmed by CVN toughness testing, provided little resistance to rapid, low-energy, brittle fracture.

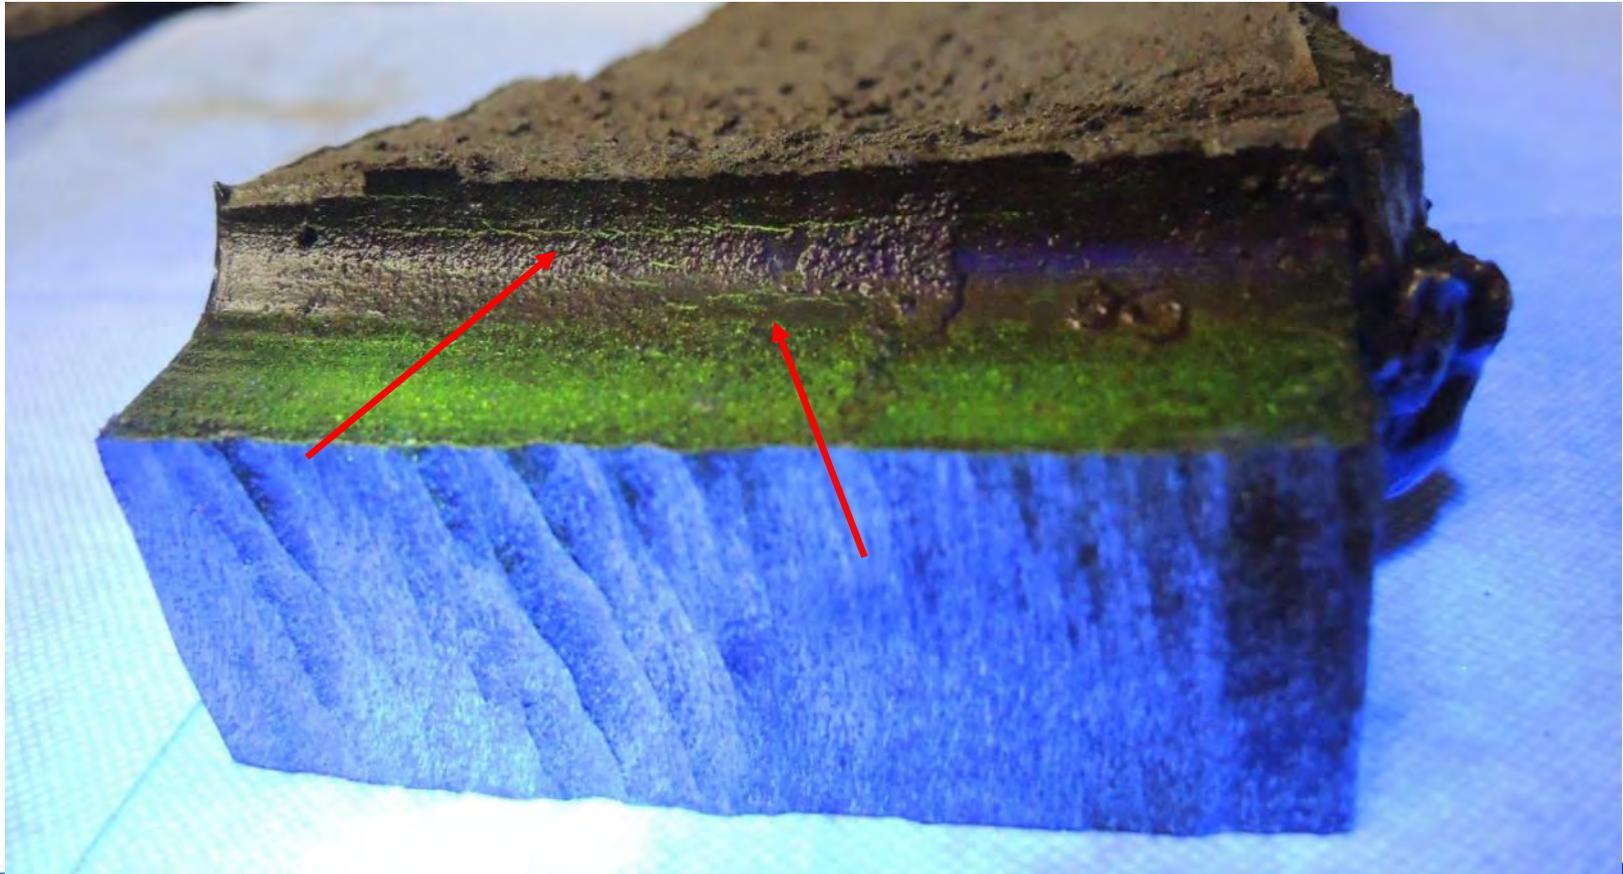
Fluorescent Magnetic Particle Testing

D.4-SW exhibited secondary cracking in the radius of the weld access hole.

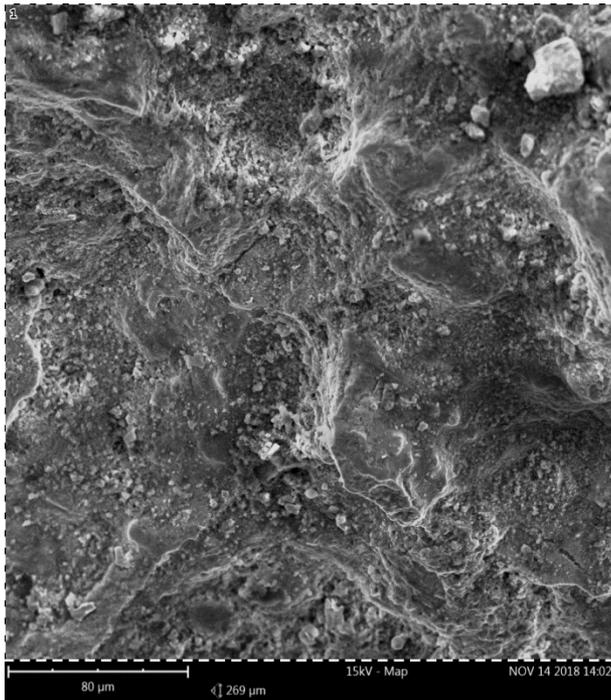
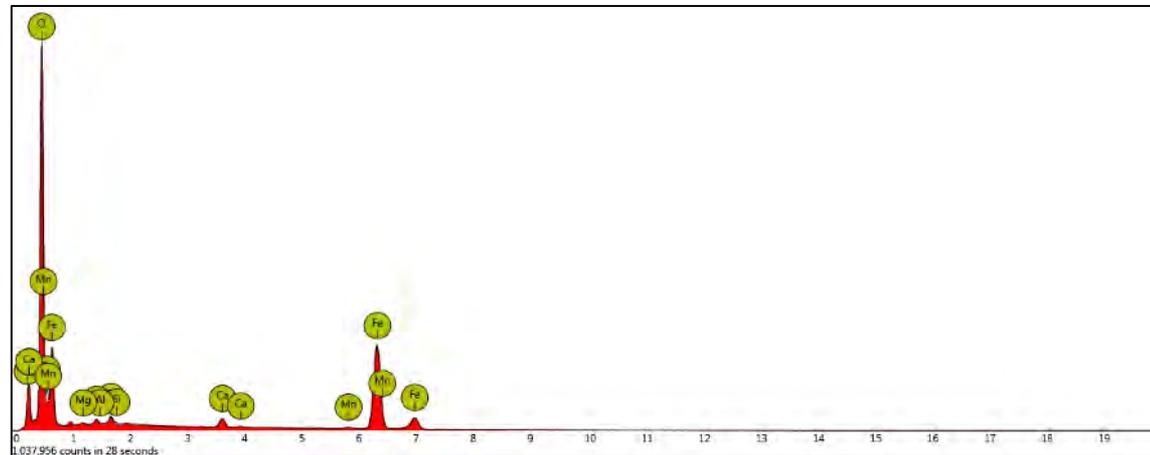
E.6-SW: EDS of surface deposit (oxide) at the origin

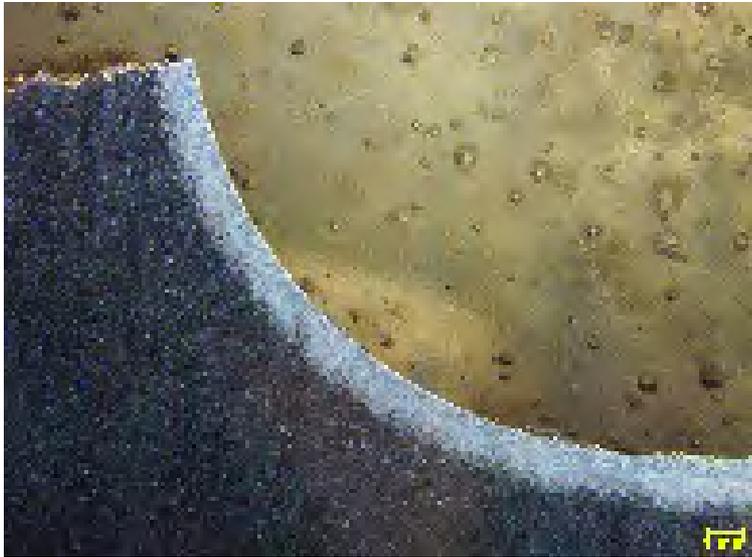
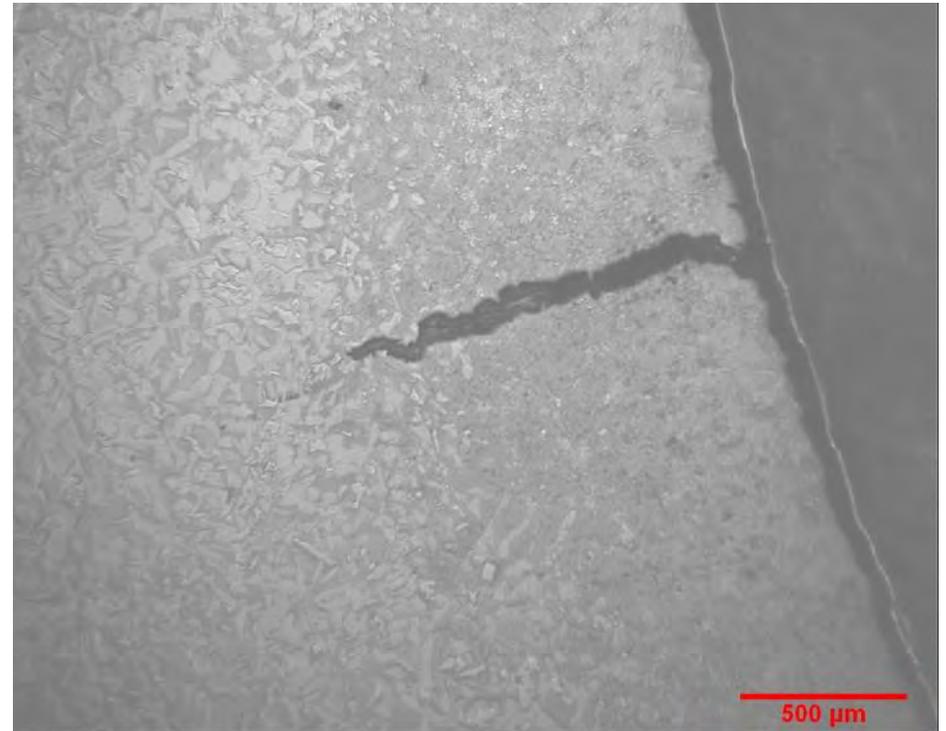
Metallographic cross-section specimens through weld access hole radii revealed a brittle martensitic surface layer from thermal cutting containing multiple shallow (micro) cracks.

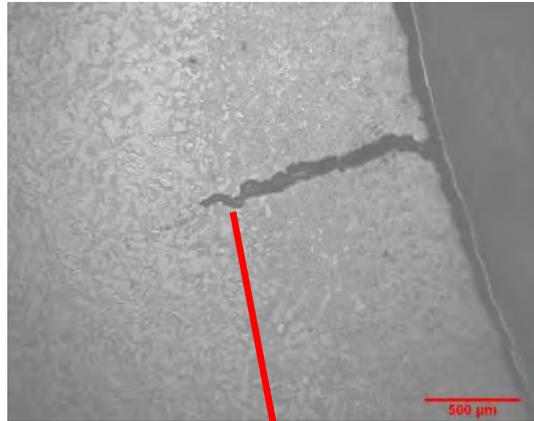
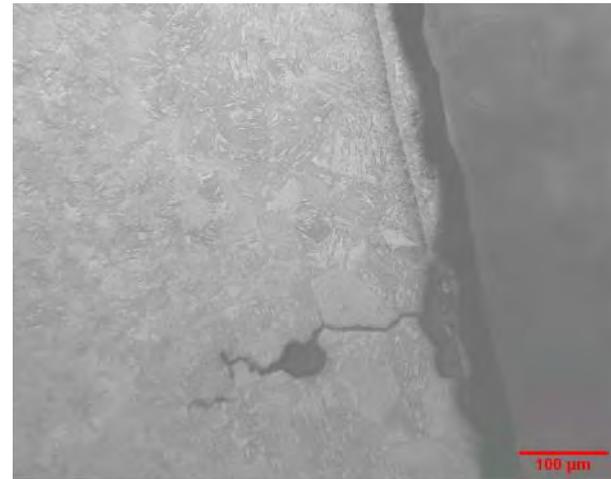
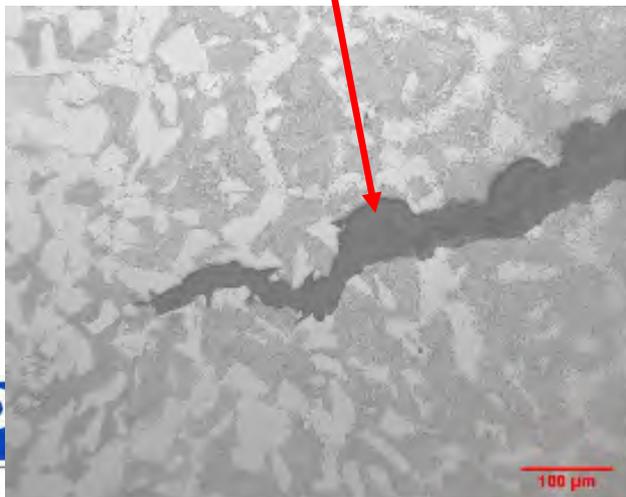
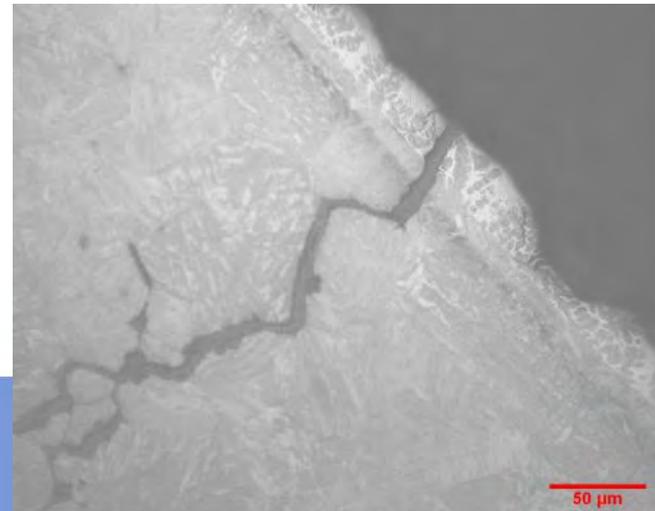
Metallographic cross-section specimens through weld access hole radii revealed a brittle martensitic surface layer from thermal cutting containing multiple shallow (micro) cracks.

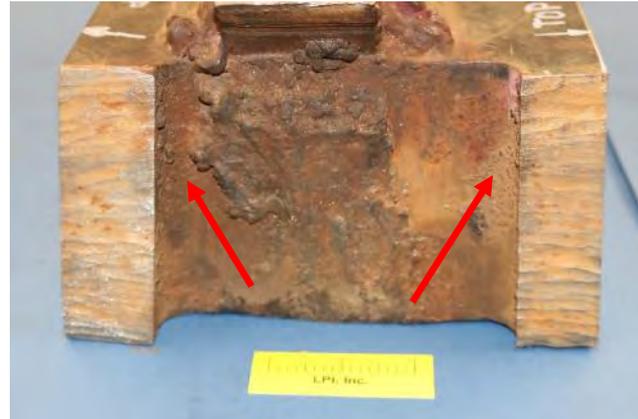
Rockwell C surface hardness (HRC) measured in the radii of the thermally cut weld access holes revealed high surface hardness.

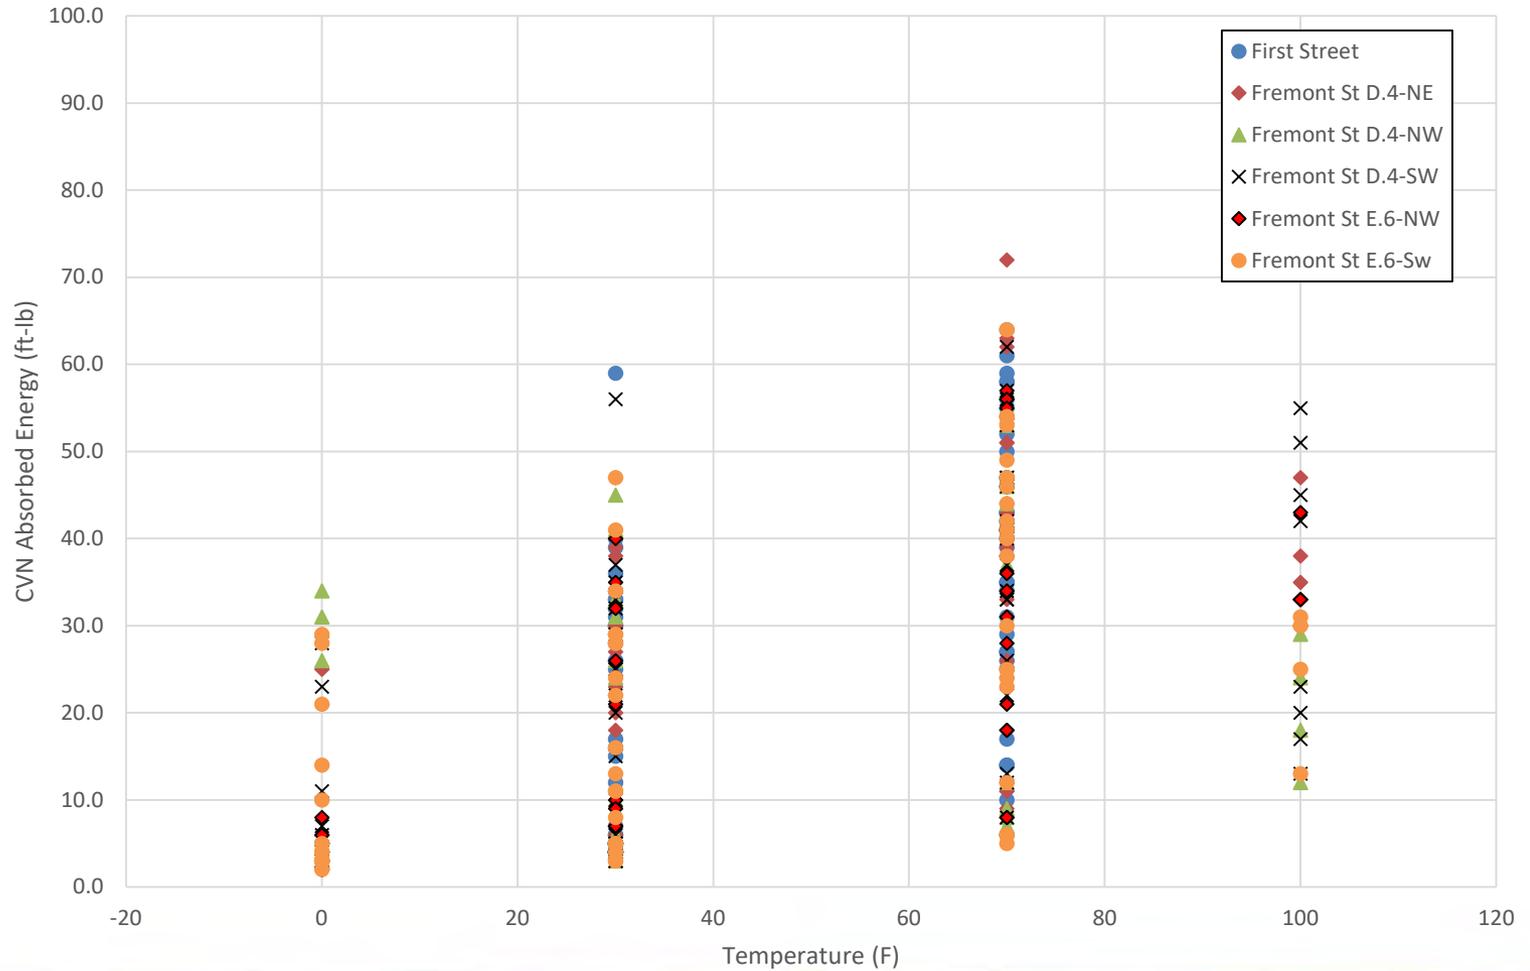
TPG3 CVN Toughness

- CVN testing was performed on all flange samples at the top, $\frac{1}{4}$ depth, mid-thickness, $\frac{3}{4}$ depth, and bottom. $\frac{1}{4}$ depth CVN results were found to be consistent with the project specification and girder plate mill certifications.

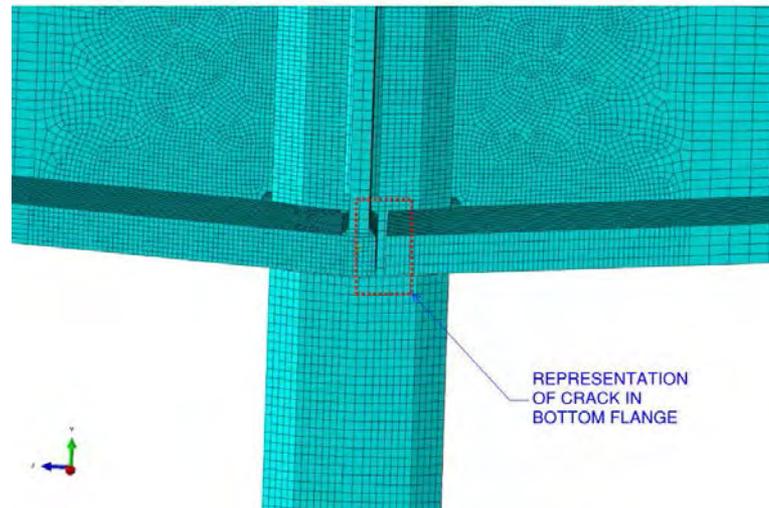
1. The cracked girders with reduced section had sufficient capacity to support the building dead loads and occupancy loads.

2. The actual forces in the girders were less than calculated using normal design procedures.
