Root Cause Assessment of Fractured Girder Flanges

Transbay (Salesforce) Transit Center, San Francisco

TJPA Board

March 14, 2019

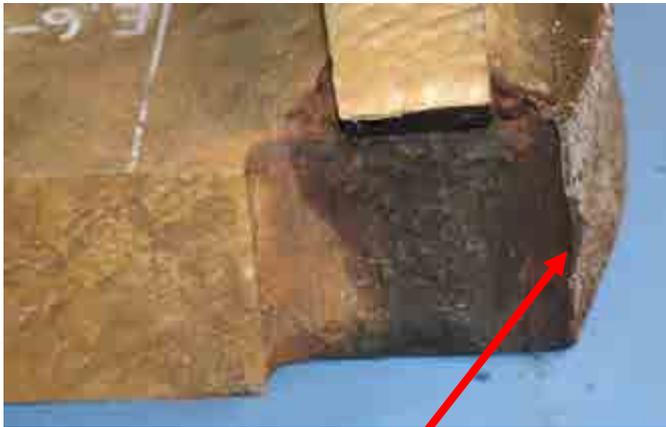
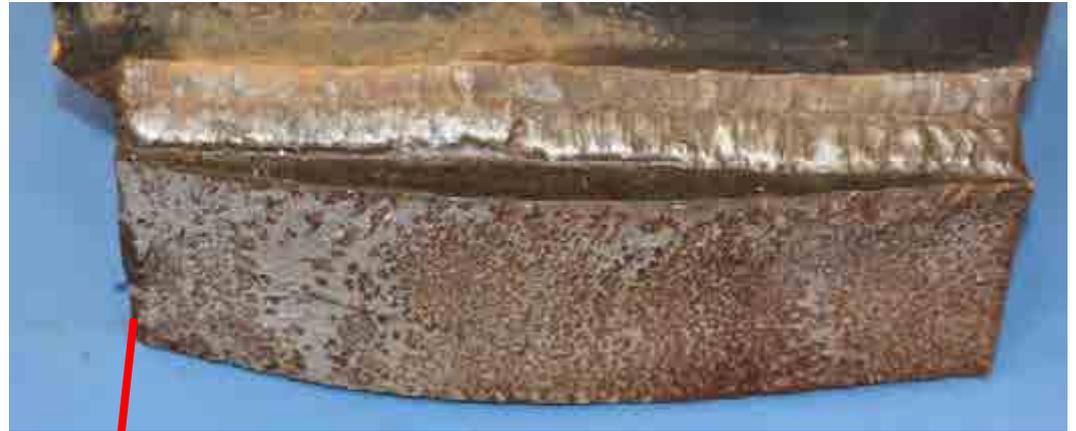
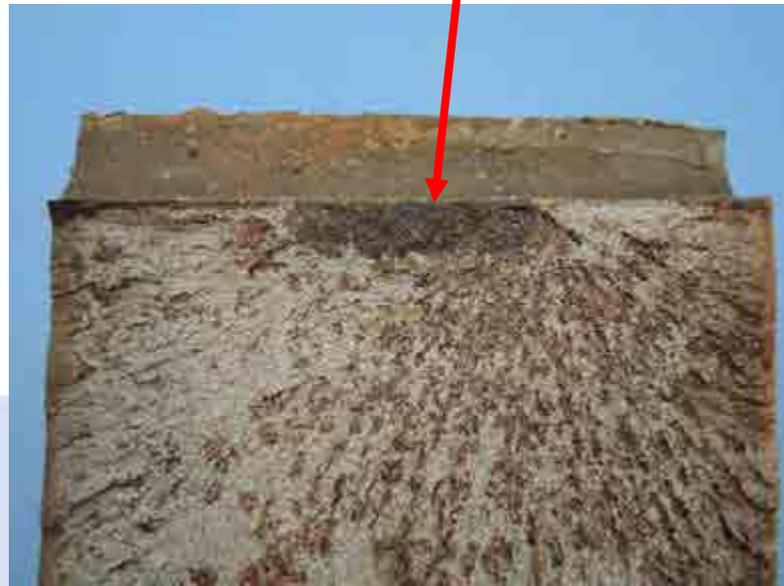
Fracture Origin in the Weld Access Hole of Girder Sample E.6-SW

All flange crack surfaces exhibited tenacious dark oxide (high temperature) with underlying low-energy (brittle) cleavage fracture as can only develop at elevated temperature during thermal cutting and CJP butt welding of the flange plates

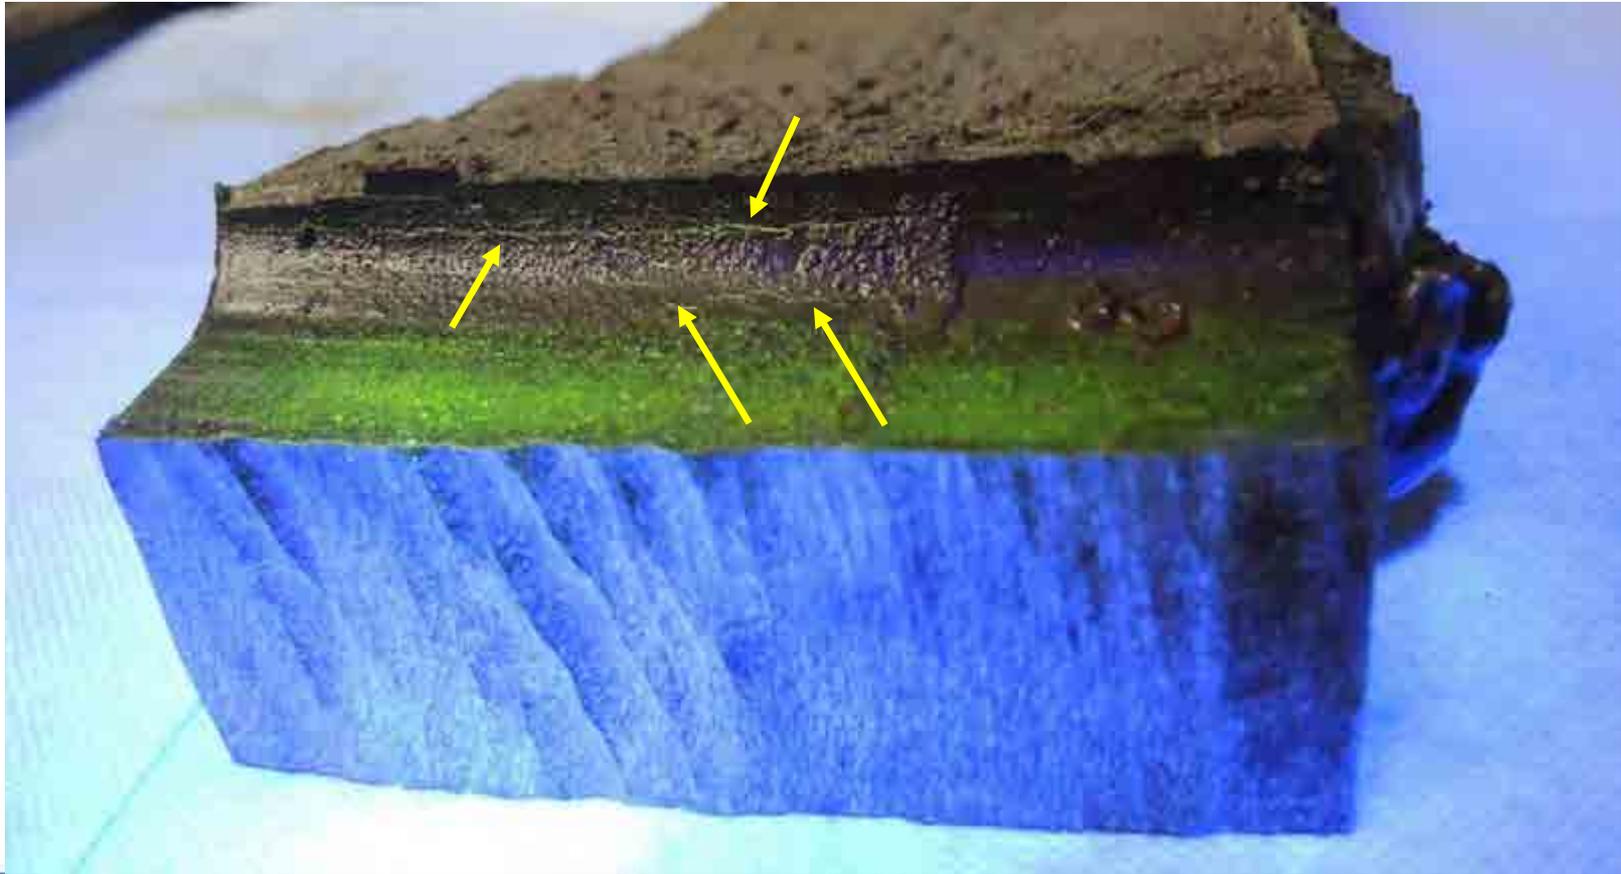
Microcracks in the D.4-SW weld access hole radius

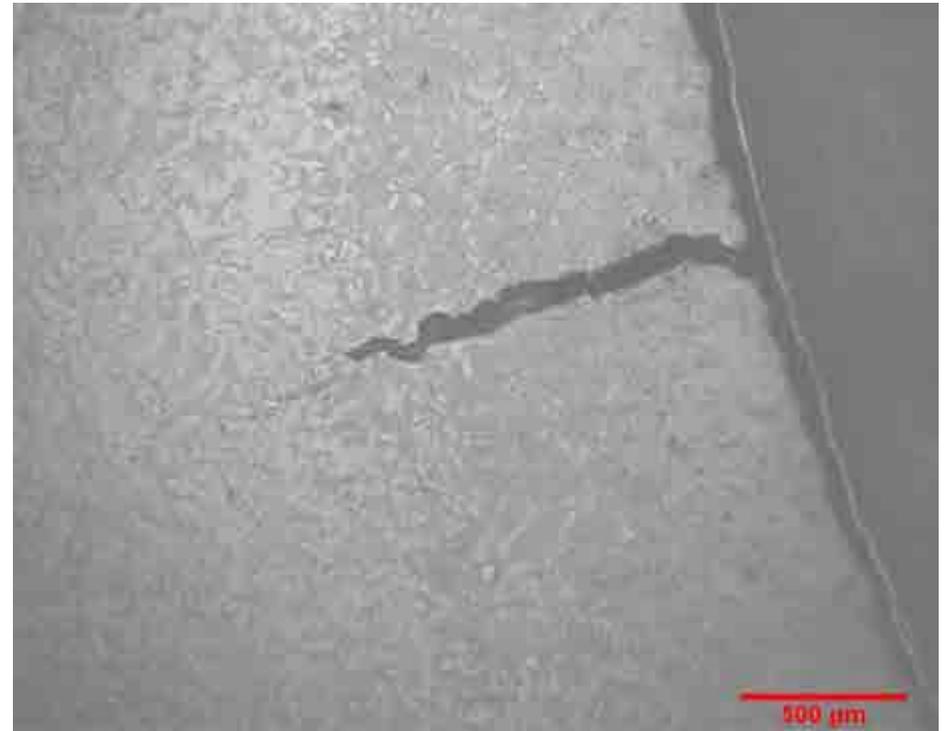
Metallographic cross-section specimens through weld access hole radii revealed a brittle martensitic surface layer from thermal cutting containing multiple small cracks.

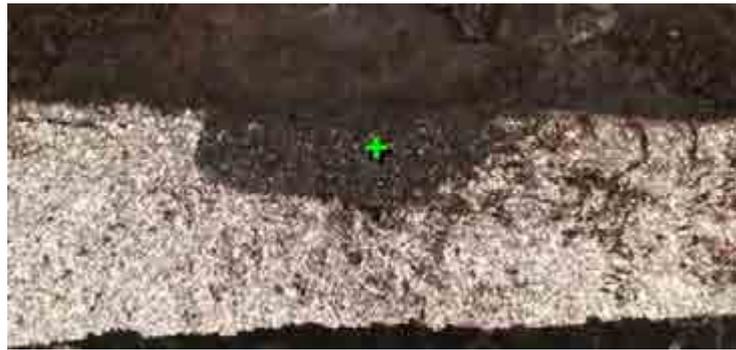
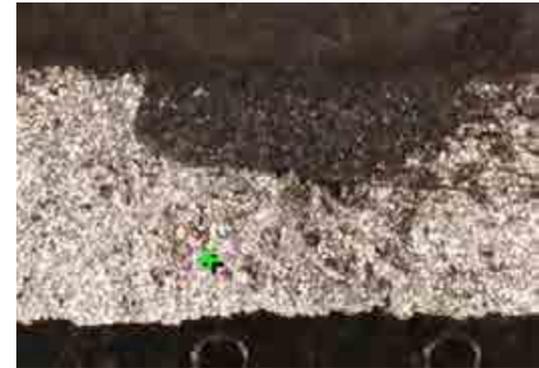
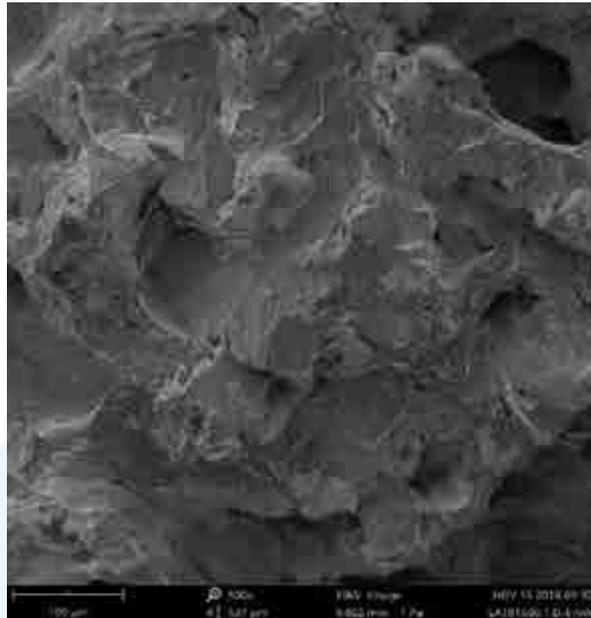
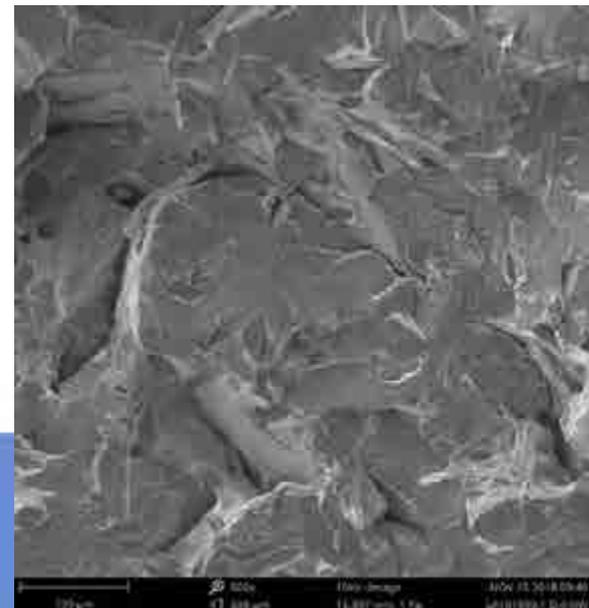
Initiation sites (pre-existing Microcracks and Pop-in cracks) for all girder fractures exhibited tenacious dark oxide (elevated temperature) with underlying low-energy (brittle) cleavage fracture. The remainder of the fracture surfaces also exhibited a cleavage fracture morphology.

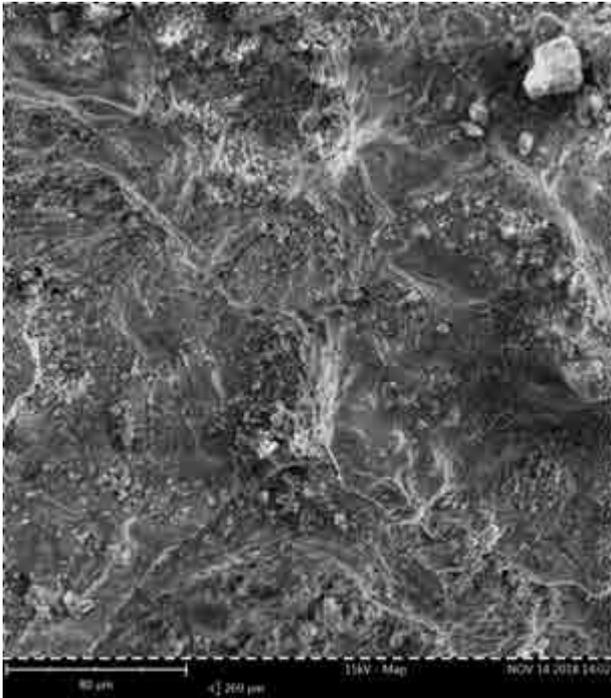
E.6-SW: EDS of surface oxide at the origin

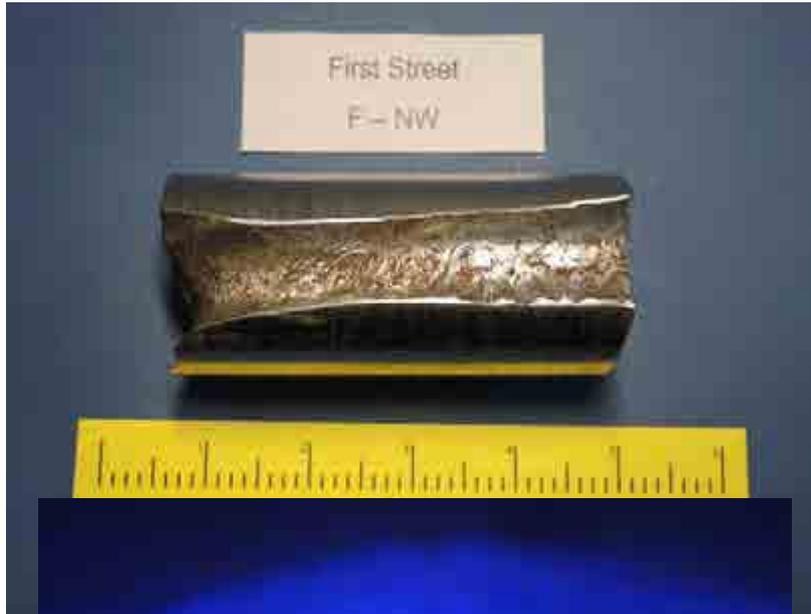
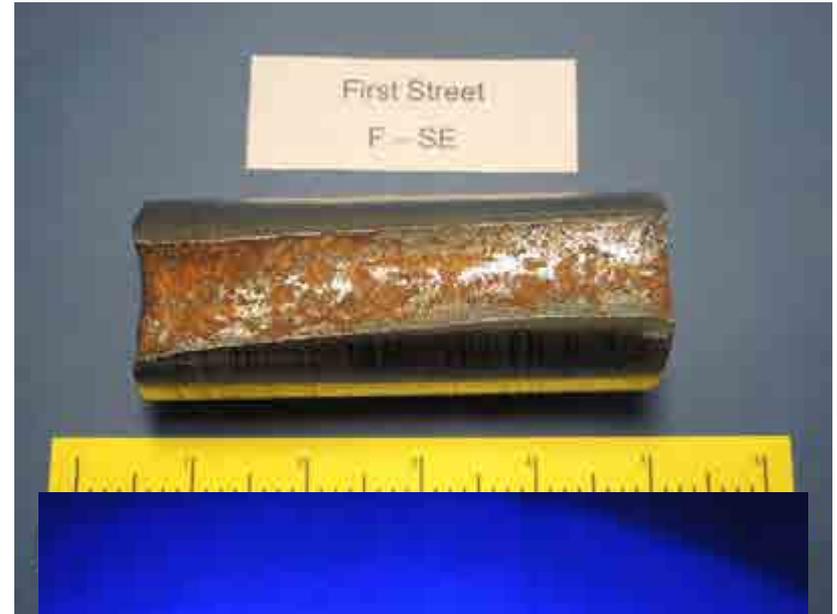
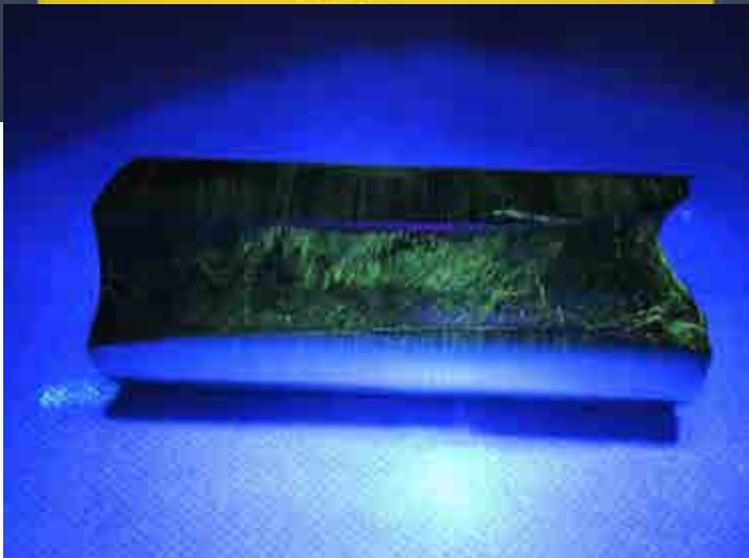
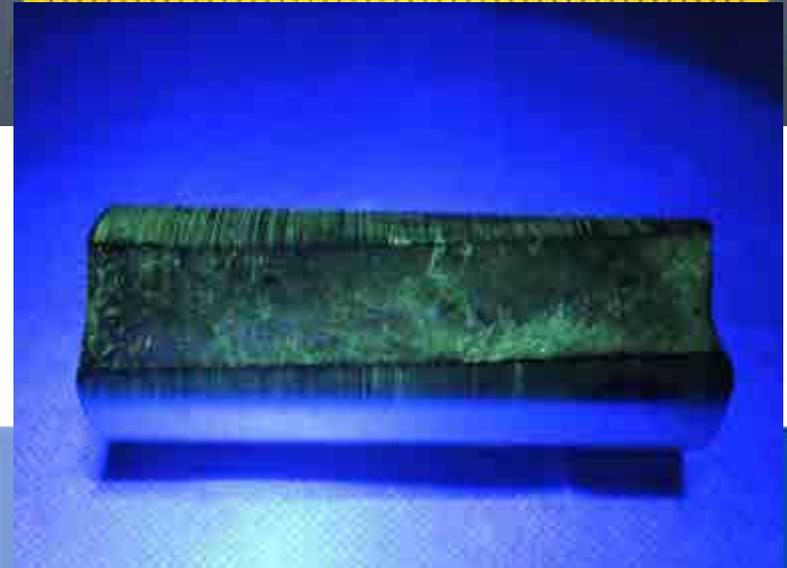
Access Hole Surfaces Were Ground Following the Fremont Street Fractures

- No Microcracks or Pop-in cracks were observed in any of the cores removed from the First Street flange weld access holes
- However, the absence of Microcracks at First Street may be attributable to the grinding performed on the access hole surfaces following the Fremont Street fractures
- The weld access holes at First Street were fabricated differently from those at Fremont St, that is, they were cut after the flange CJP butt weld was completed
- The Fremont Street access holes were made prior to welding of the flange CJP butt weld

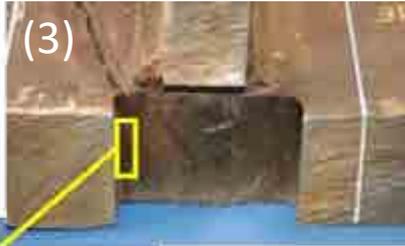
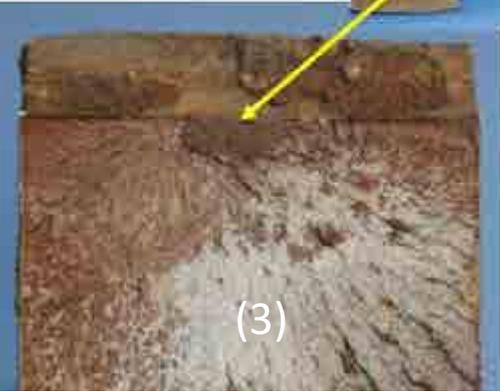
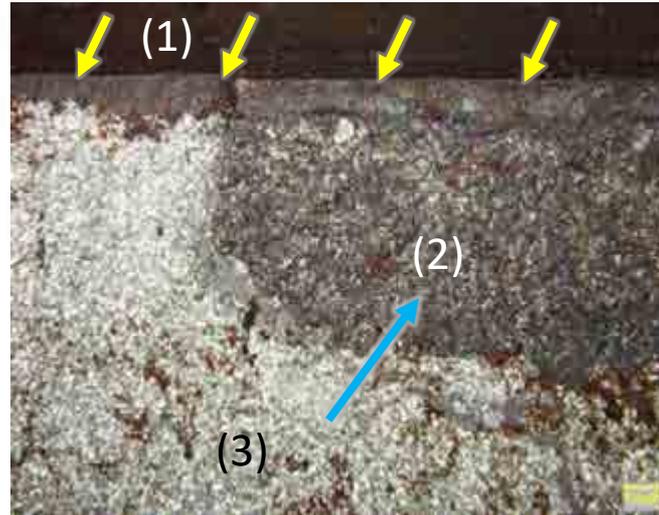
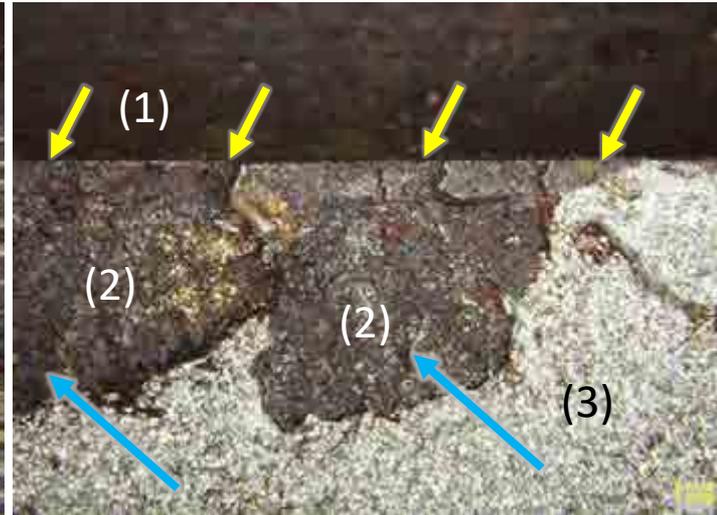
Fremont St D.4-NW Fracture Origin

Microcrack (1) - Elliptical
Depth ~ 0.04 to 0.06 in. x ~ 1.5 in.

Pop-in Crack (2) – Elliptical
0.38 (a) x 1.2 (2c) in.

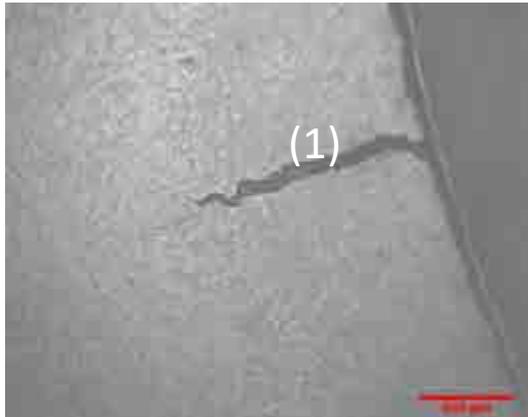
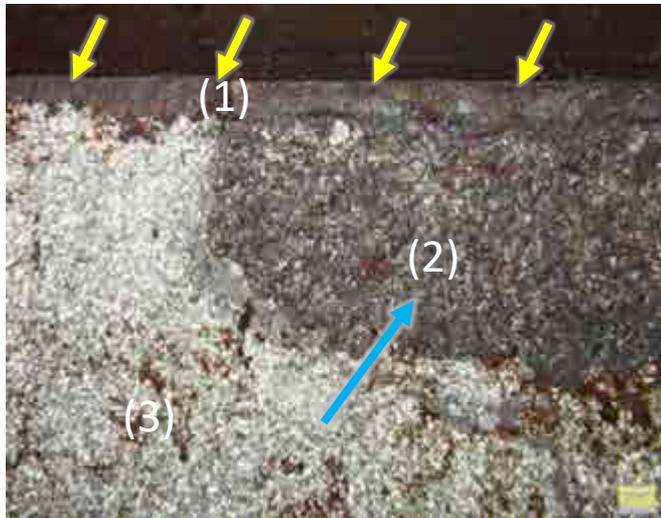
Fremont St Pop-in Crack Initiation

- Microcracks (1) formed during thermal cutting of the weld access holes and varied in depth (a) to a maximum of 0.06 in.
- Microcracks located in untampered martensite → Fracture toughness (K_{1c}) could be at the lower bound for structural steel, which is ~ 25-30 ksi√in. and up to the maximum $\frac{1}{2}$ -t toughness of 55-60 ksi√in. at 50°F
- The only stress present at the time the Pop-in cracks initiated was the self-limiting residual stress associated with welding of the flange CJP butt weld
- This residual stress is highest at the access hole surfaces and drops off rapidly as the distance from the access hole surface increases into the flange width
- An estimate of the residual stress developed during welding and, necessarily present to initiate the Pop-in crack, can be determined by calculating the stress required to initiate the Pop-in crack from the Microcracks

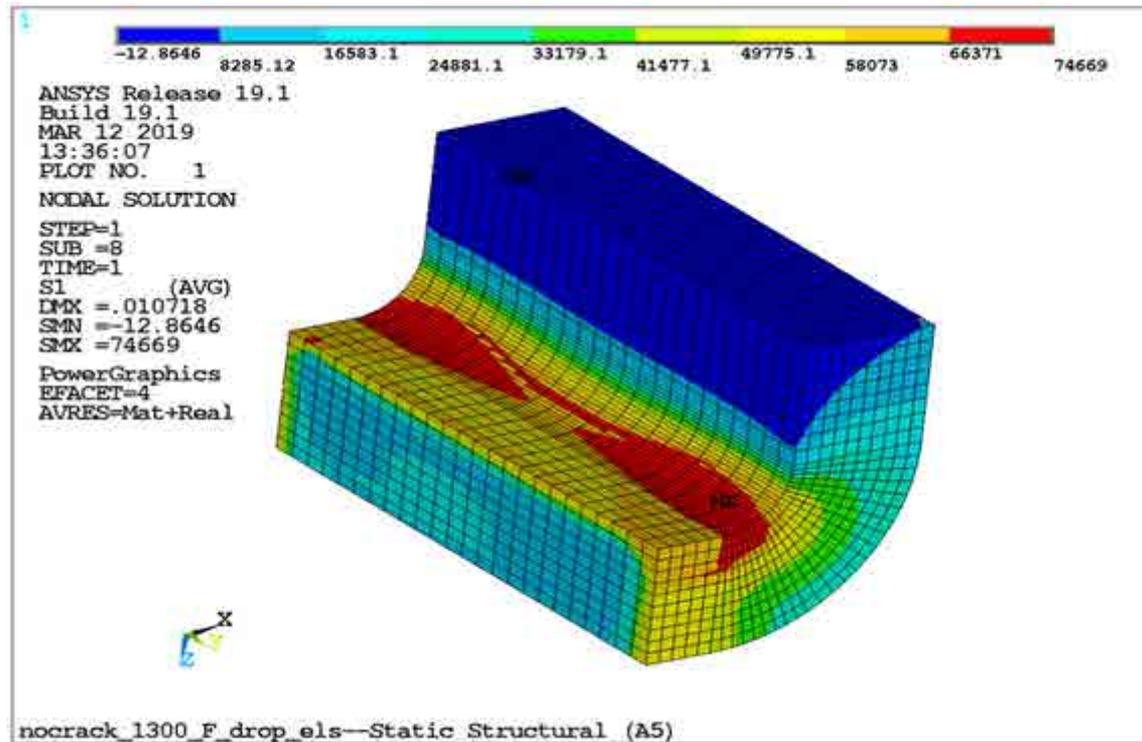
Weld access holes thermally cut before welding

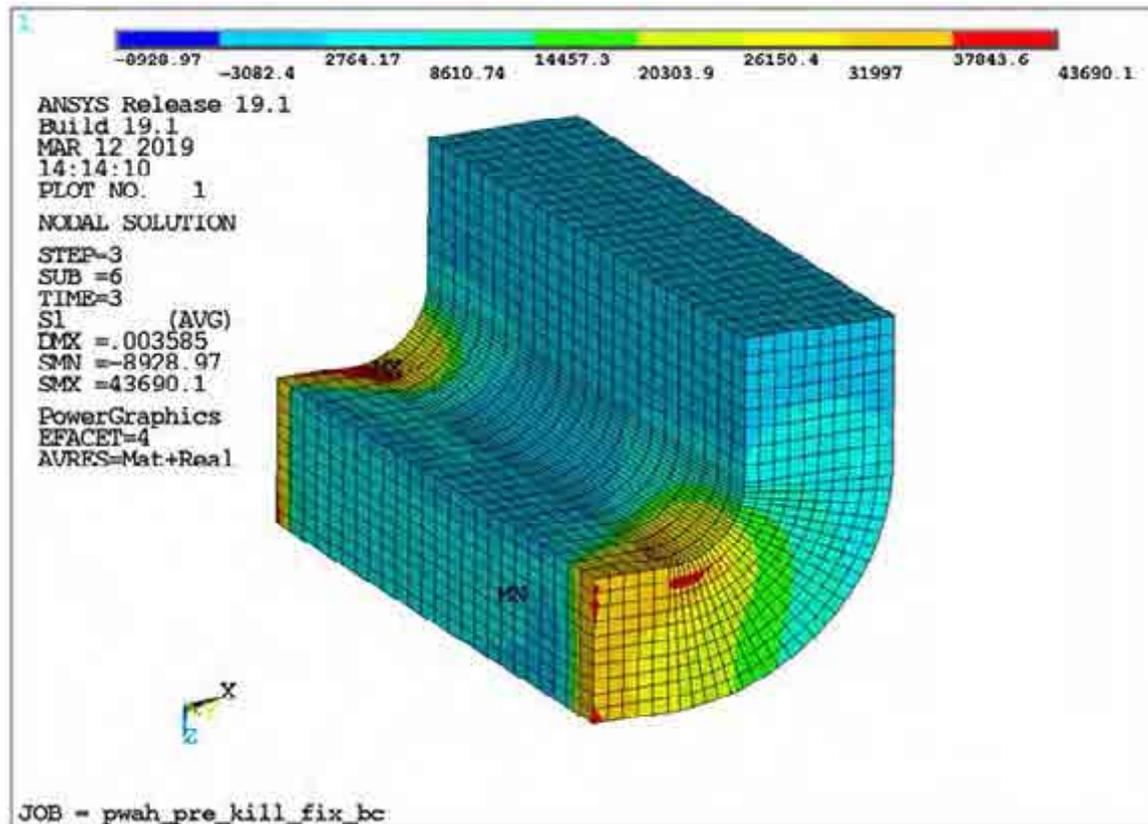
Weld access holes thermally cut after welding

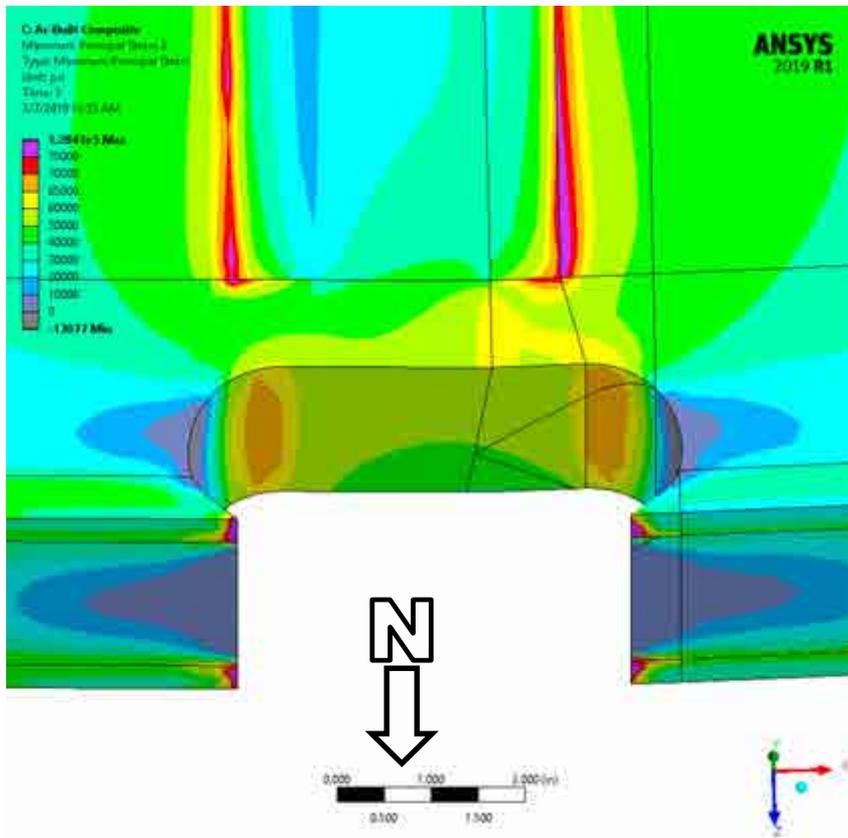
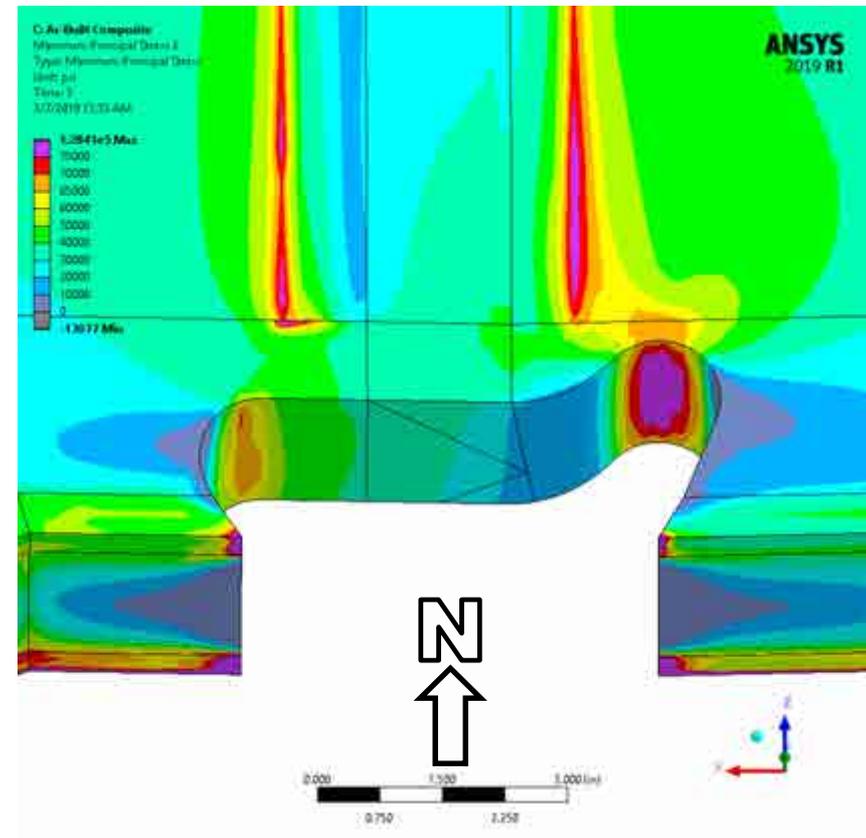
First Street F (S)

As-Built under 1.2DL + 1.6LL

- **Stresses in the First Street girder under the fully factored load state are considered normal and acceptable prior to the bolted repair solution**
- **The bolted repair at First Street provides additional load carrying capacity beyond what is required**
