Update on the temporary closure of the Salesforce Transit Center

October 11, 2018

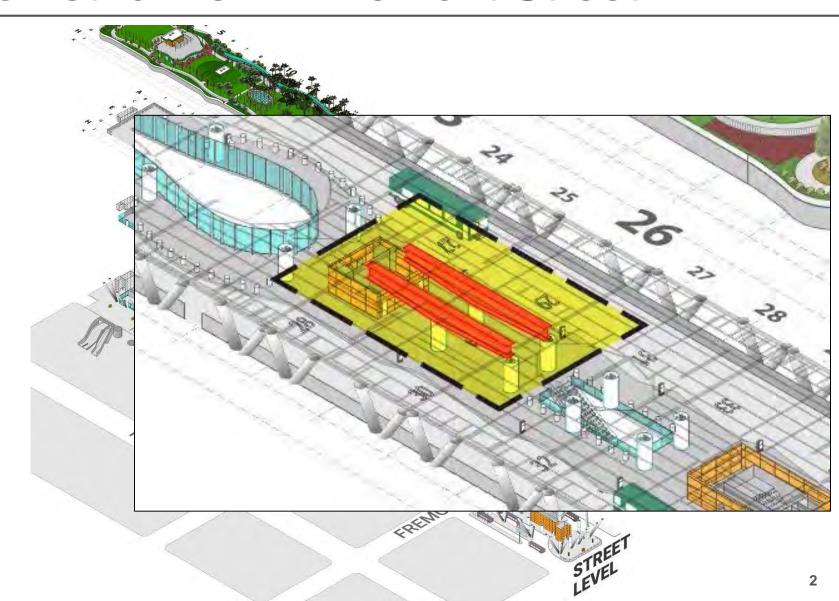
Isometric View – Fremont Street

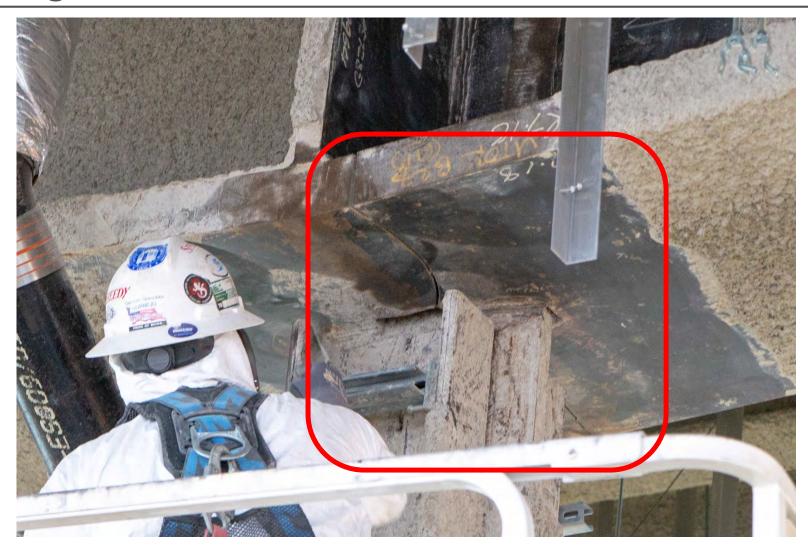
Hanger Beam

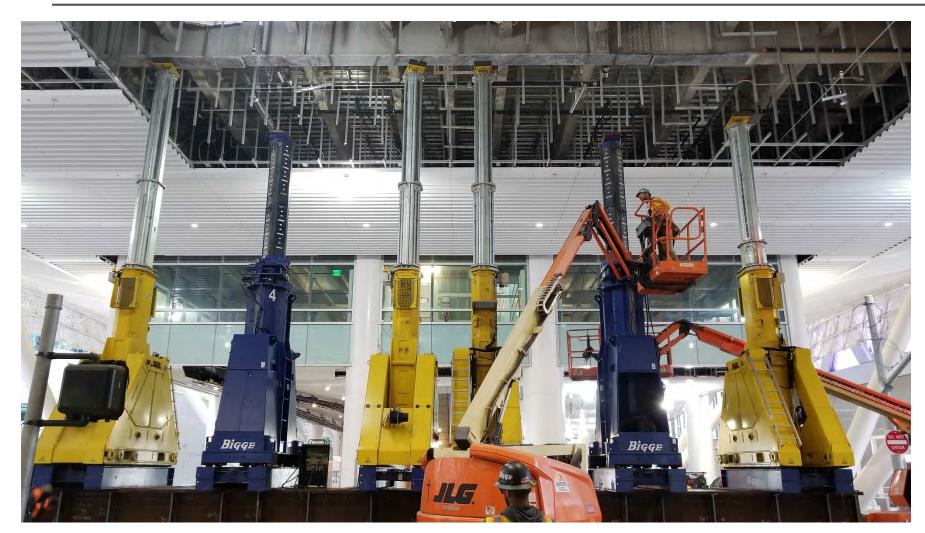
Fremont Street Temporary Support Initial Stabilization Removed - Phase 1

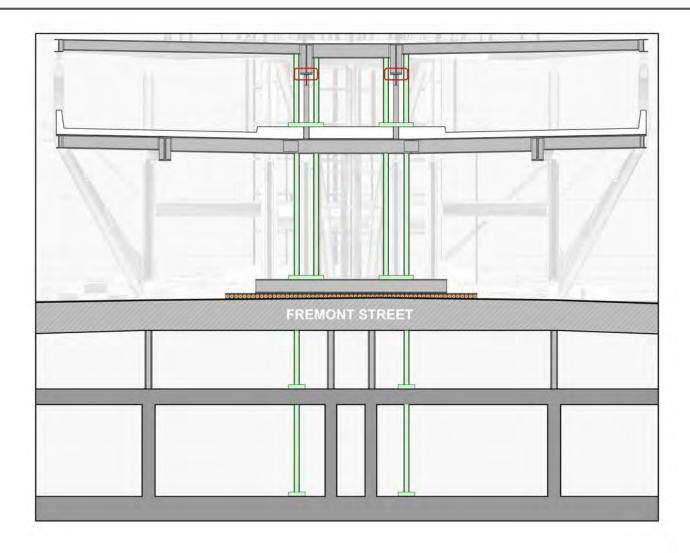
Fremont Street Temporary Support Schematic – Phase 2

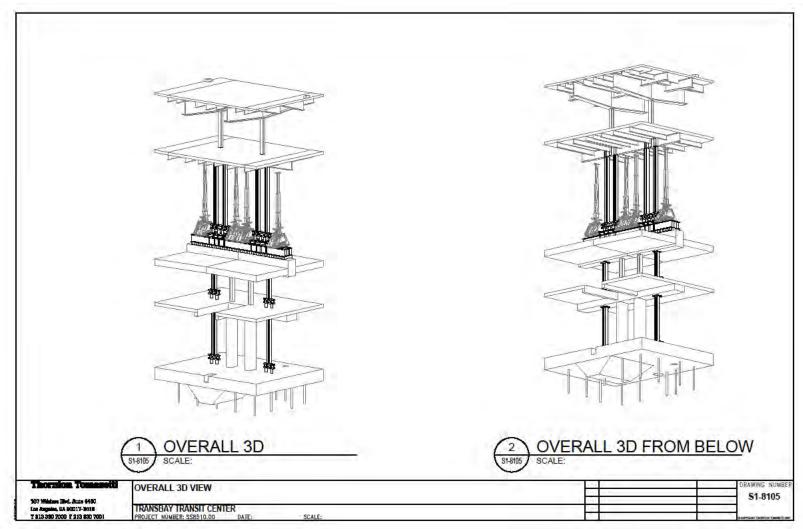
Fremont Street Temporary Support Schematic – Phase 2

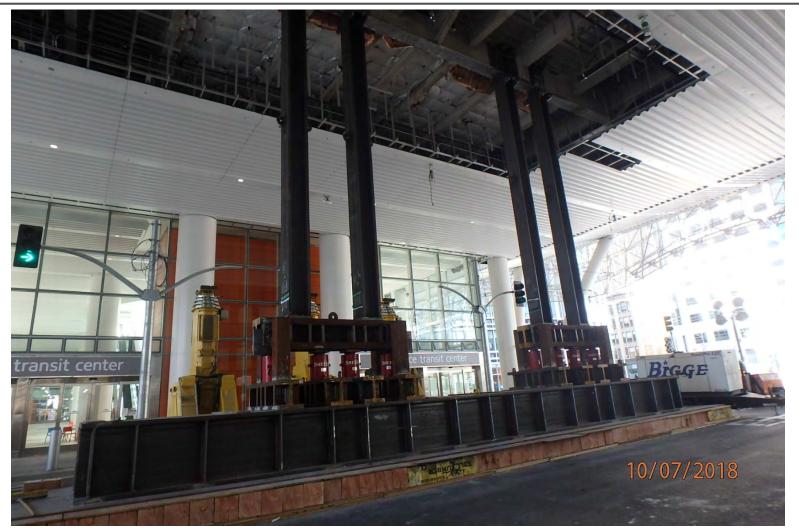
Fremont Street Temporary Support Phase 2 (Ground Level)

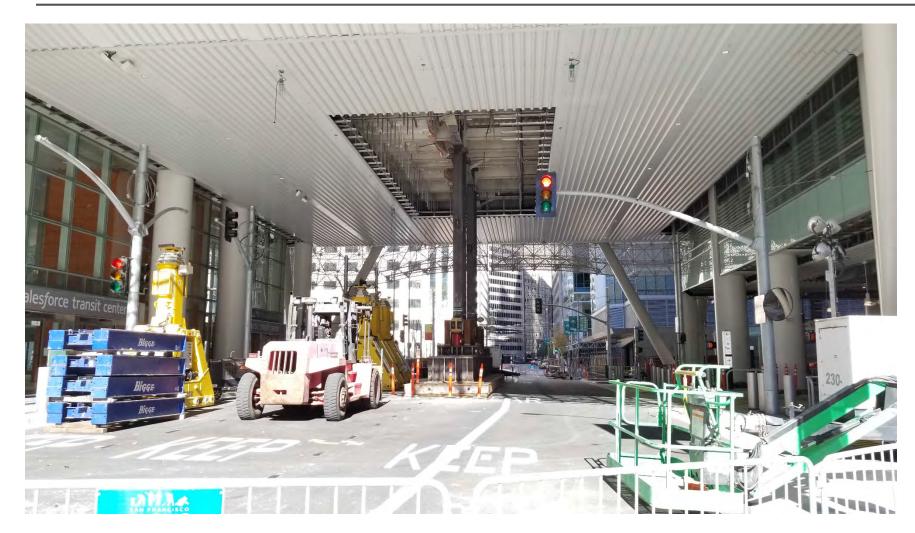
Fremont Street Temporary Support Phase 2 (Ground Level)

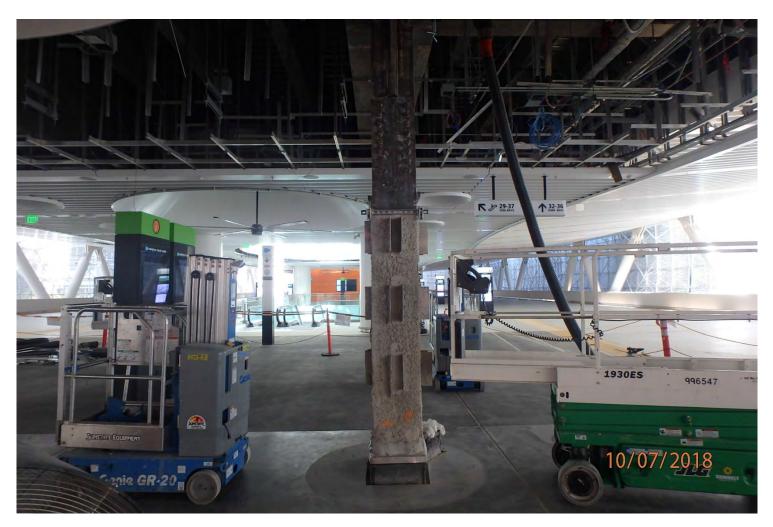
Fremont Street Temporary Support Phase 2 (Bus Deck Level)

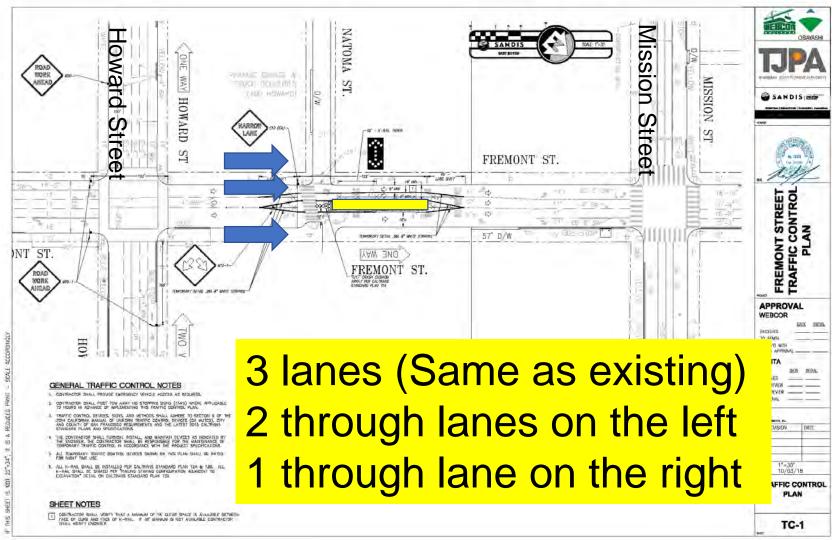
Fremont Street Temporary Support Traffic Control Plan

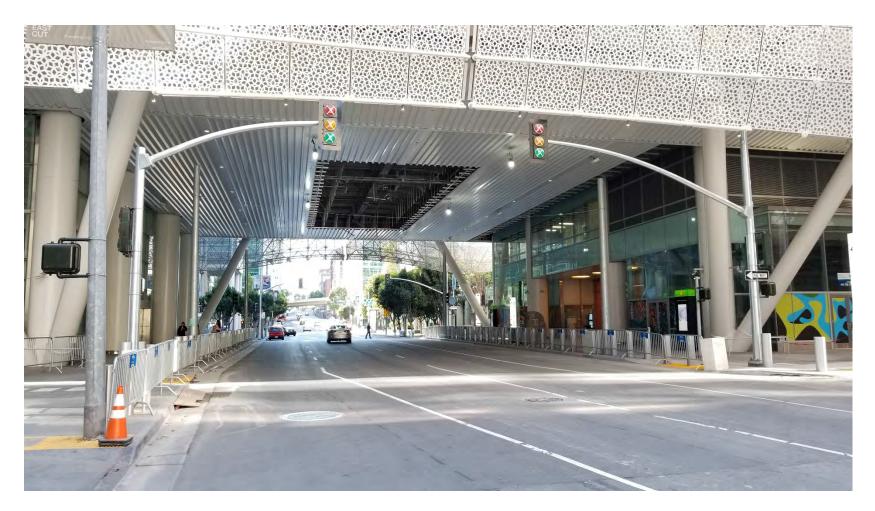
First Street Temporary Support Preparation

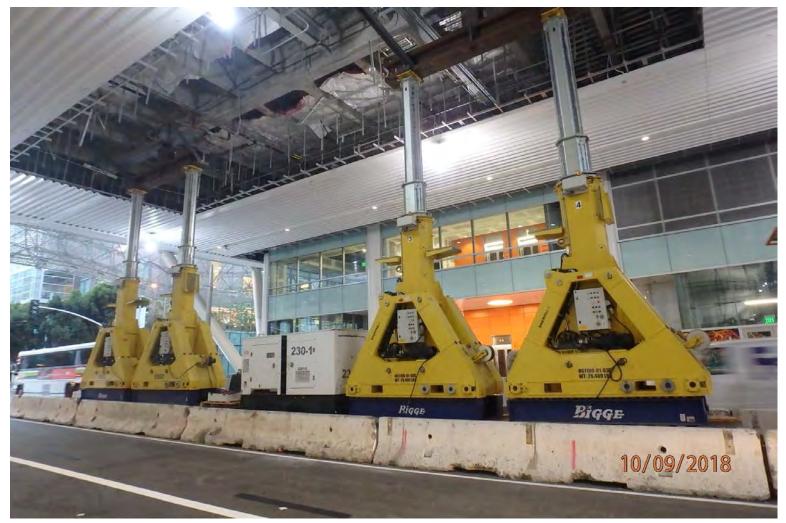
First Street Temporary Support Gantry Jacks installed

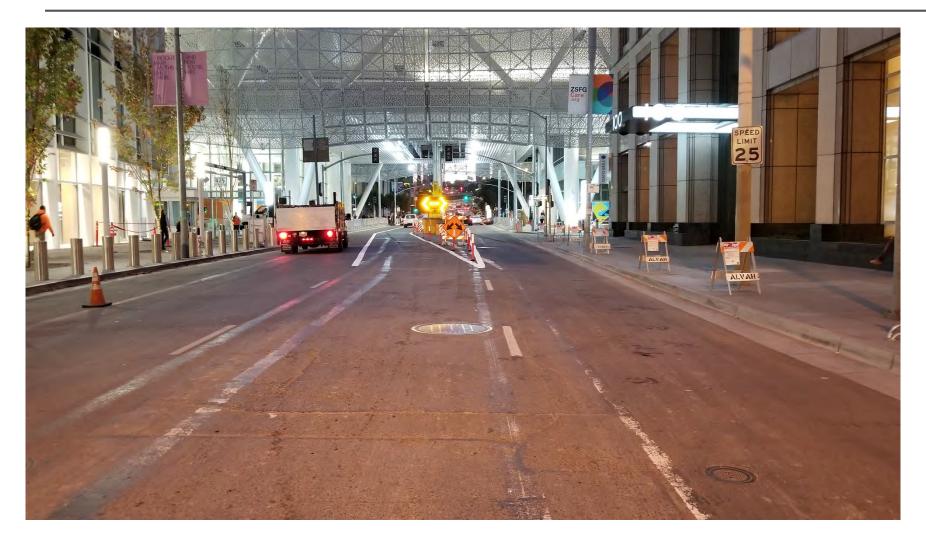
First Street Temporary Supports and Traffic Control installed

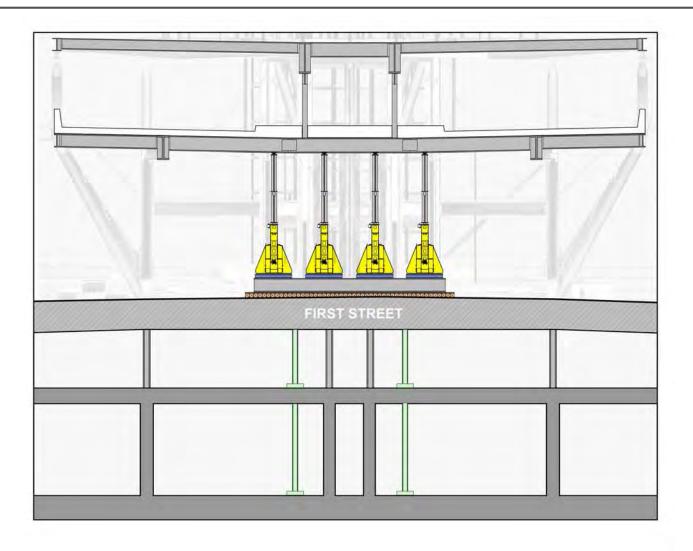
First Street Temporary Support Schematic

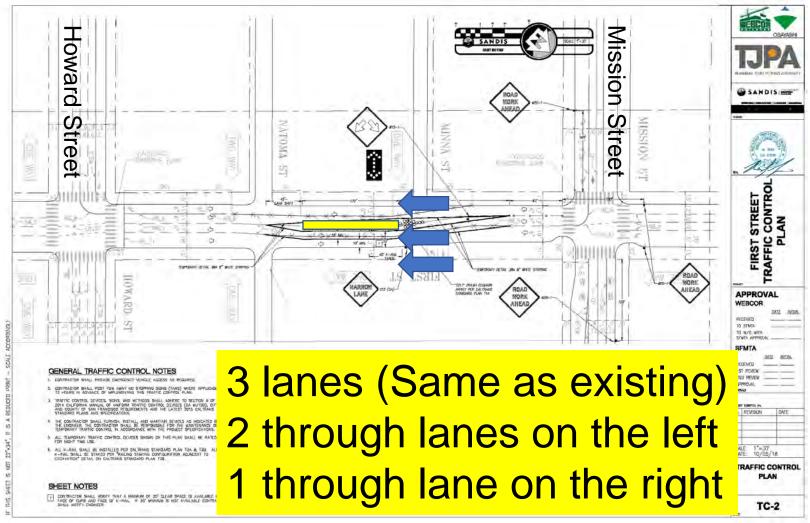
First Street Temporary Support Traffic Control Plan
