# Archaeology at the Temporary Terminal Site

June 10, 2008

# Transbay Transit Center

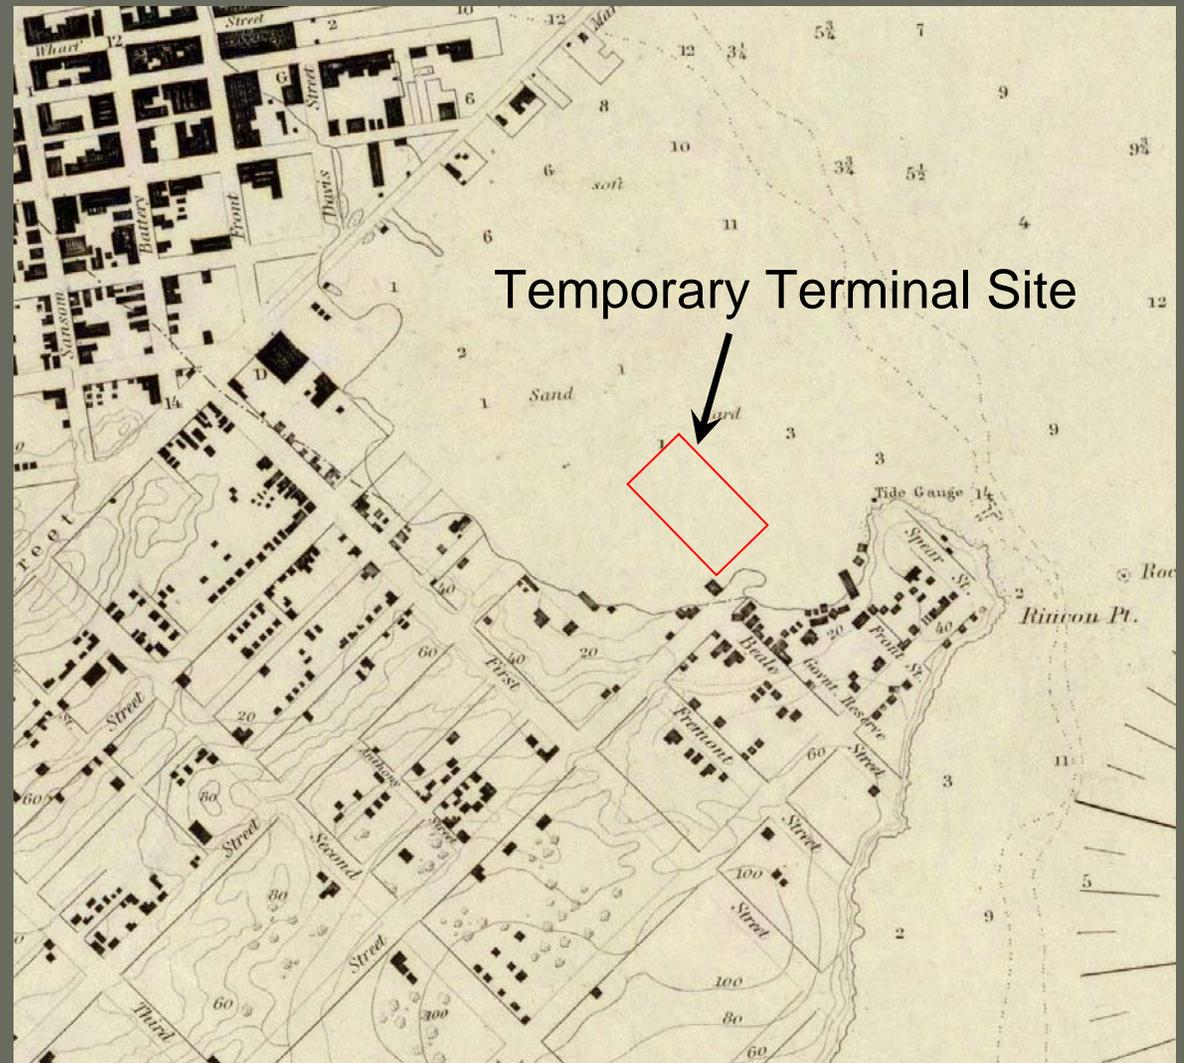
Source: U.S. Coast Survey 1853

- Located almost entirely within the waters of Yerba Buena Cove
- Single building (Building 22) constructed in the southern corner

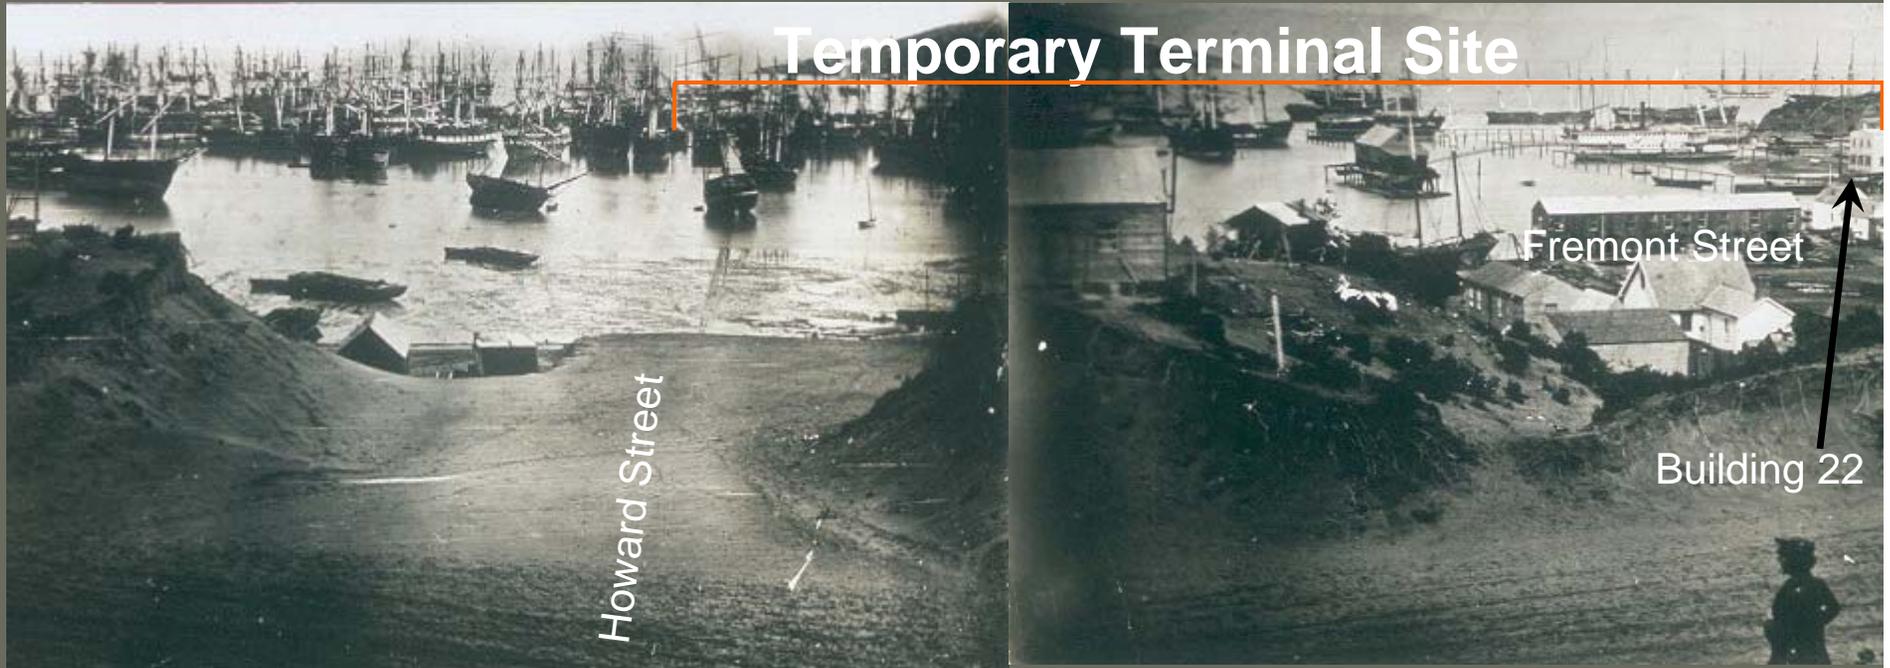
# Temporary Terminal Site View from Rincon Hill, 1851

Temporary Terminal Site

Howard Street

Fremont Street

Building 22

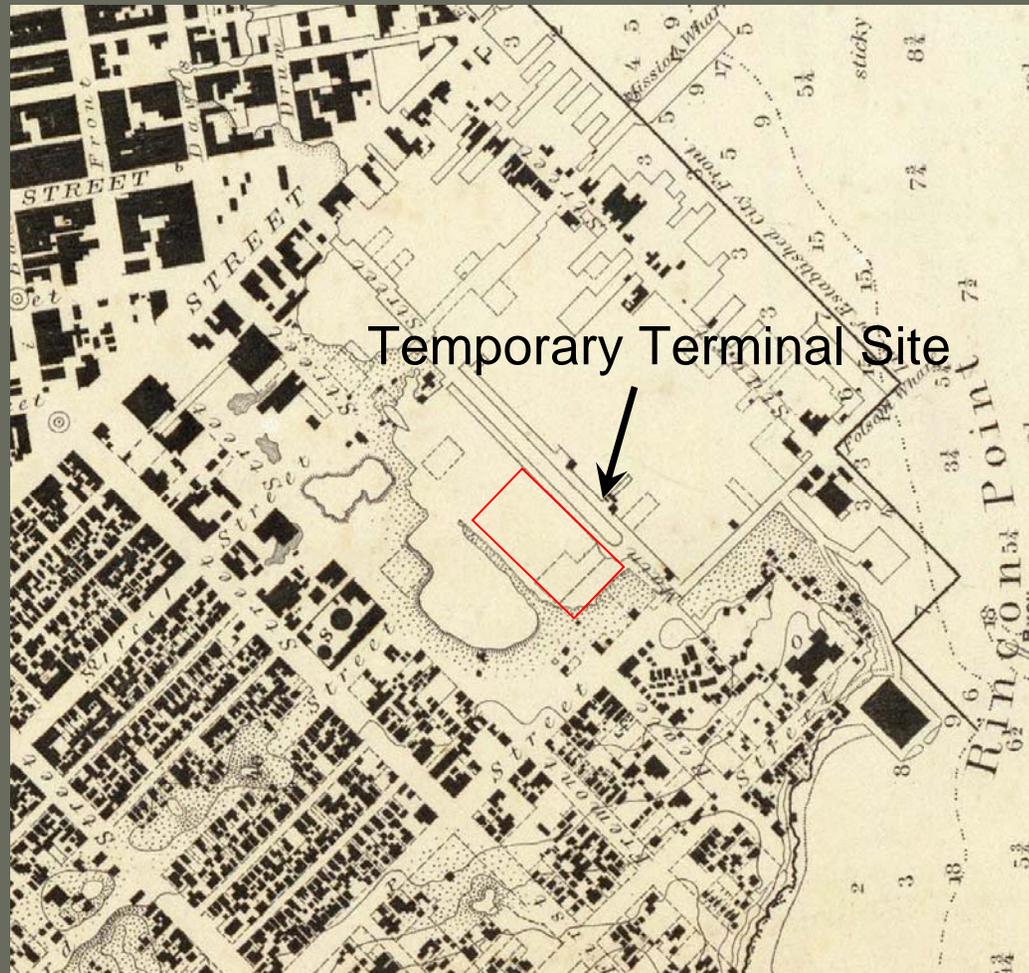
Source: U.S. Coast Survey 1859

- Block has been partially filled
- Structures along Folsom Street
- Bounded by Main Street double wharf

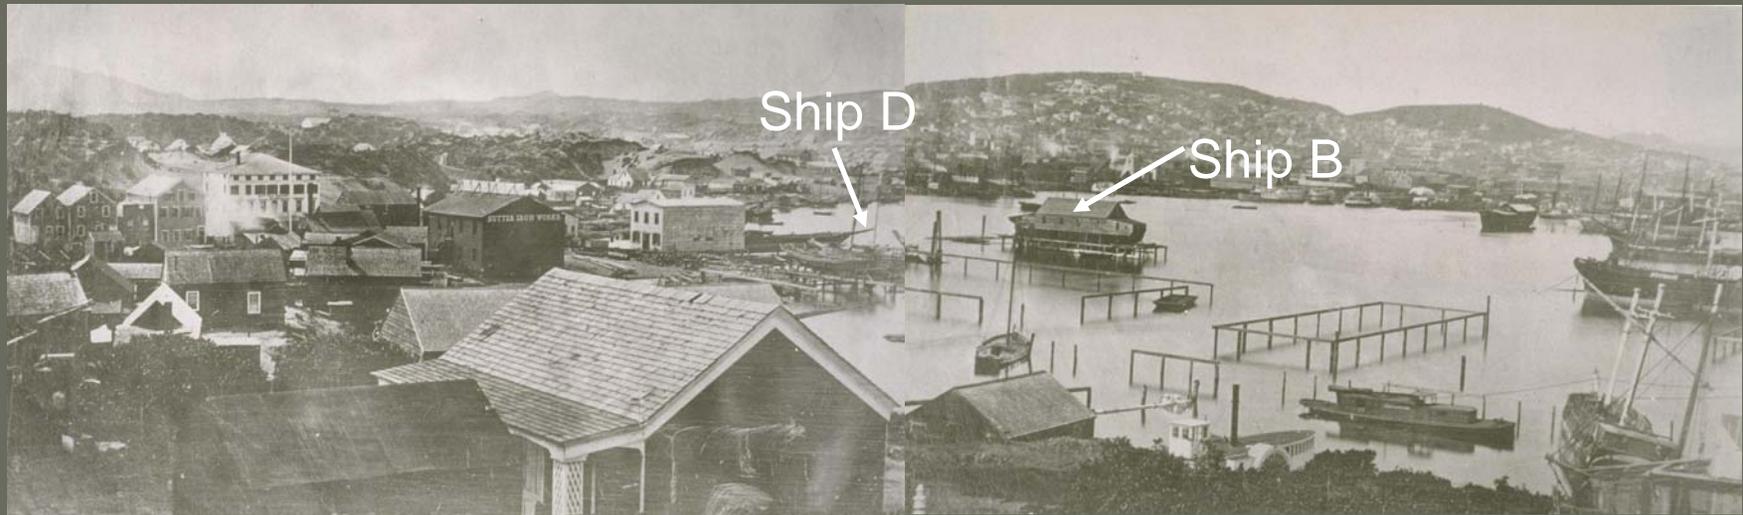
Shew Panorama, 1853

- **Ship B** – abandoned, roofed over and used for storage in 1853; by 1857 it had been removed or dismantled and covered by fill
- **Ship D** - appears in 1852-1853 photos; no evidence of remains found during 1990 borings; Temporary Terminal construction will not disturb soil to depth below fill
- Ship remains potentially buried under 10-18 ft. of historic fill

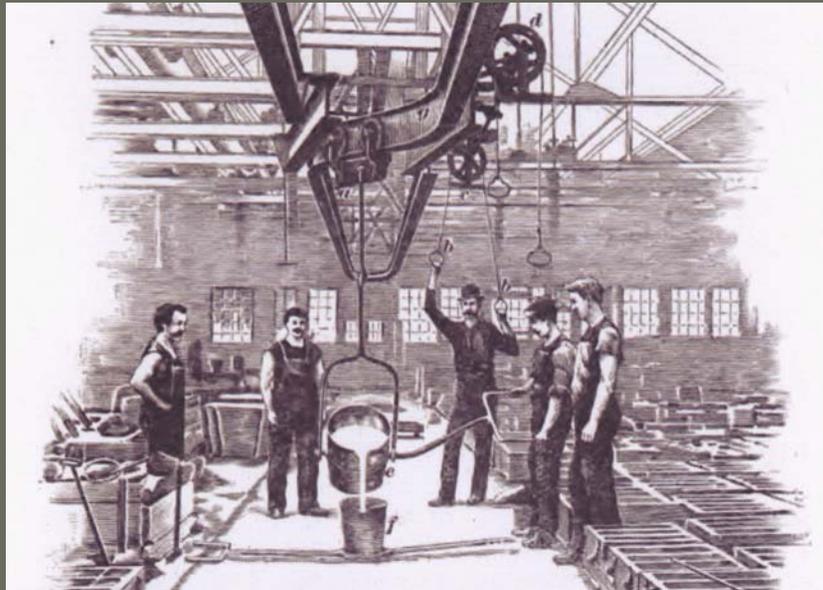
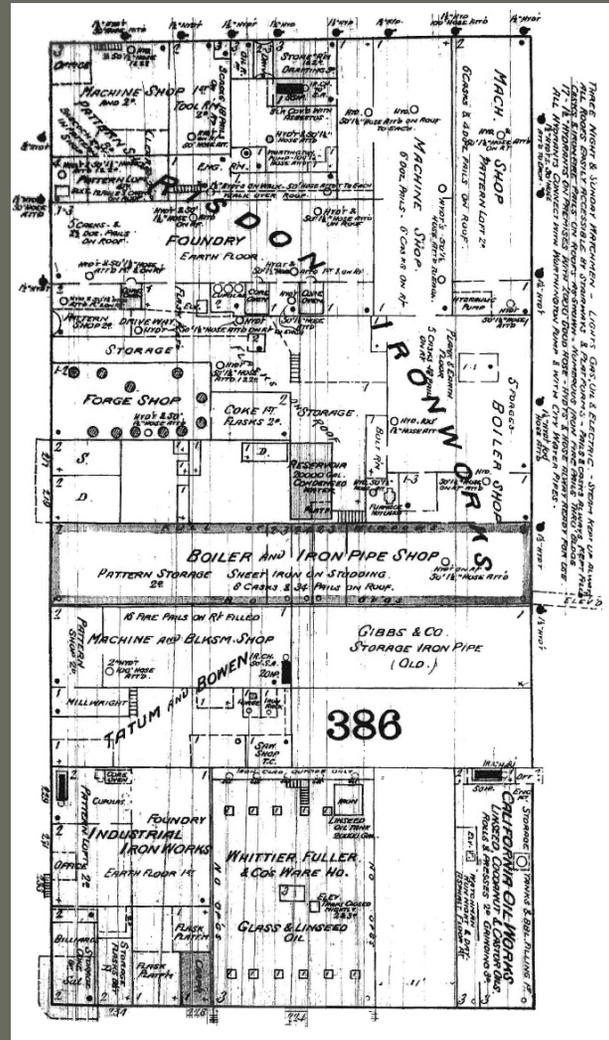
Source: 1887  
Sanborn Map

- Risdon Ironworks (est. 1868)
- Tatum & Bowen (machine and blacksmith shop)
- Industrial Ironworks
- Whittier Fuller & Co. Warehouse
- California Oil Works

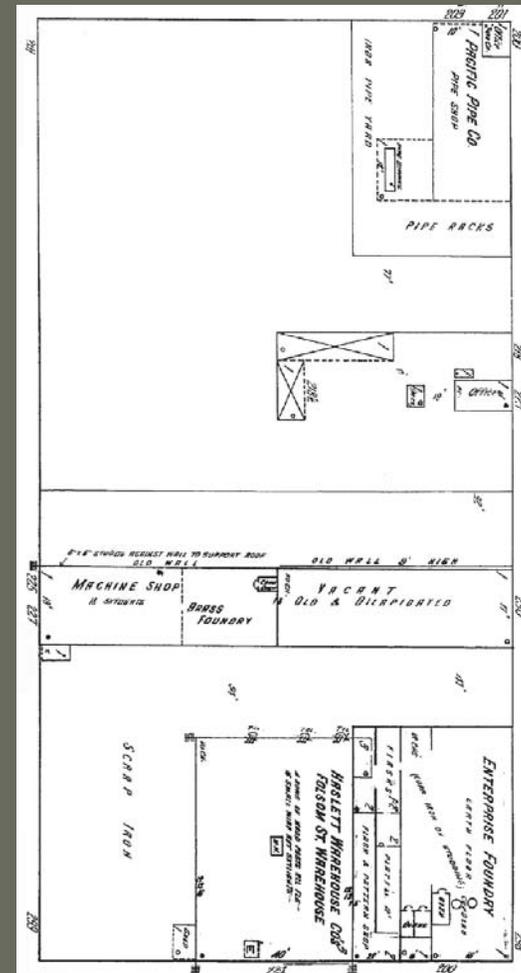
Source: 1913 Sanborn Map

- Most of site vacant land in 1913
- Pacific Pipe Co.
- Machine Shop
- Brass Foundry
- Enterprise Foundry
- Haslett Warehouse
- Scrap Iron Storage
- Vacant Building

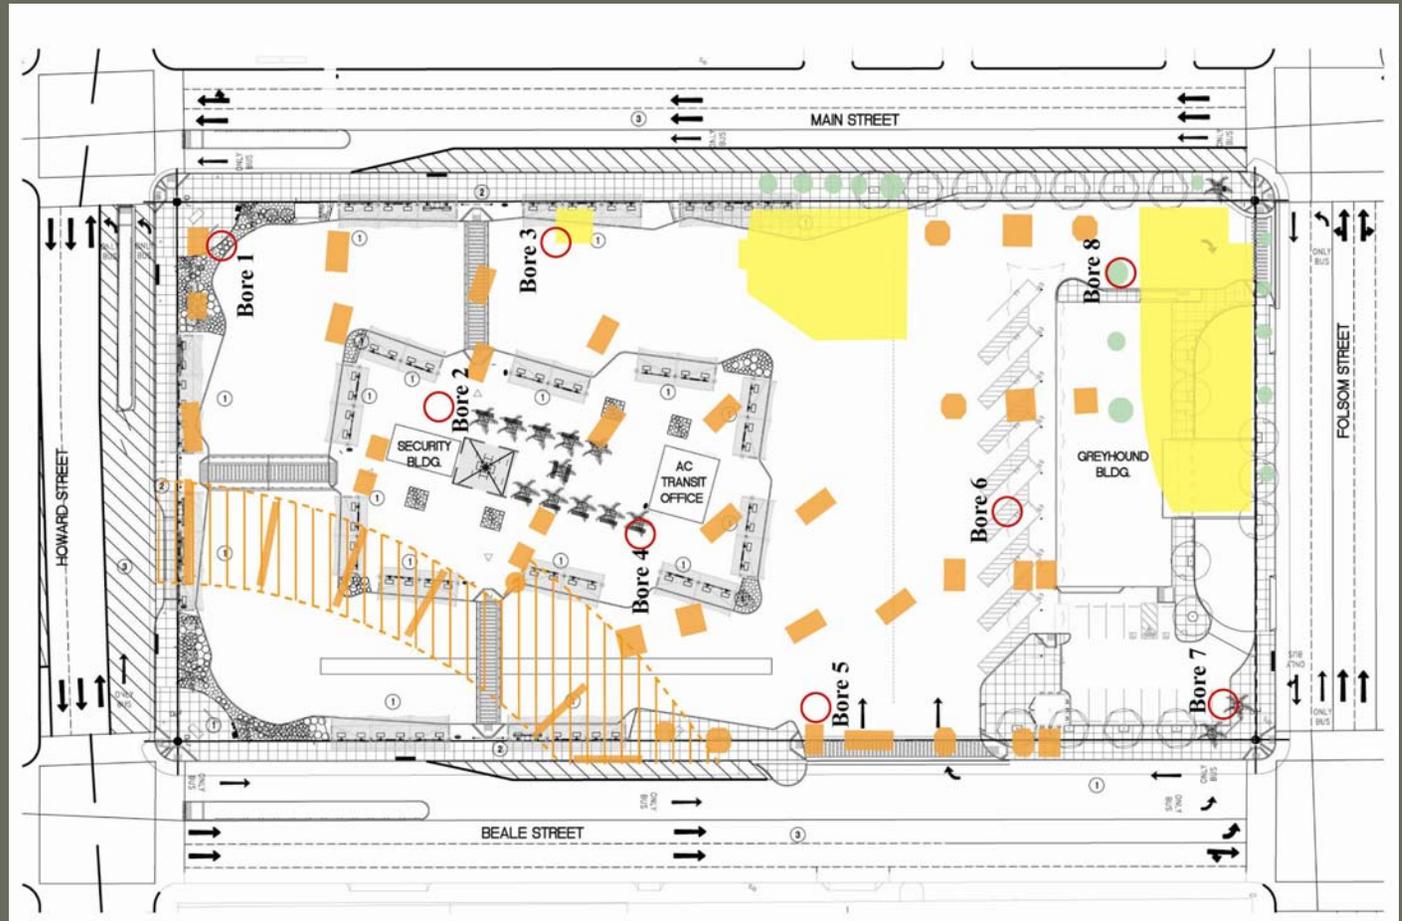
# Temporary Terminal Site Previous Disturbance

- Transbay Viaduct
- Footings for SF-480
- Soil Bores
- Buildings

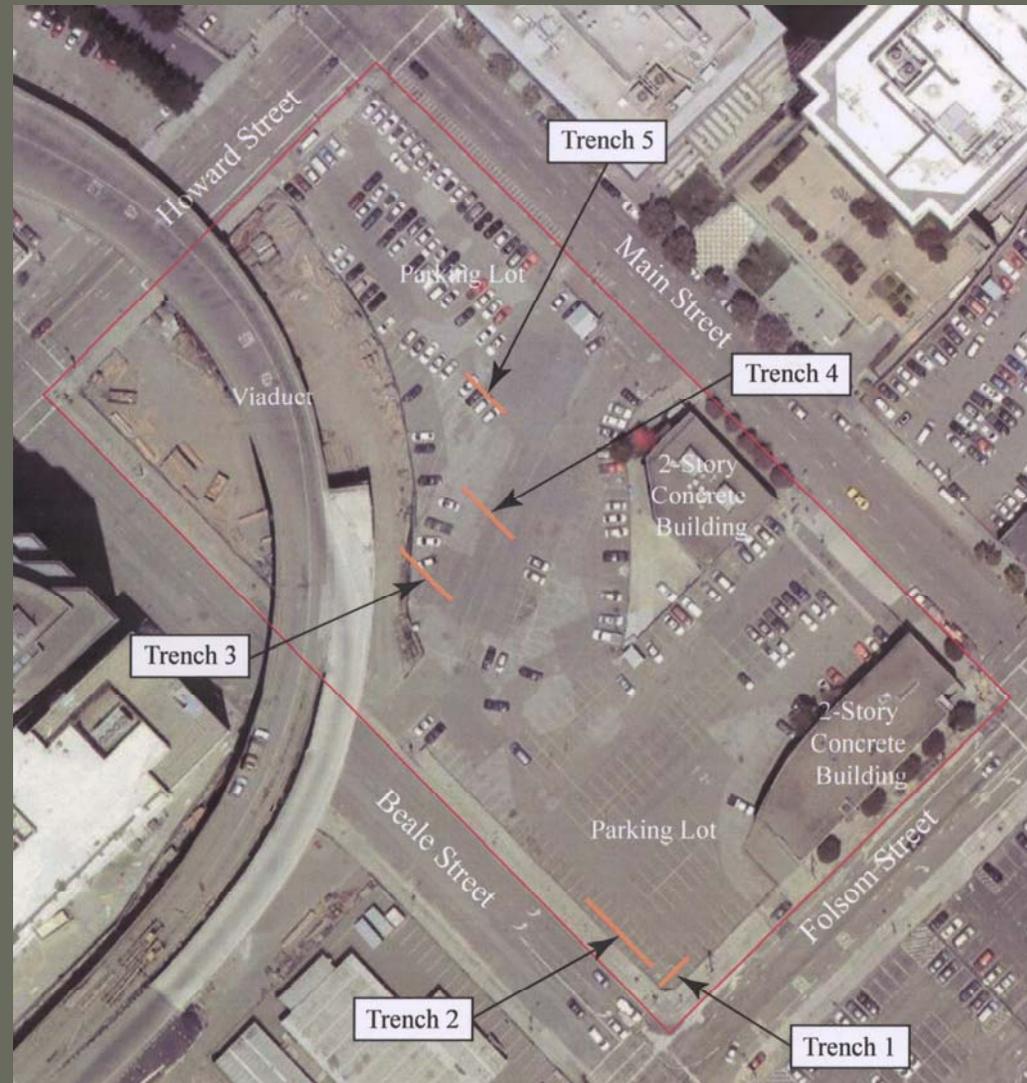
# Temporary Terminal Site Proposed Testing Program

- 5 test trenches (each 3 ft. wide, 4 ft. deep)
- Intact archaeological deposits limited by previous disturbance
- Testing limited to areas of proposed ground disturbance for current project
- Testing designed to identify archaeological deposits that are potentially eligible for listing in the NRHP
