# Transbay Transit Center Project Shoring Wall and Excavation Construction

June 8, 2010

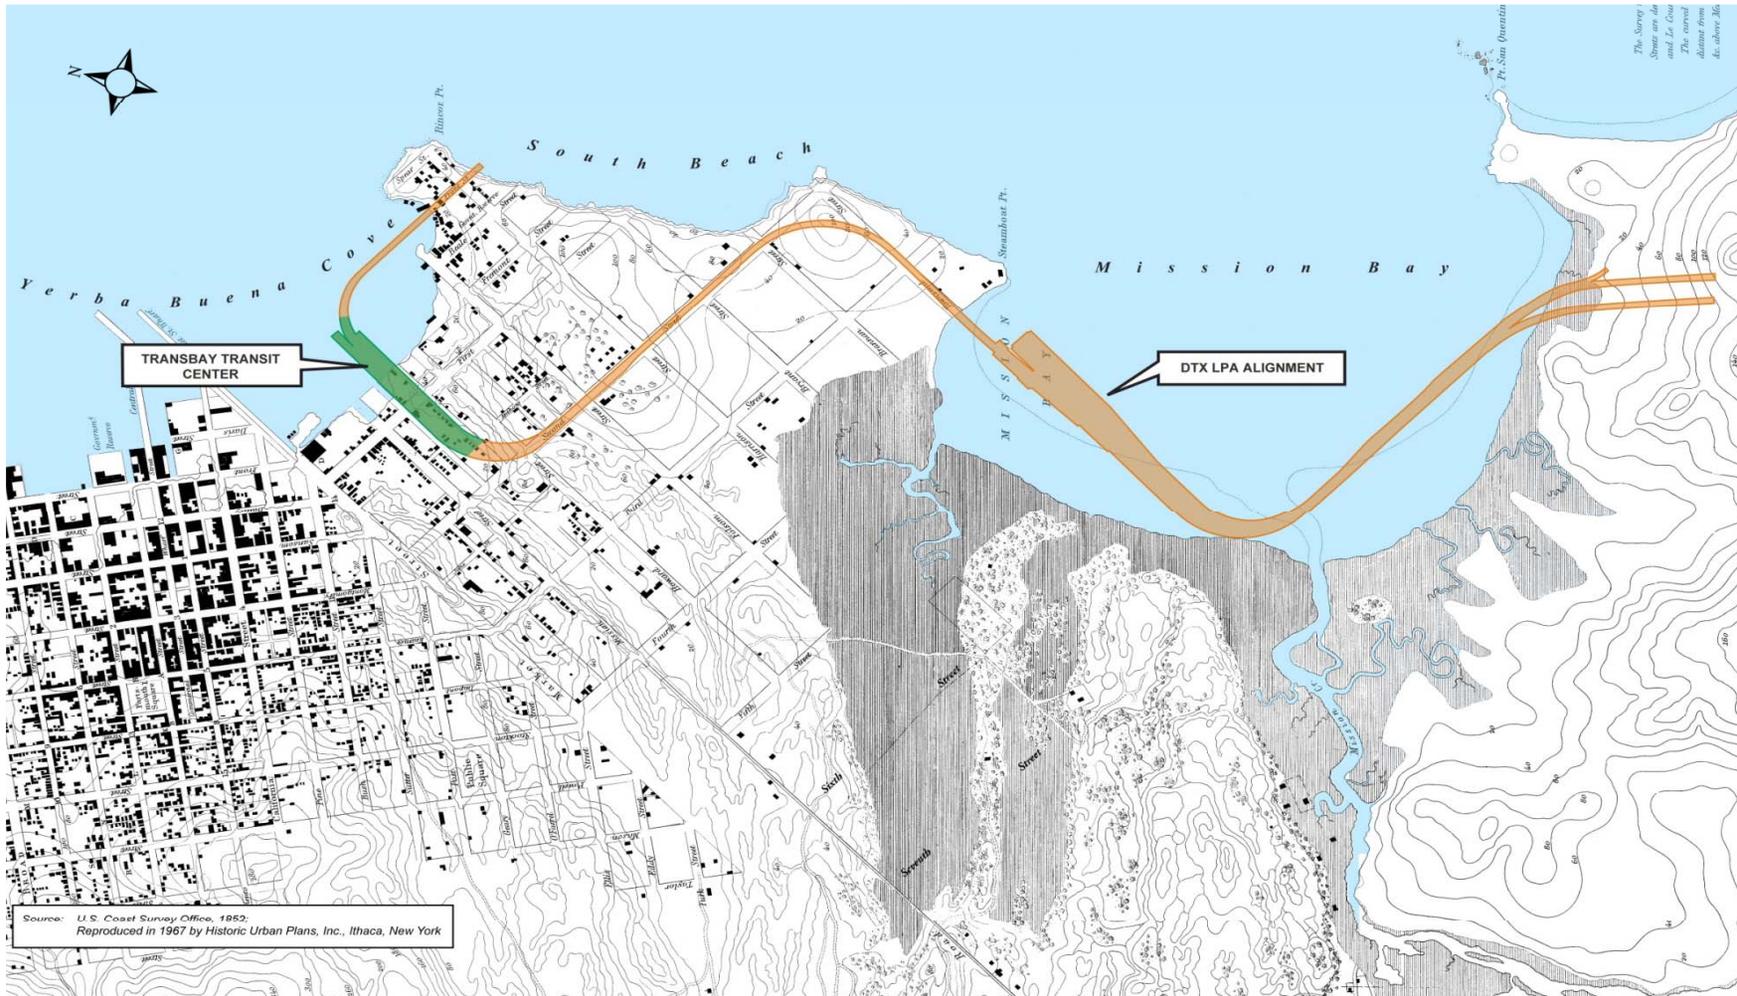
# 1852 Shoreline and Site Conditions Relative to the DTX and the Terminal

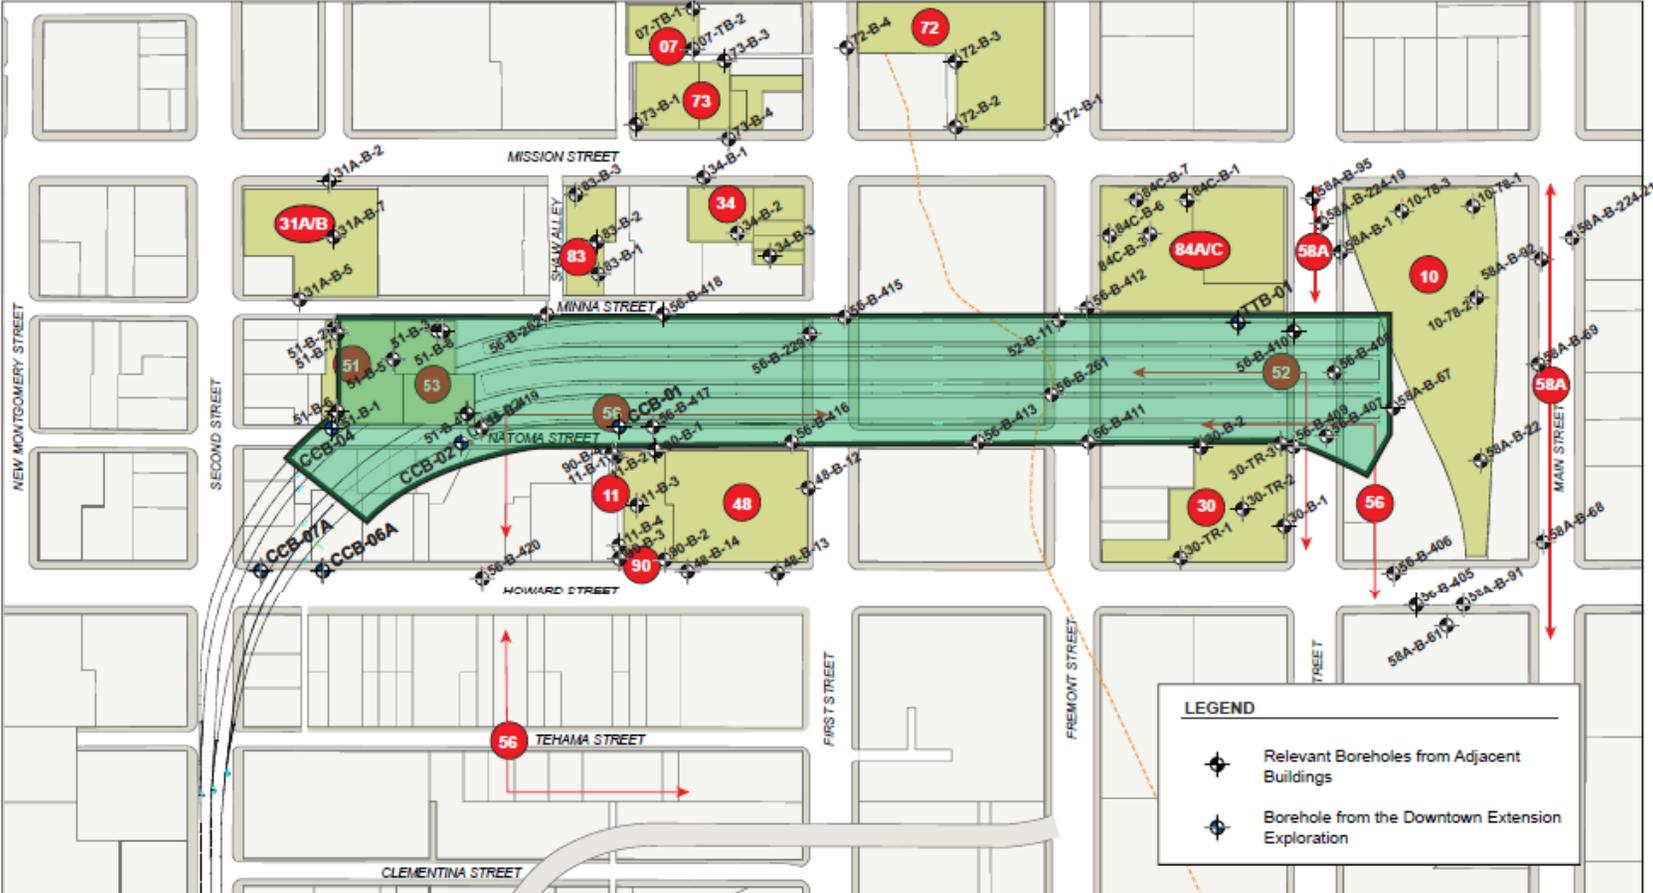
PLATE 4

# Borehole Locations and Adjacent 3<sup>rd</sup> Party Geotechnical Data

LOCATIONS OF BOREHOLES WITH RELEVANT GEOTECHNICAL DATA IN THE VICINITY OF THE TRANSBAY TRANSIT CENTER  
 Transbay Transit Center  
 Final Geotechnical Data Report  
 Transbay Joint Powers Authority  
 San Francisco, California  
 February 2010

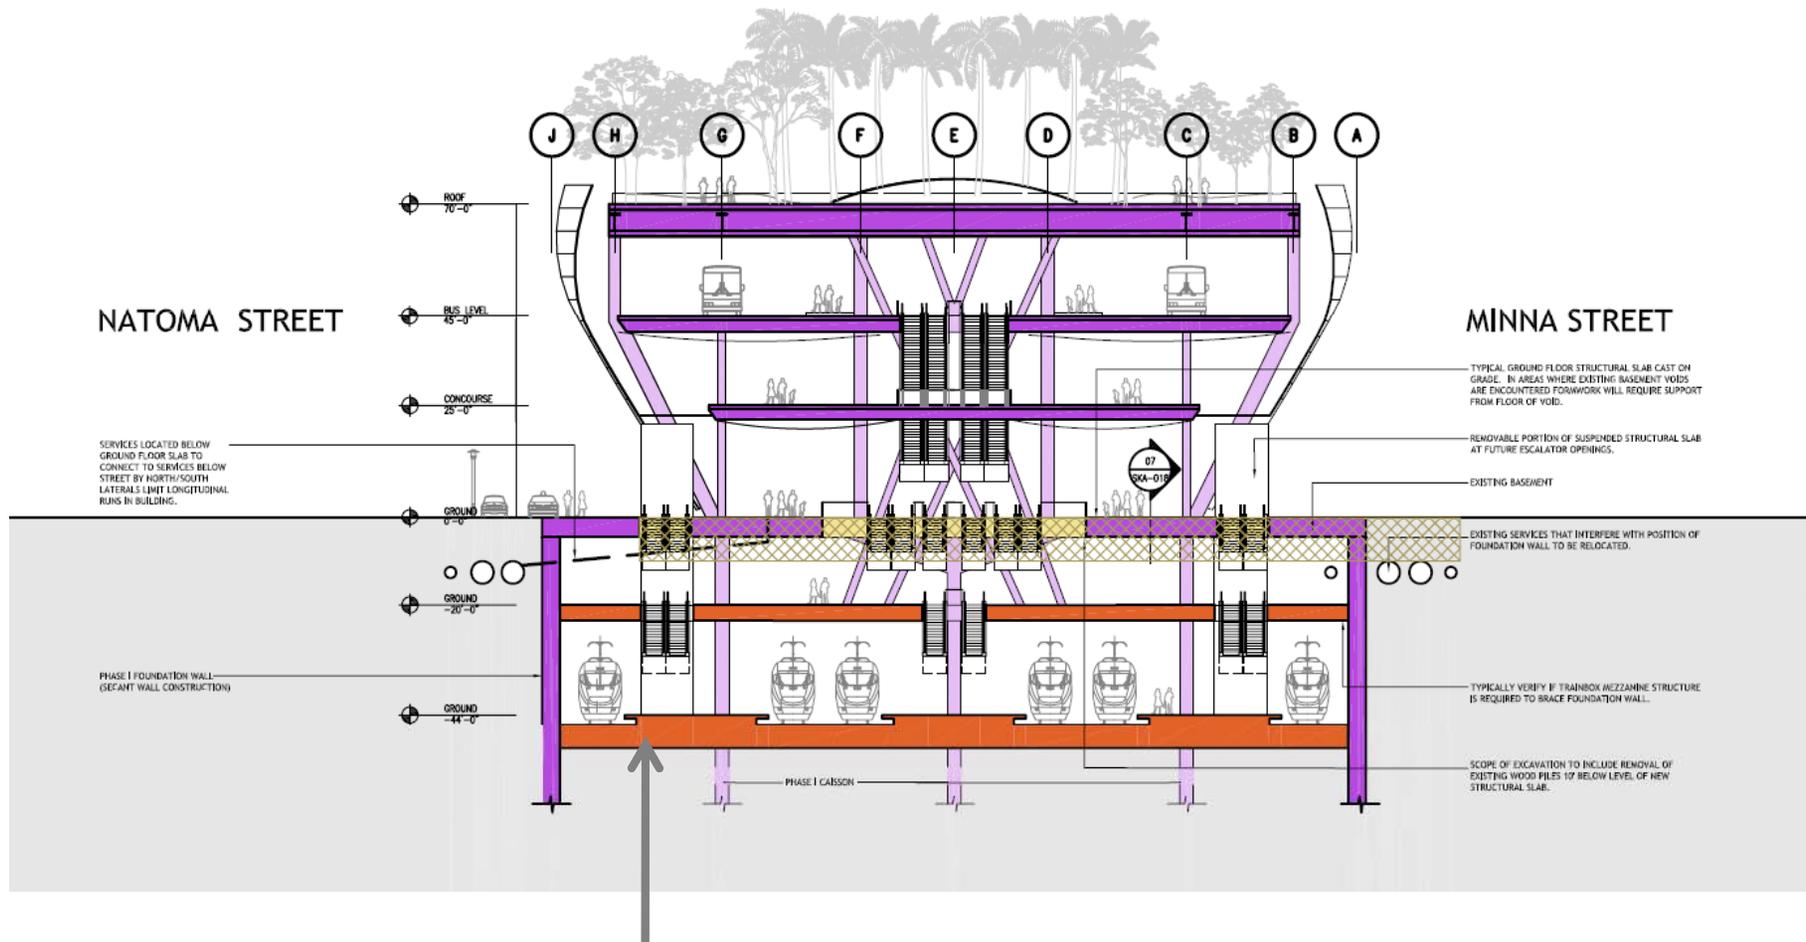
# Train Box and Superstructure: Transverse Section

Underside of base mat: -41 ft NAVD88

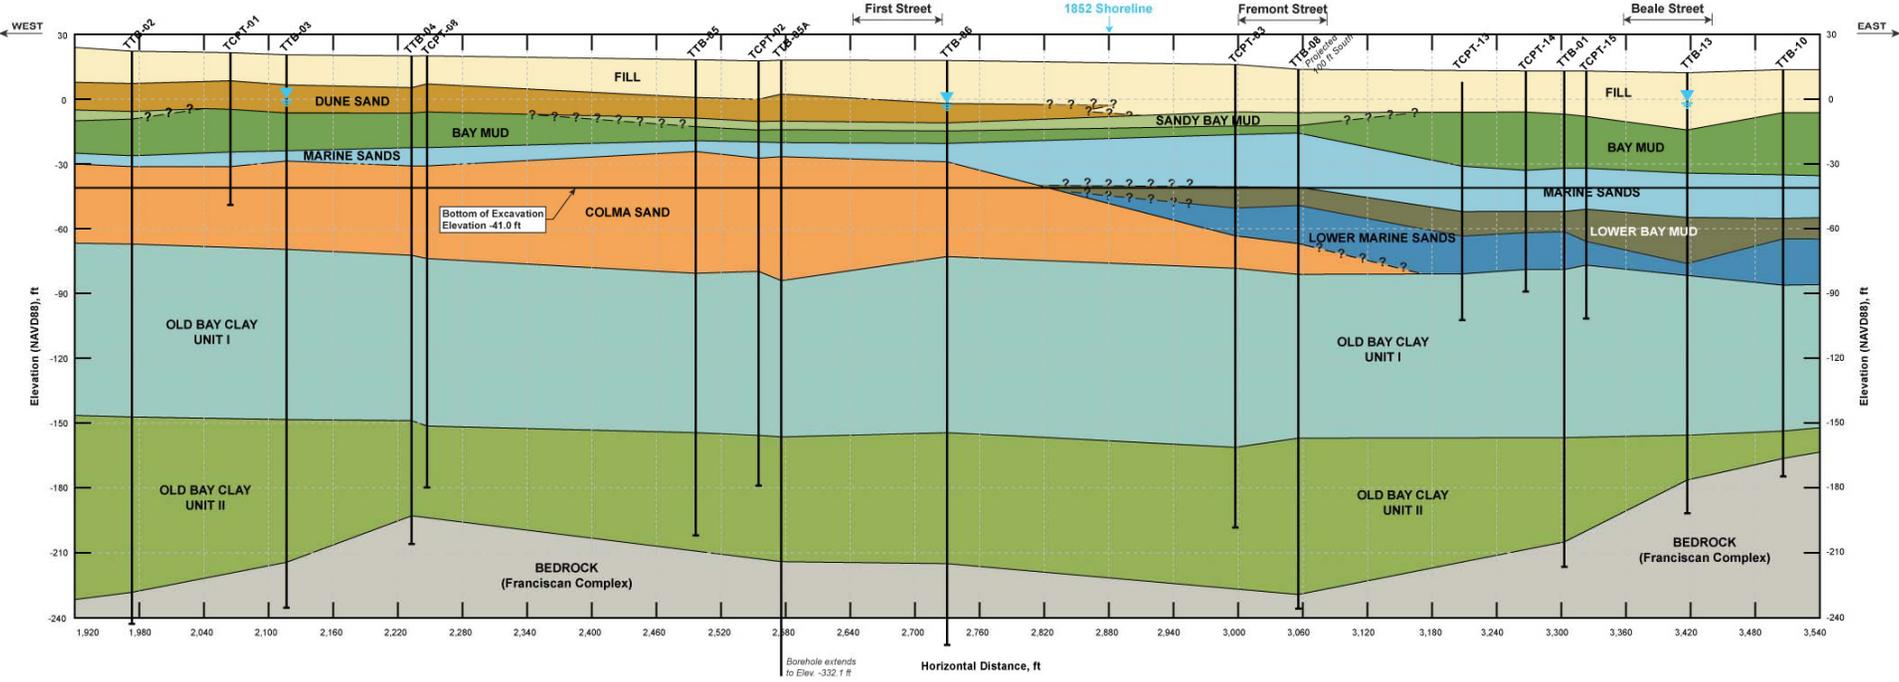
# Vertical Section Along Minna Street

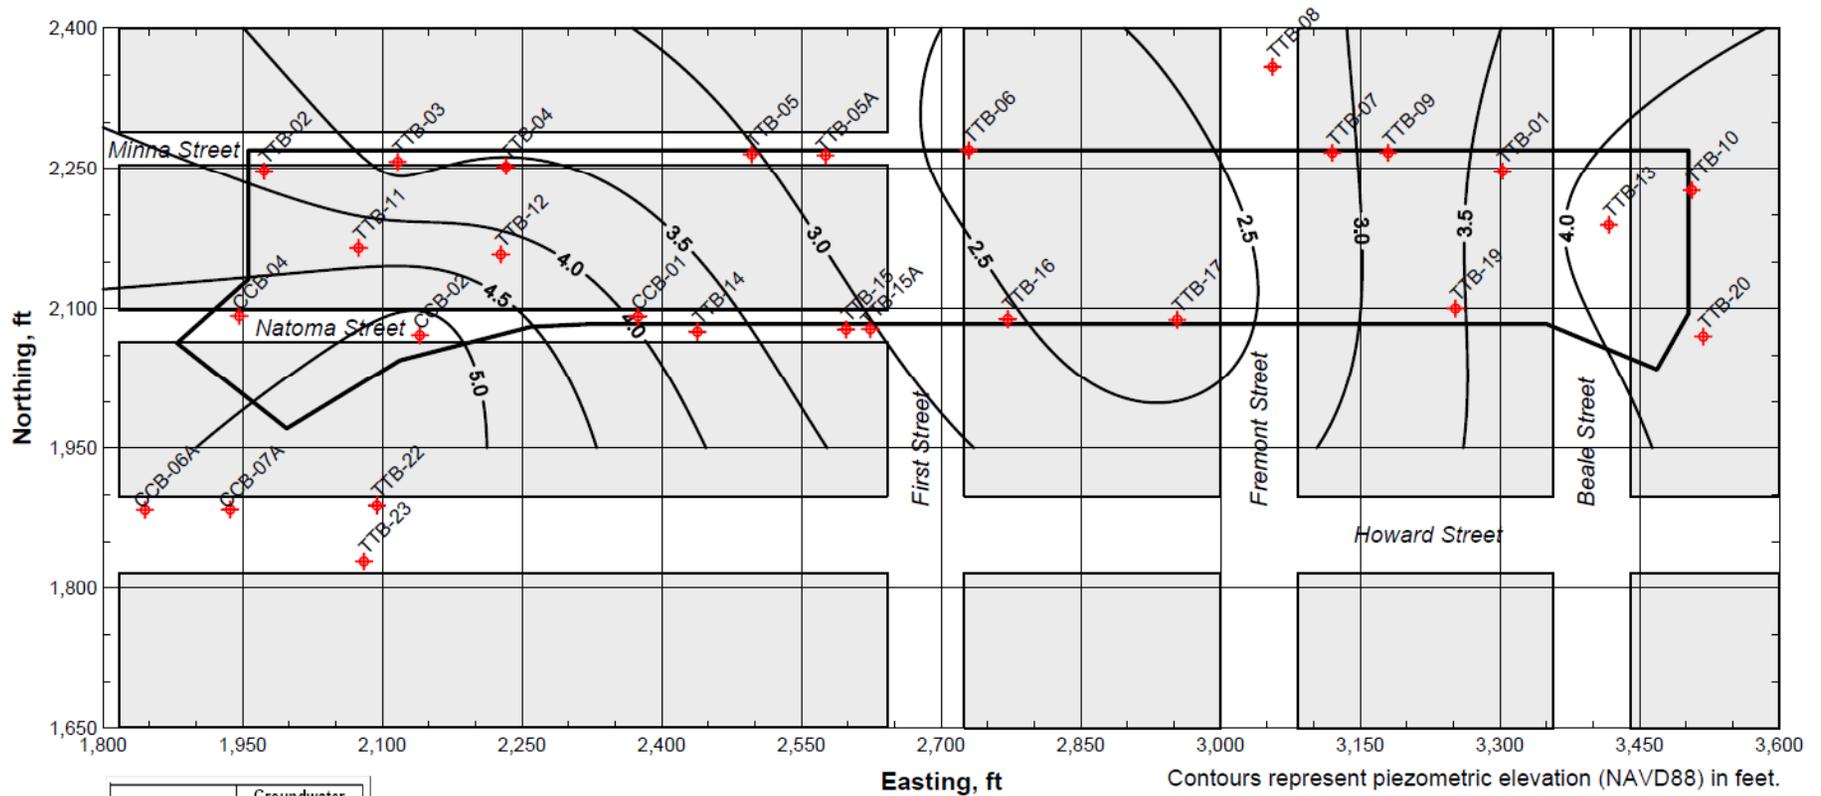
# Water Level Contours

Borehole ID	Groundwater Elevation (NAVD88), ft
TTB-03	3.34
TTB-06	2.37
TTB-13	4.22
TTB-14	3.73
TTB-17	2.13
TTB-22	5.23
CCB-02	5.28

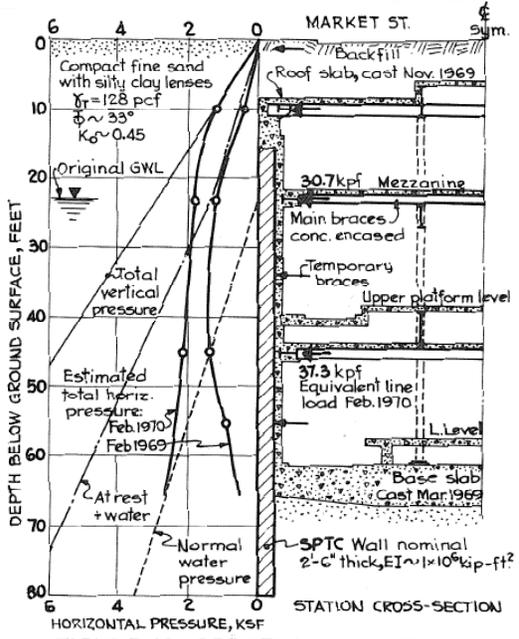
# Construction of train box inside temporary braced shoring wall

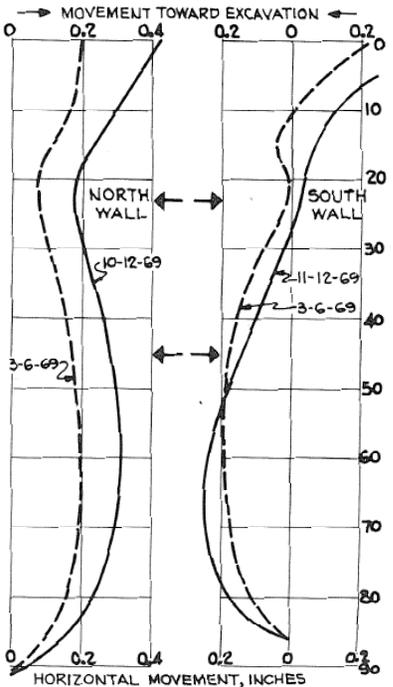
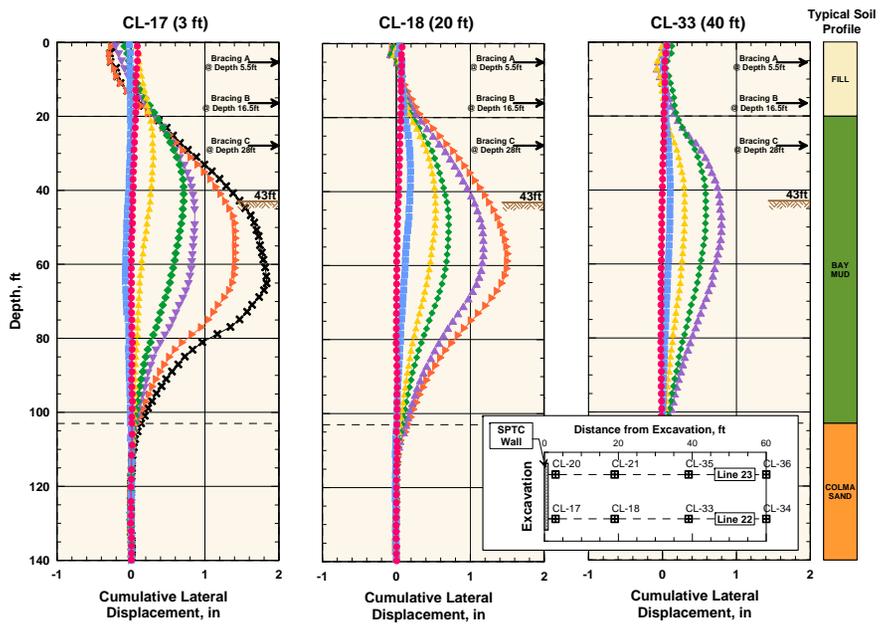
FIGURE 13, OBSERVATIONS AT POWELL ST. STATION, BART

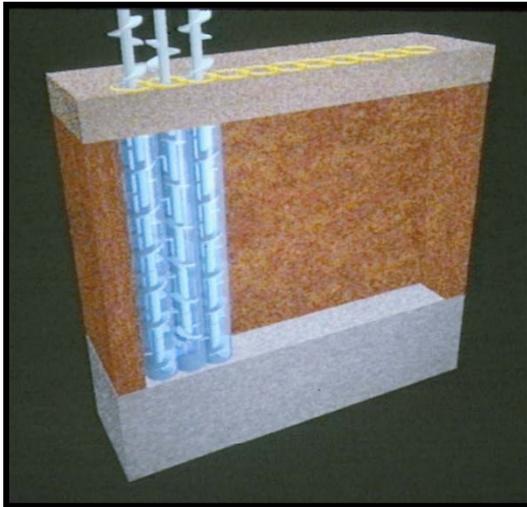
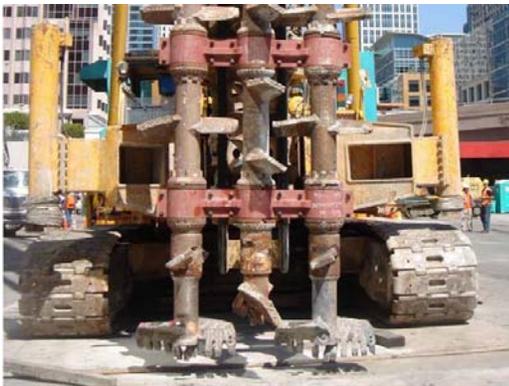
# Soil-Cement Walls – Sequence of Installation

## 1) Mixing of First Primary Panel

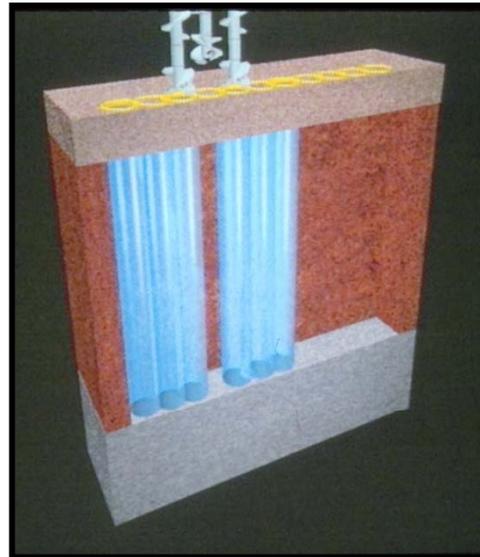
## 2) Mixing of Second Primary Panel

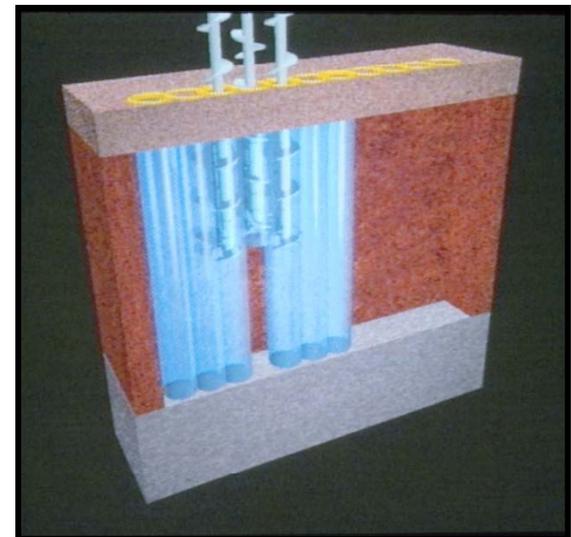
## 3) Mixing of Secondary Panel Between Two Primary Panels

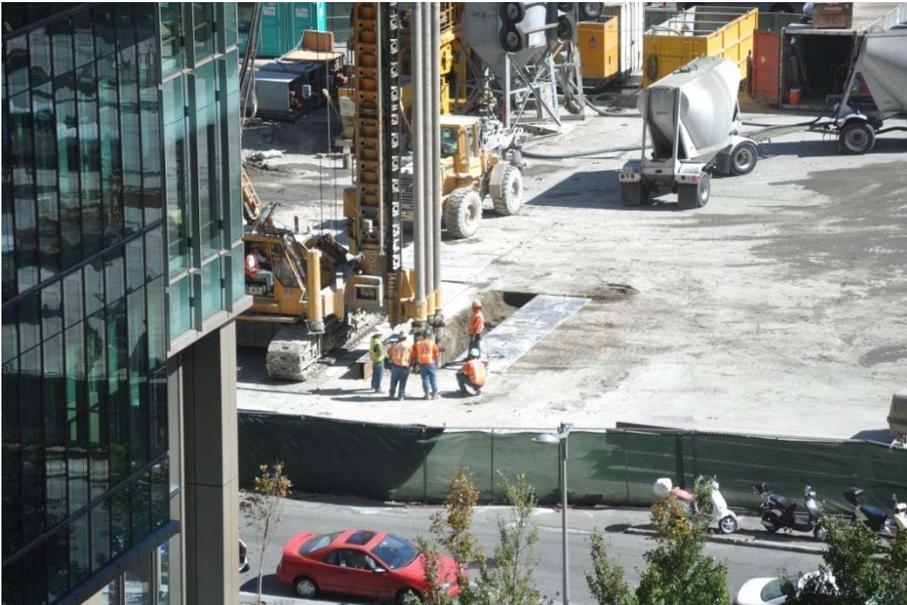
## DMM Rig during constructability trials

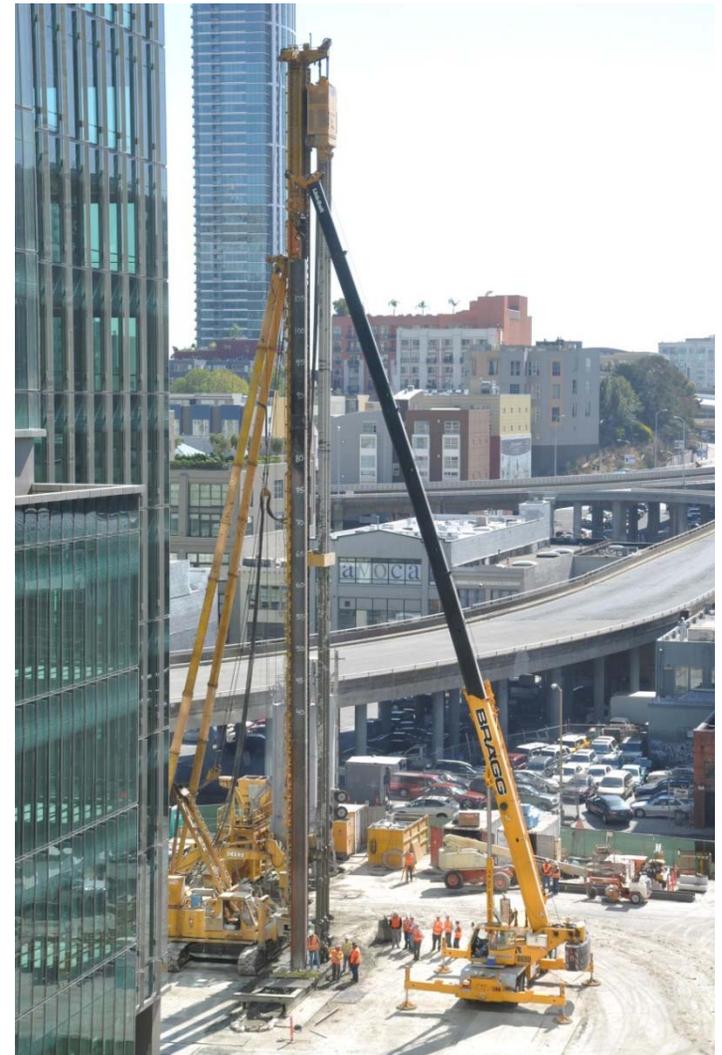
## Installation of Beam

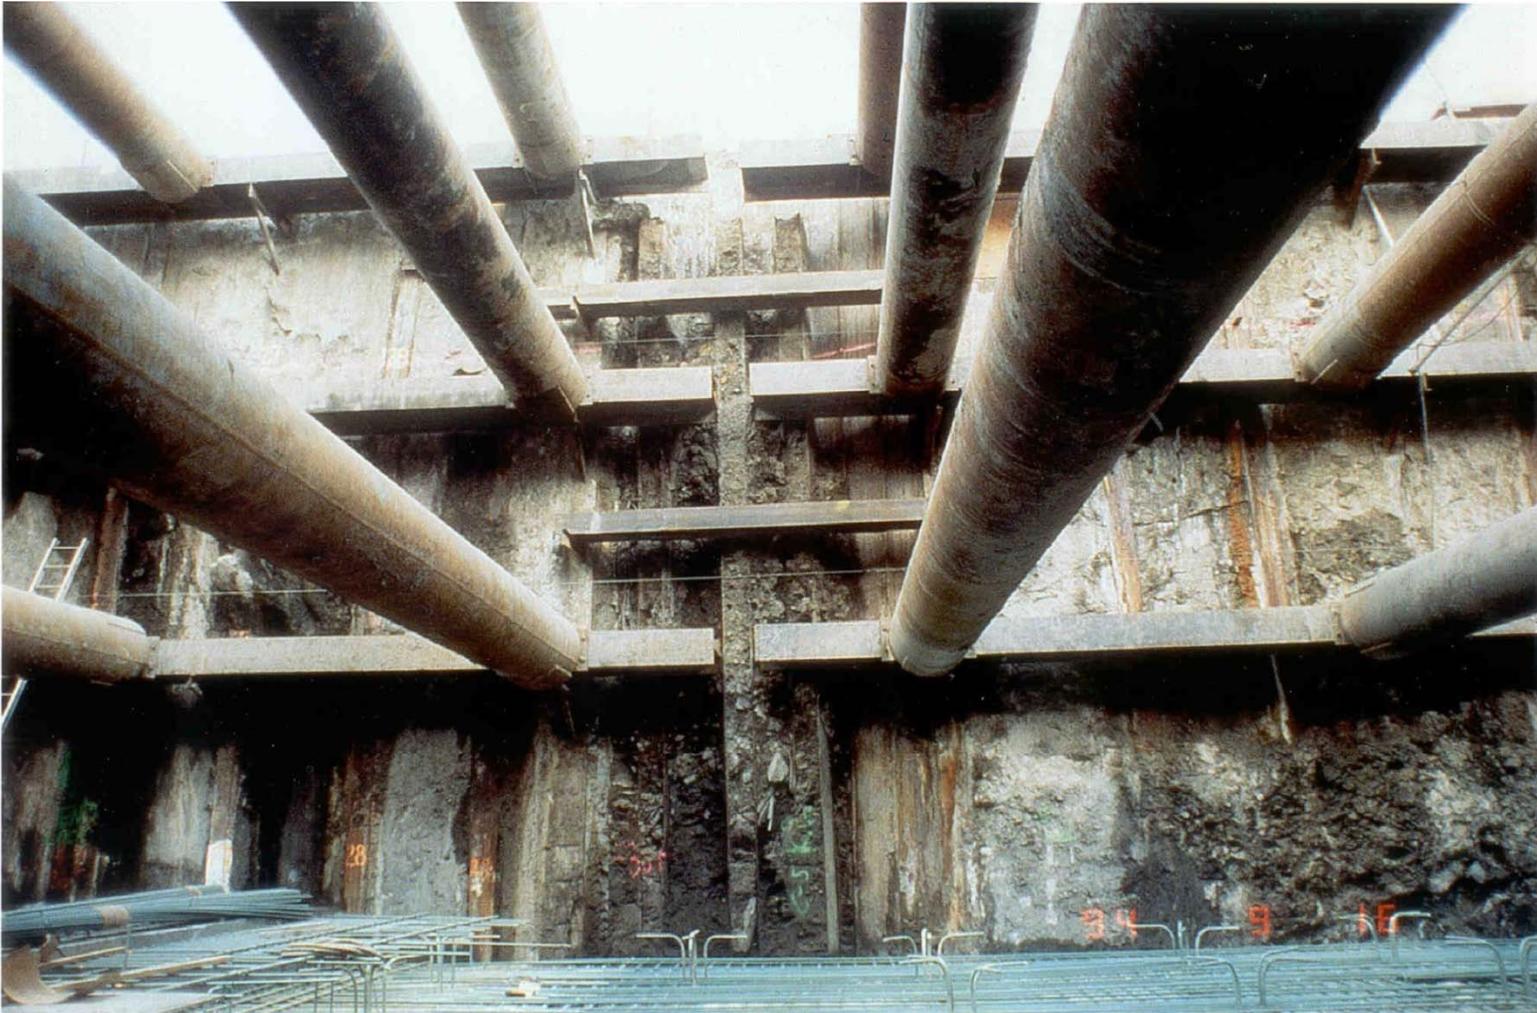
**Typical Cross Lot Bracing  
Deep Excavation Along The Embarcadero  
Muni Metro Turnback Project**

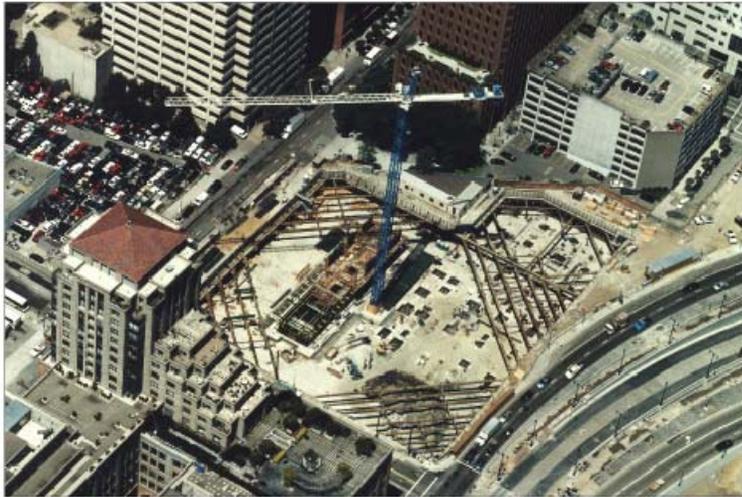
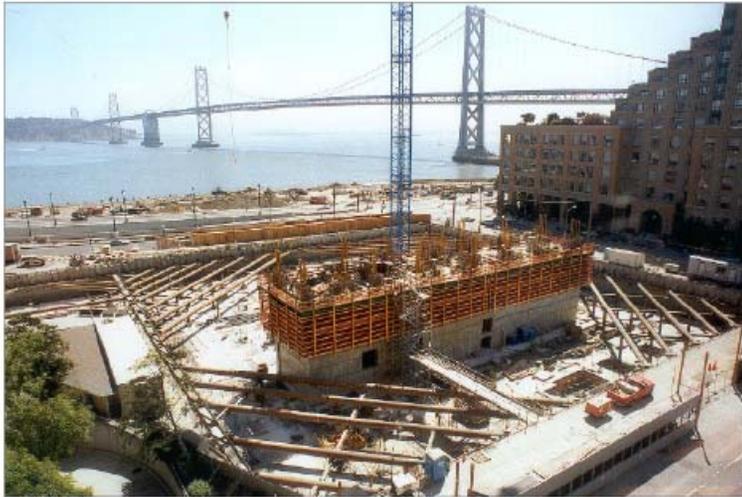
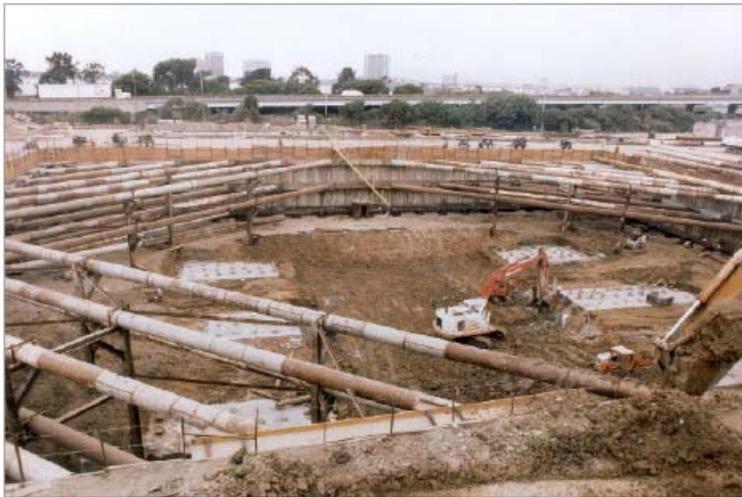
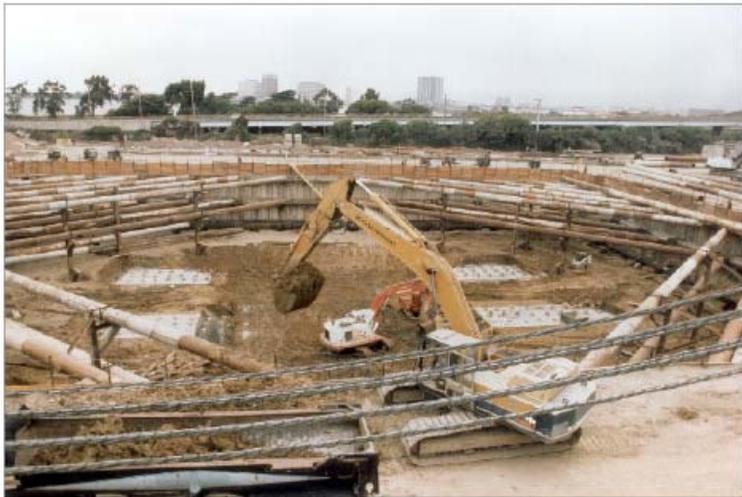
# Typical Diagonal Bracing of Deep Excavations Gap Building and EBMUD Wet Weather Building

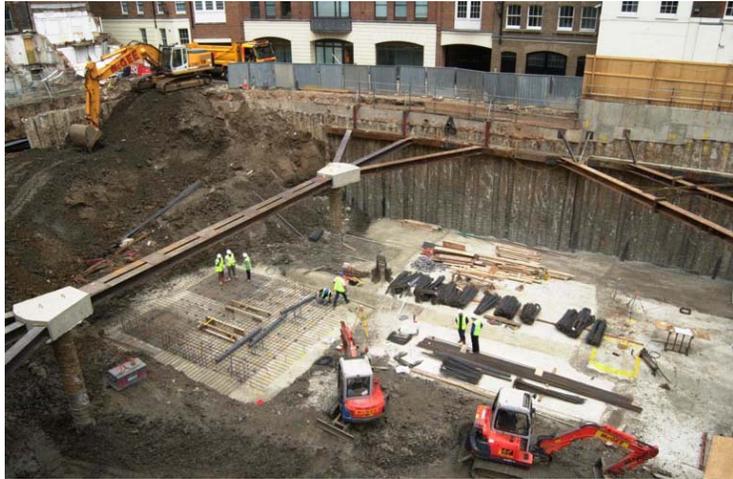
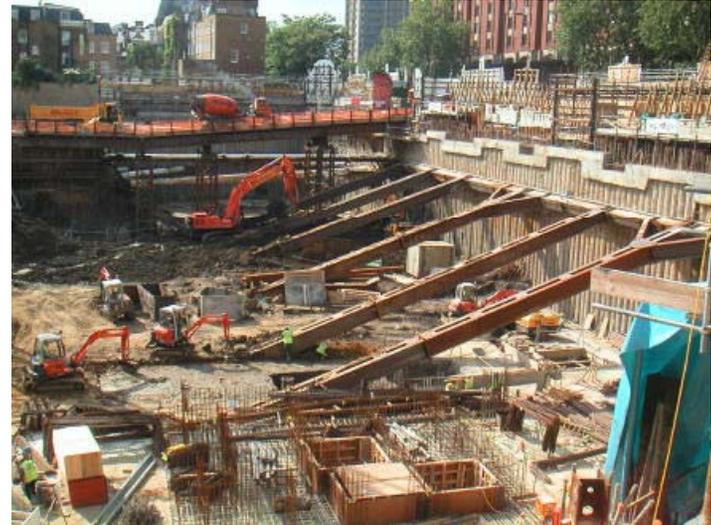
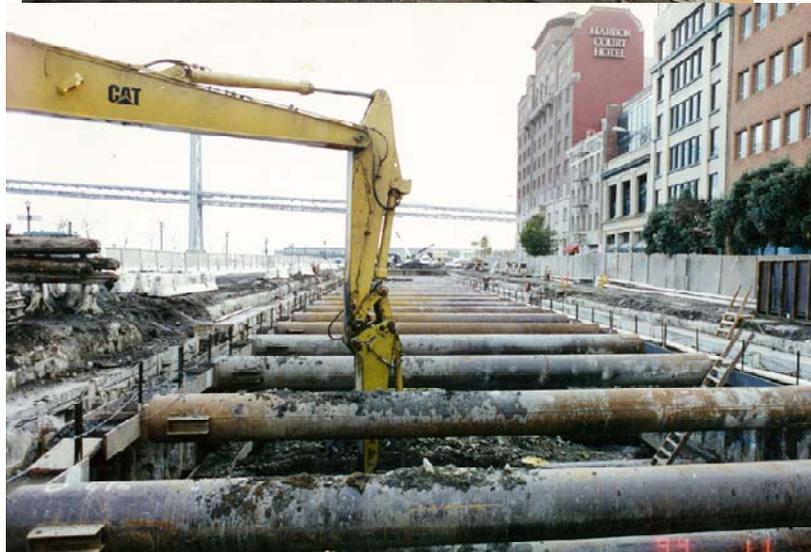
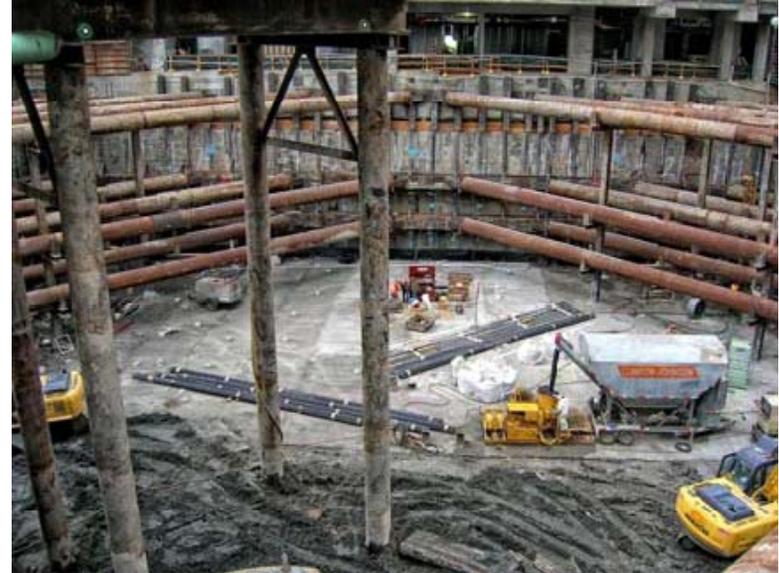
# Many ways of providing internal support to deep excavations

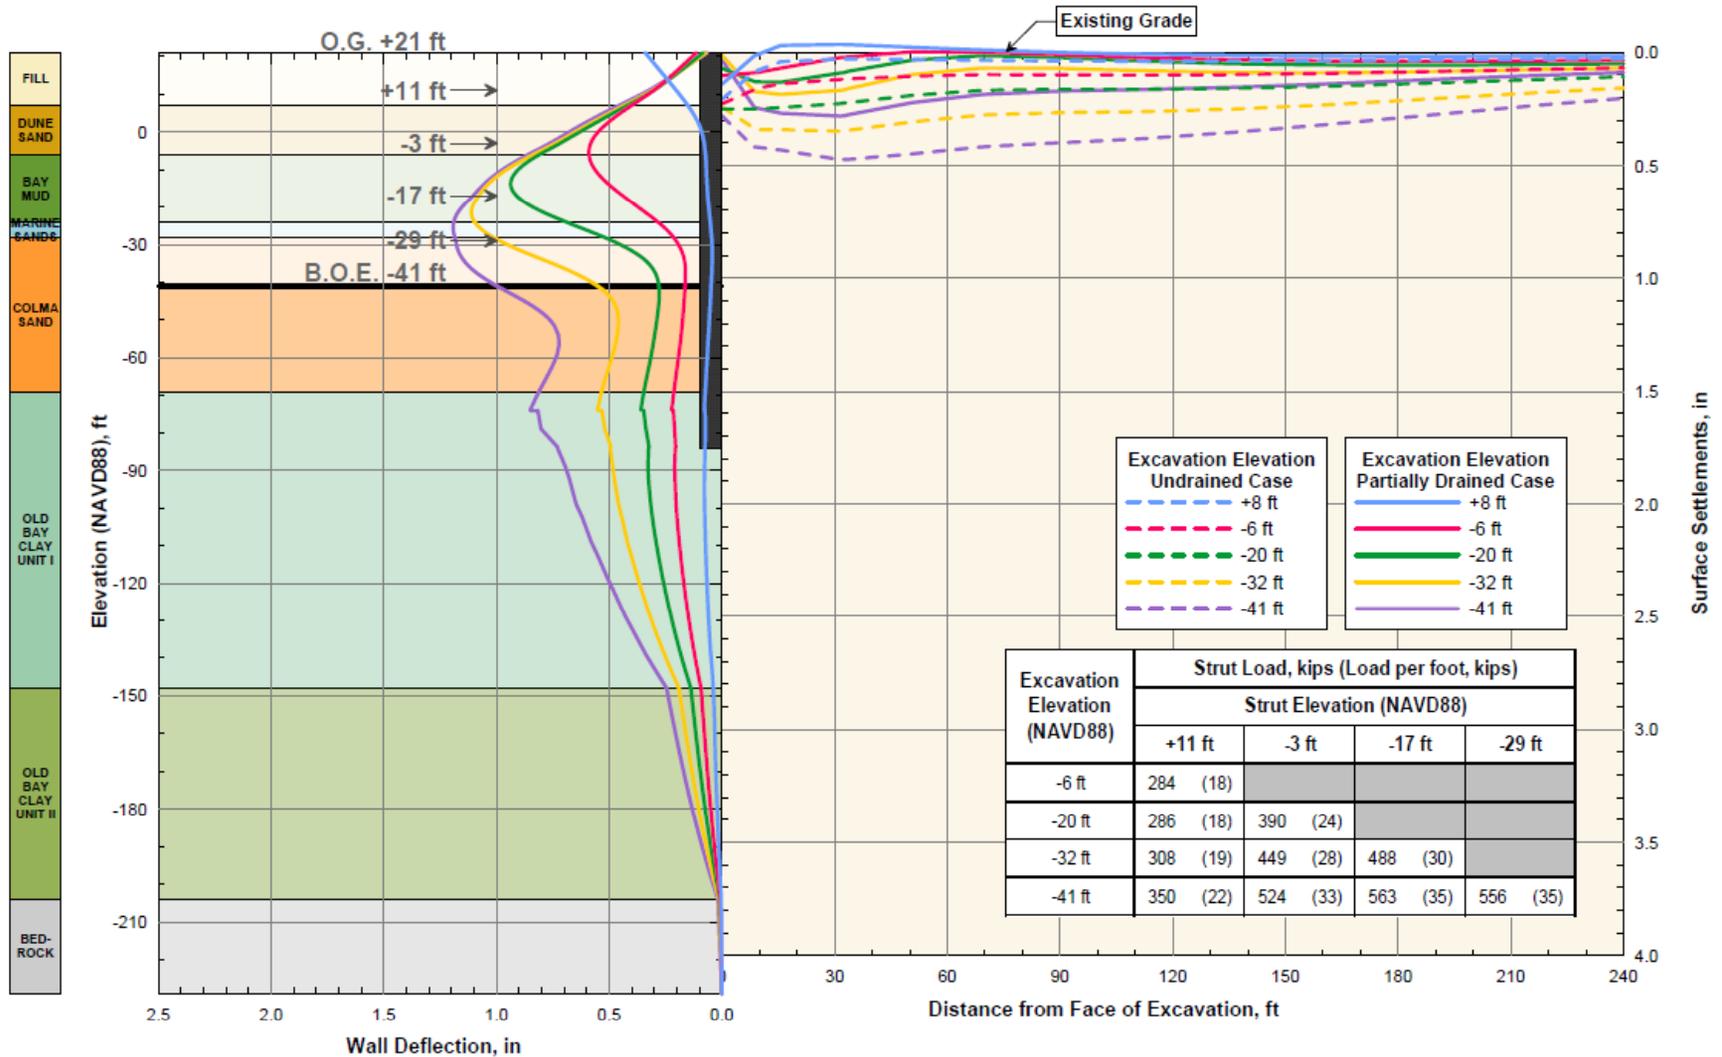
# West Base Case I

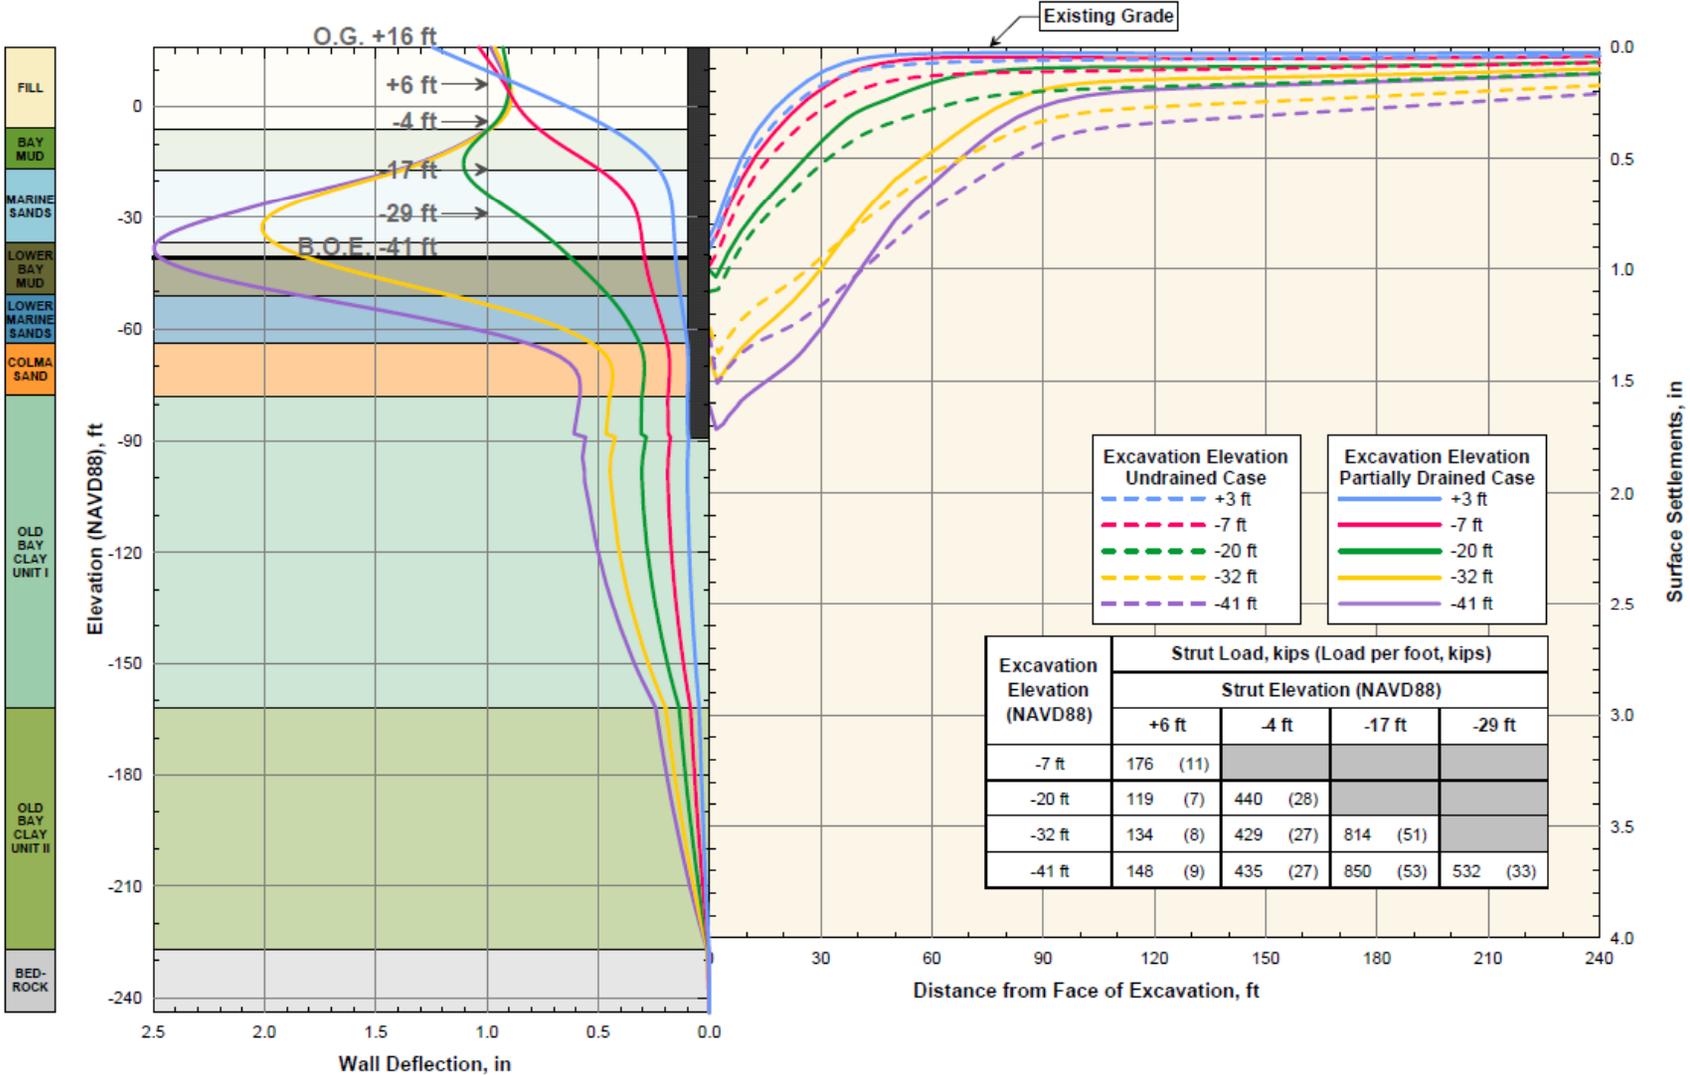
# East Base Case I

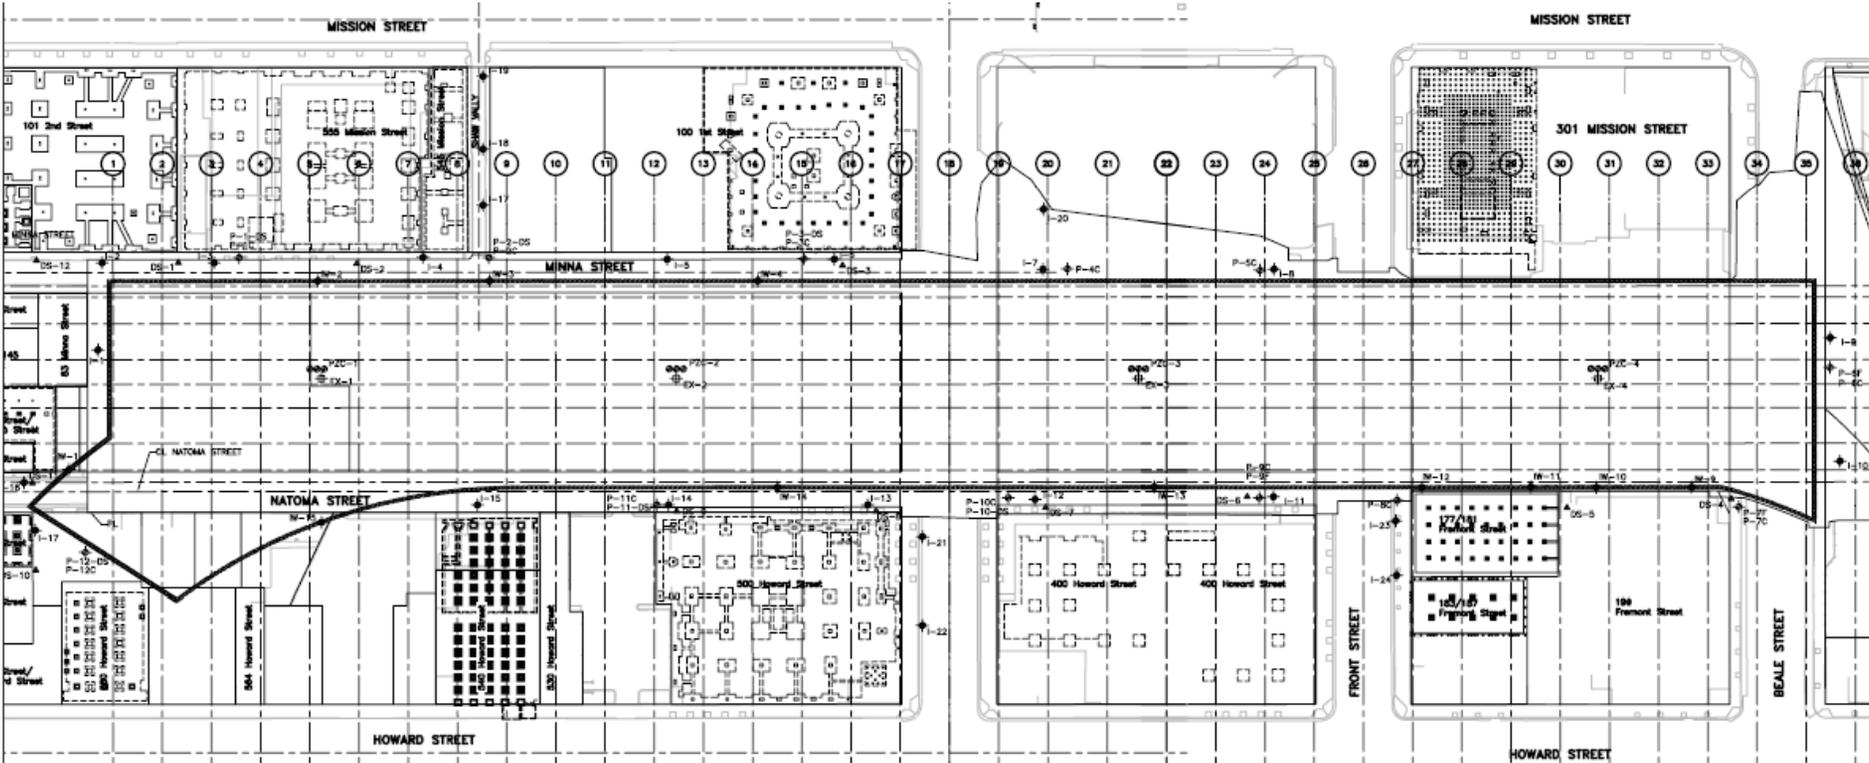
# Ground and Wall Monitoring Instrumentation

INCLINOMETER No. 3 INSTALLED BEHIND THE SHORING WALL
	INCLINOMETER No. 1 INSTALLED THROUGH SHORING WALL
	STANDPIPE PIEZOMETER No. 1 INSTALLED IN DUNE SAND (P-1-DS) AND COLMA SAND (P-1C)
	PIEZOMETER No. 6 INSTALLED IN FILL

PIEZOMETER CLUSTER No. 1 – VIBRATING WIRE PIEZOMETERS INSTALLED AT VARIOUS DEPTHS ADJACENT TO TRESTLE PILES
	EXTENSOMETER No. 1 INSTALLED AT PIEZOMETER CLUSTER PZC-1
	DEEP SETTLEMENT MARKER No. 1 INSTALLED AT THE LEVEL OF THE FOUNDATION OF THE CLOSEST BUILDING

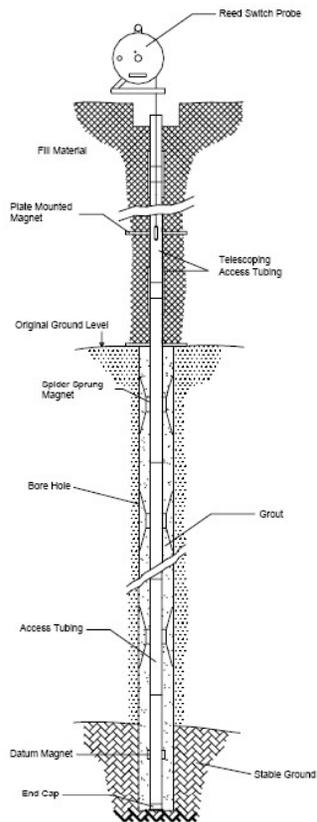
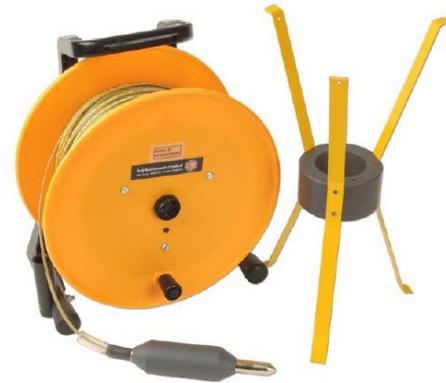
# Monitoring ground movements

**Extensometer**

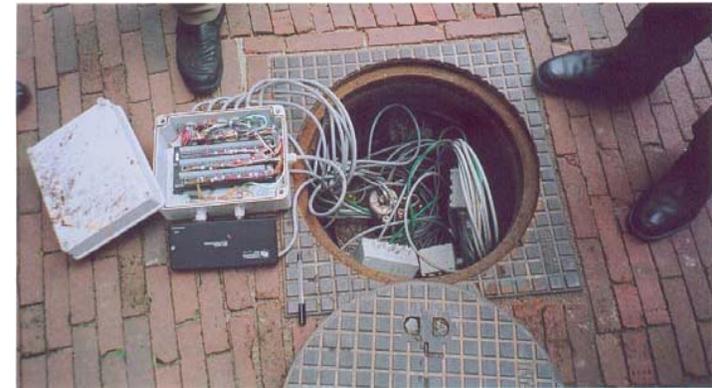
**Real time extensometer & inclinometer installation**

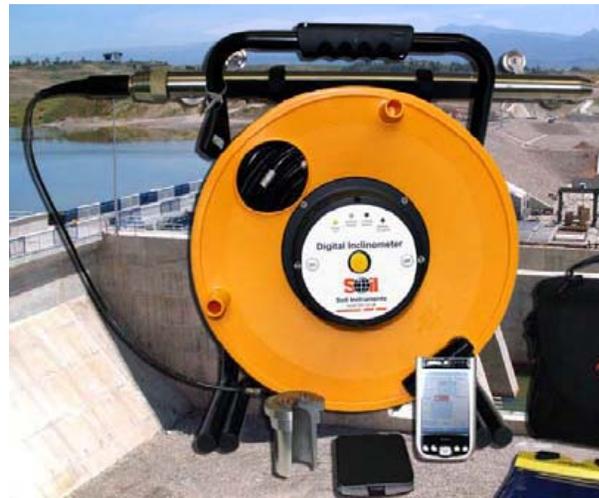
**Inclinometer and logging device**

**Inclinometers and extensometers(sub surface displacements).**

**Can be real time or manual  
Inclinometer (x, y, 0.002 in/ft)  
Extensometer (z, +/- 0.01 inch)**
