# Transbay Transit Center Project Shoring Wall and Excavation Construction

June 8, 2010

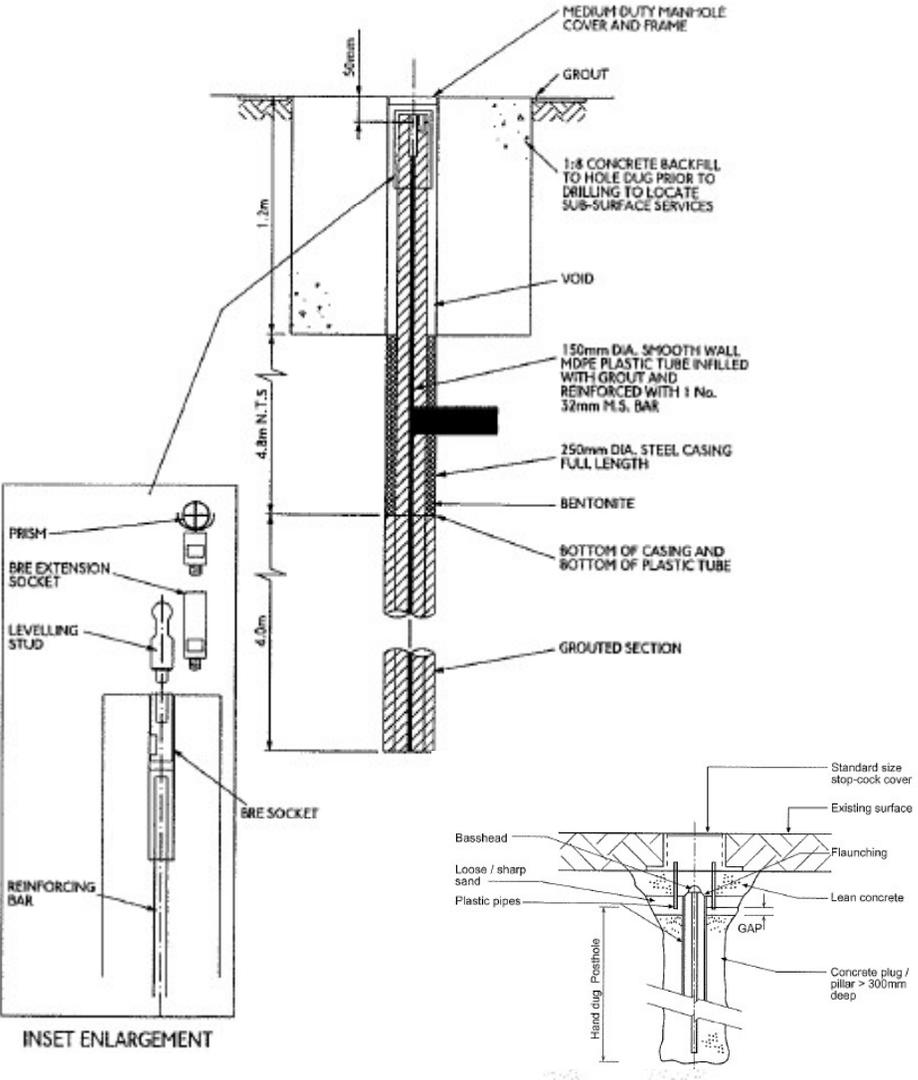
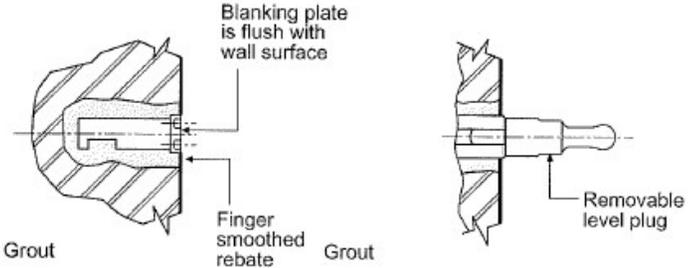
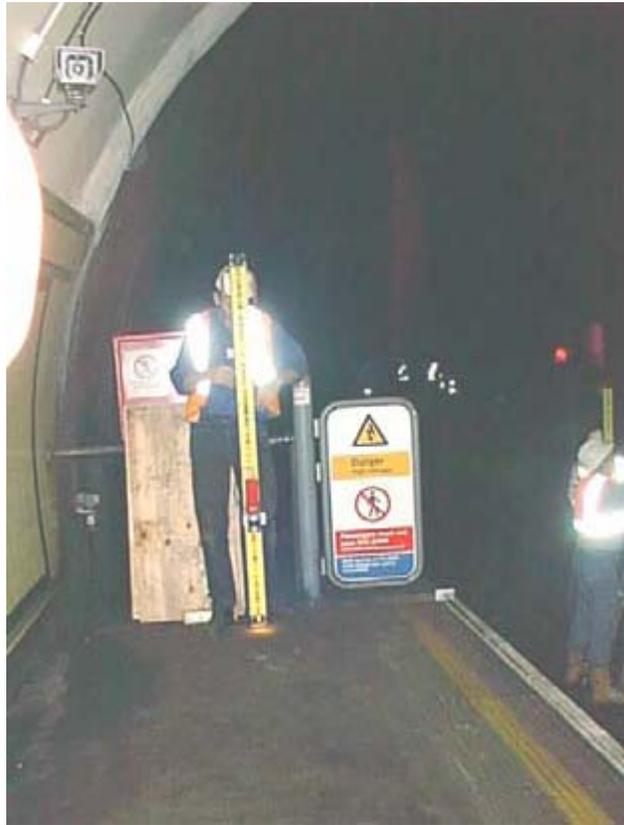
# Deep settlement marker and levelling points
