Root Cause Assessment – Fractured Girder Flanges

Transbay (Salesforce) Transit Center, San Francisco

December 13, 2018

Salesforce Transit Center Girder Repairs

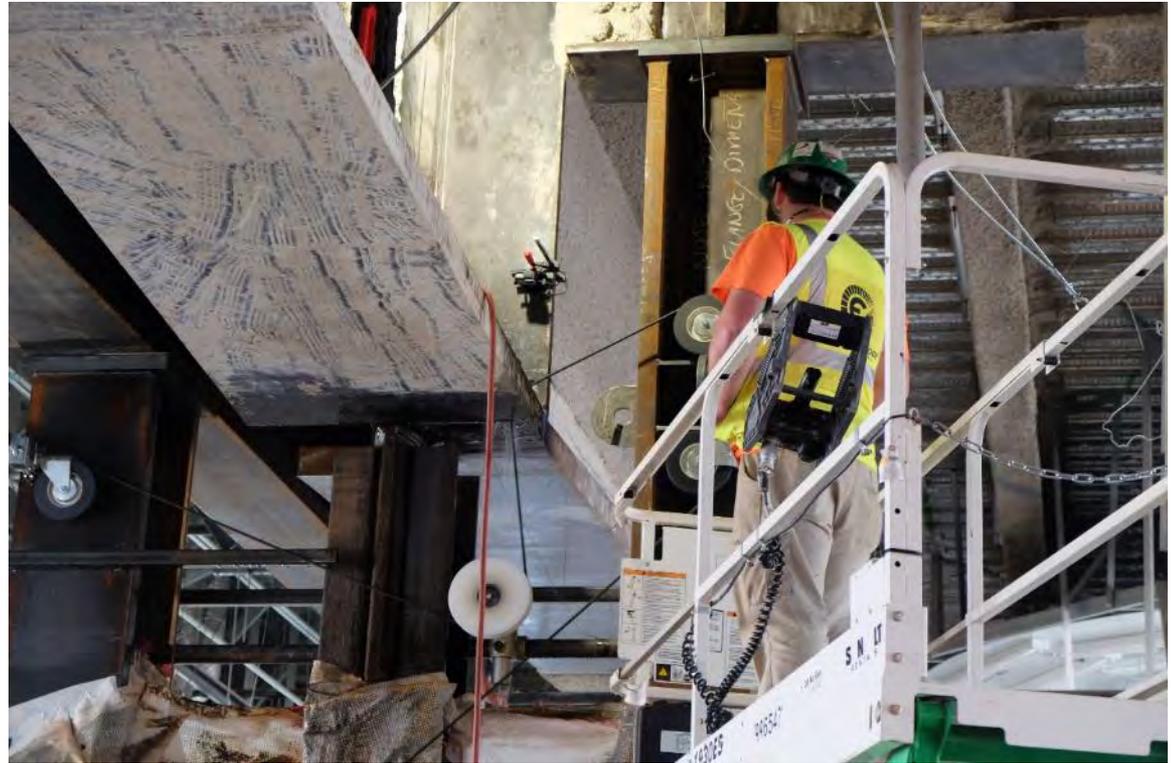
Girder Sample Removal

- Four samples were removed from the fractured Fremont St. girders
 - North Girder, D.4-NE-NW (cracked)
 - North Girder, D.4-SE-SW (cracked)
 - South Girder, E.6-NE-NW
 - South Girder, E.6-SE-SW (cracked)

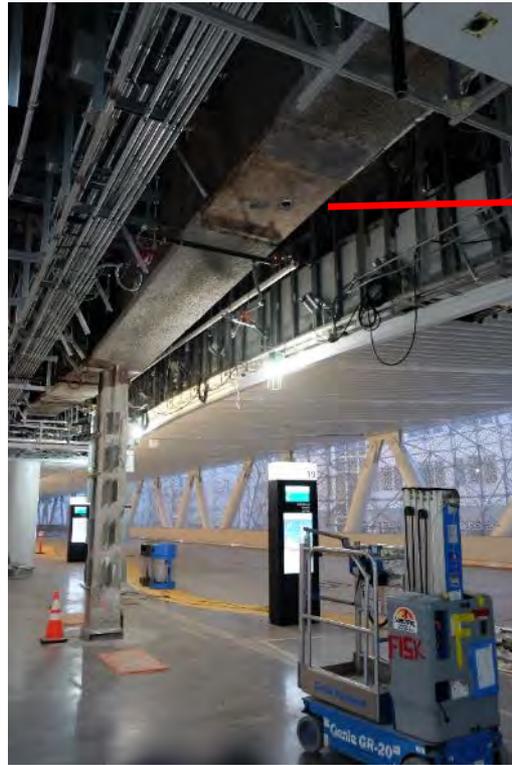
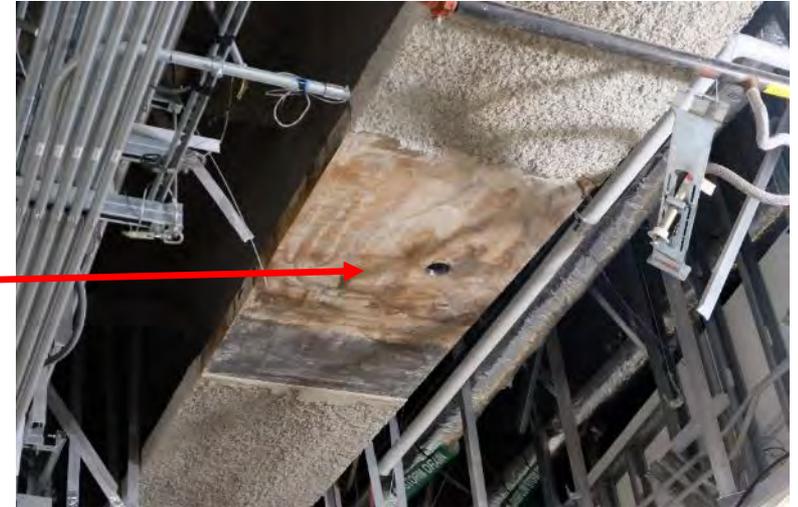
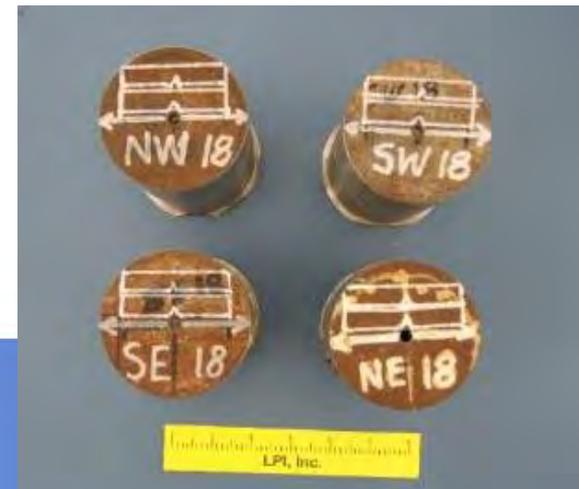
Girder Core Removal

- Four 3-in. diameter cores removed from the girder flanges at First Street

- NE-18
- NW-18
- SE-18
- SW-18

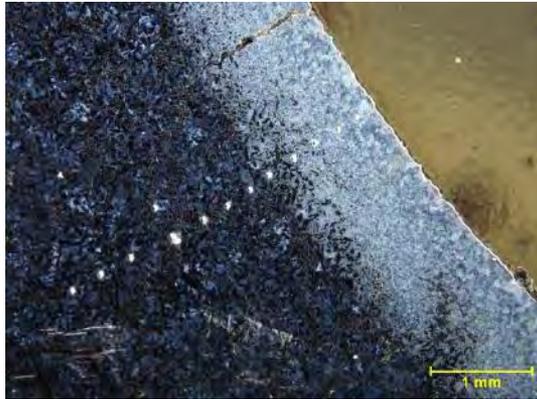
D.4-SW

Vickers Microhardness measurement locations, access hole surface to center

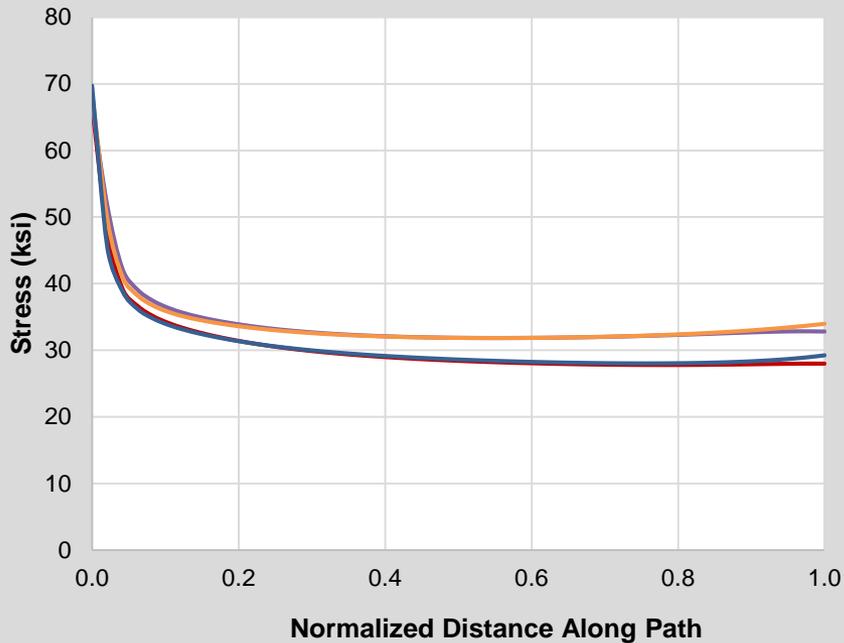
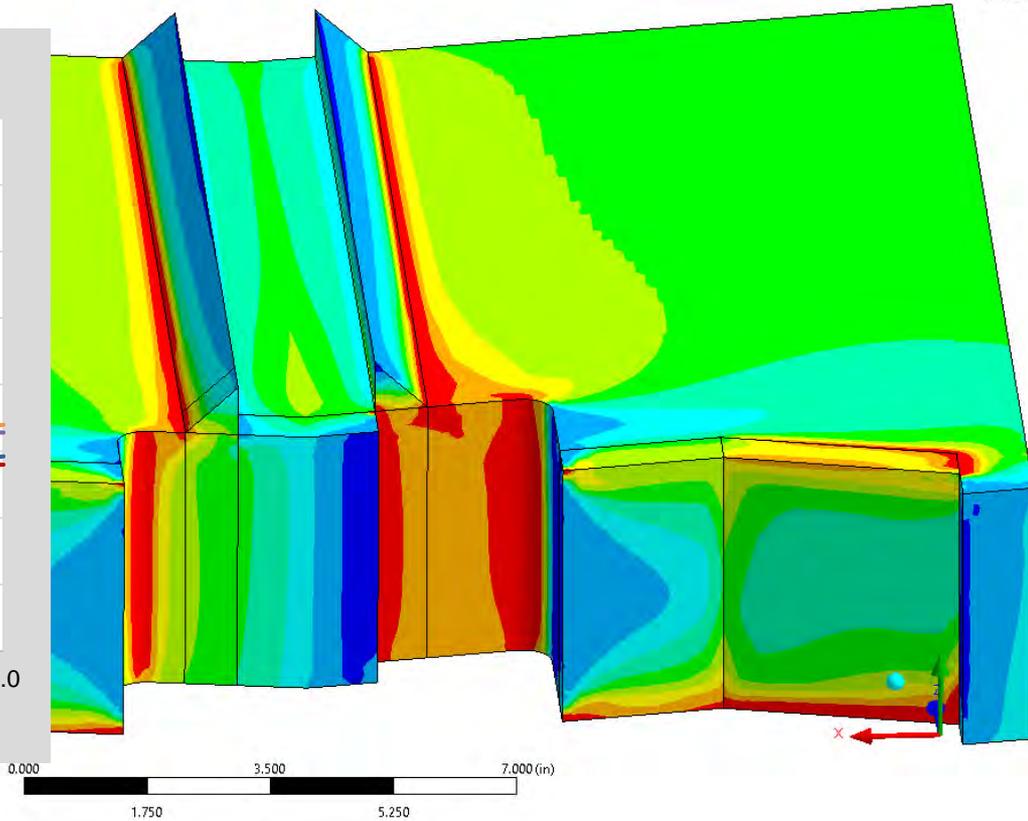
Weld Access Holes - Max Principal Stress

A: 1st Street SOUTHE.6 - Noncomposite - TT Loads - 60/86 NL
Maximum Principal Stress
Type: Maximum Principal Stress
Unit: psi
Time: 2
