Root Cause Assessment of Fractured Girder Flanges

Transbay (Salesforce) Transit Center, San Francisco

TJPA Board

March 14, 2019

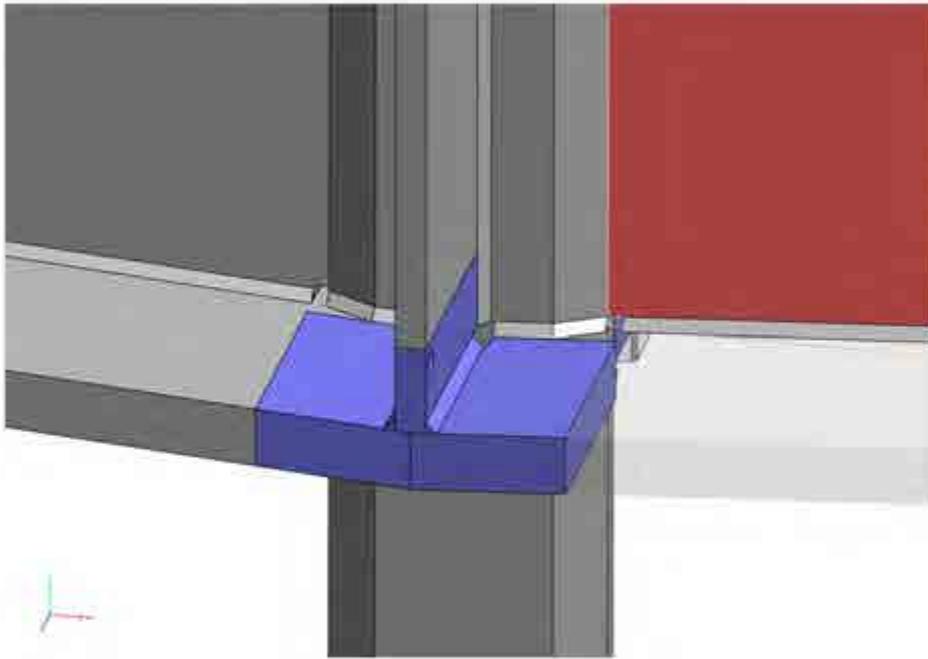
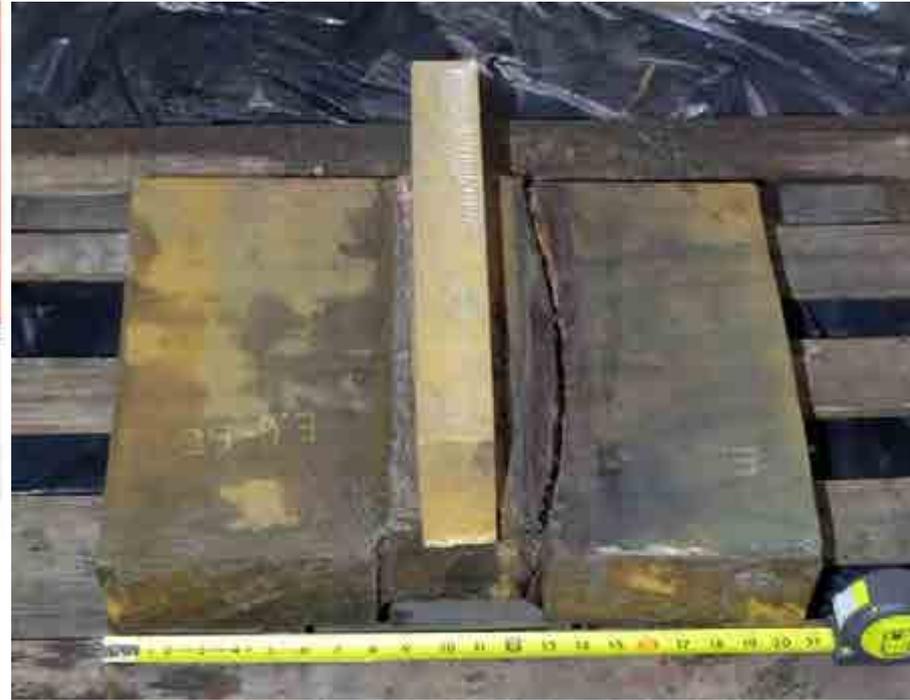
Typical Fremont Street Girder Sample

- Fremont St, South girder, E.6-SE-SW (fractured)

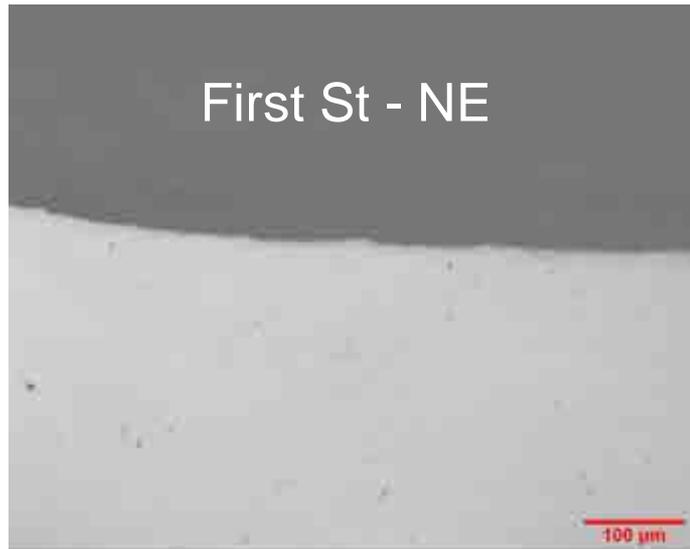
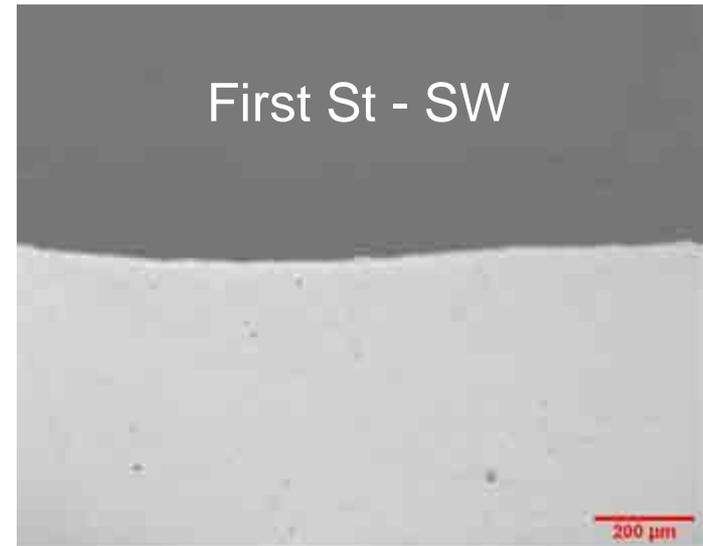
First St Core Sample Examination

- No Microcracks or Pop-in cracks were observed in any of the cores removed from the First Street flange weld access holes
- However, the absence of Microcracks at First Street may be attributable to the grinding performed on the access hole surfaces following the Fremont Street fractures
- The weld access holes at First Street were fabricated differently from those at Fremont St, that is, they were cut after the flange CJP butt weld was completed
- The Fremont Street access holes were made prior to welding of the flange CJP butt weld

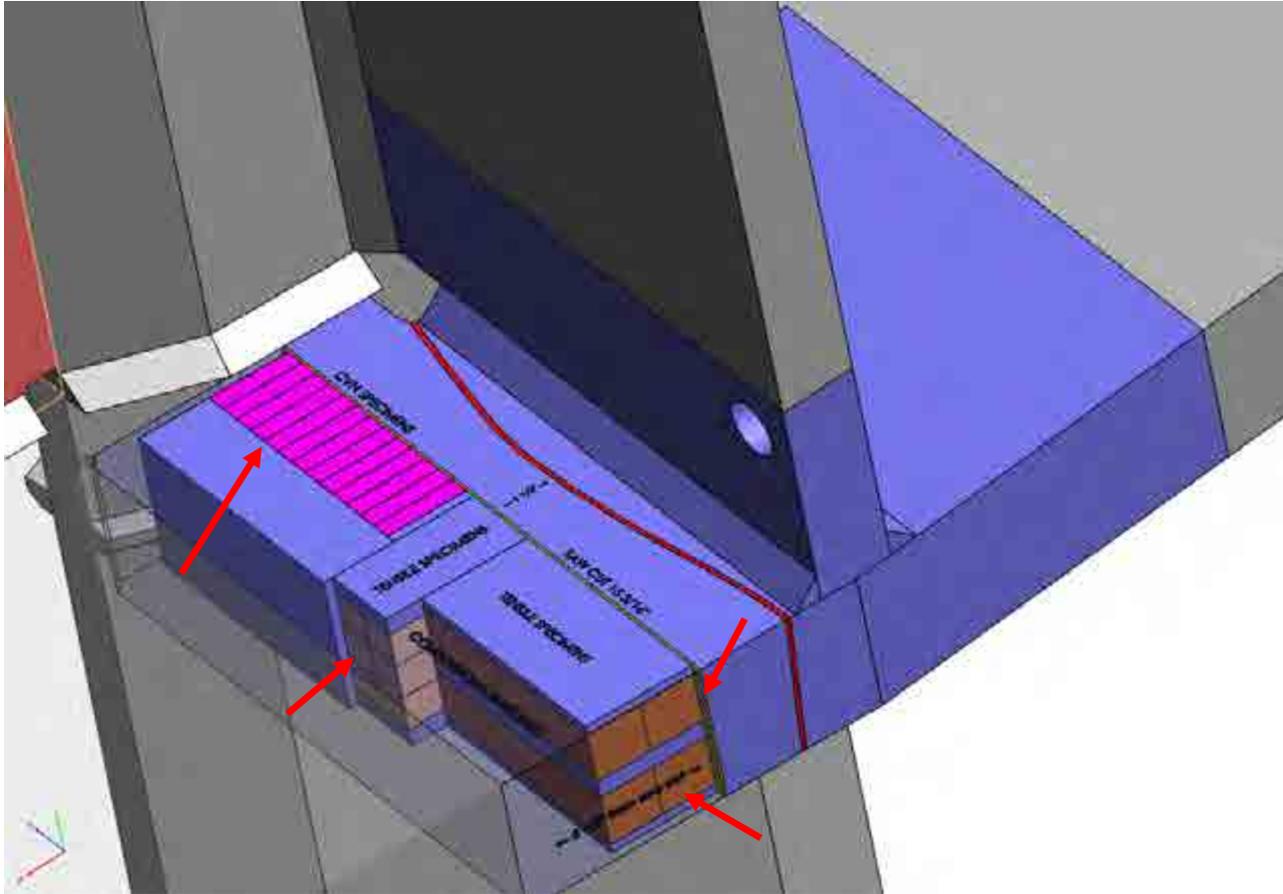
Fremont Street girder sample tensile and CVN specimen removal locations and orientation

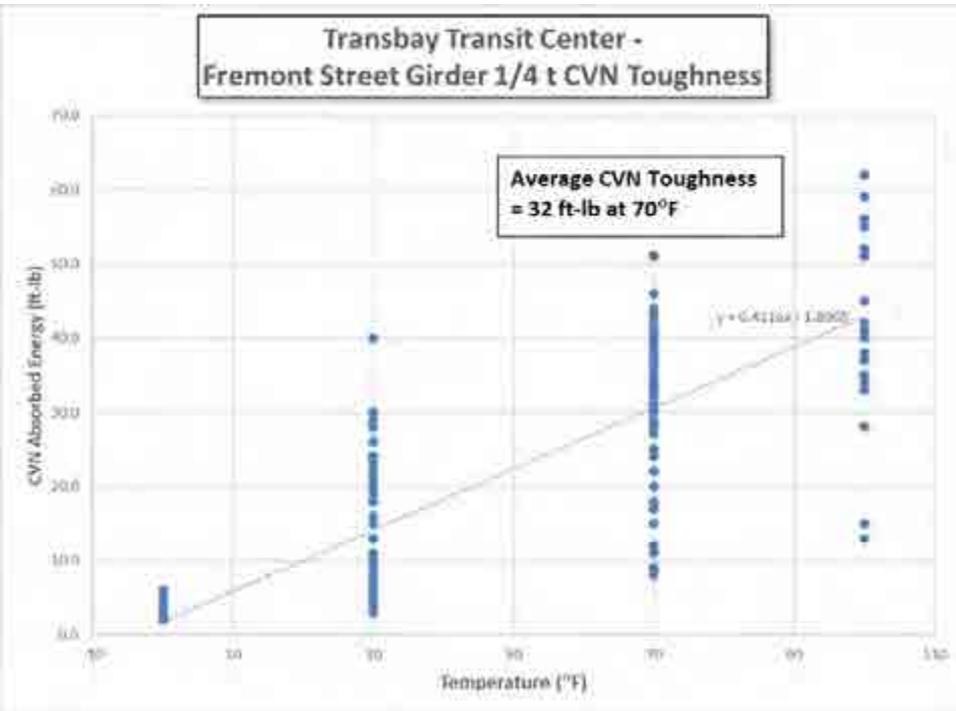
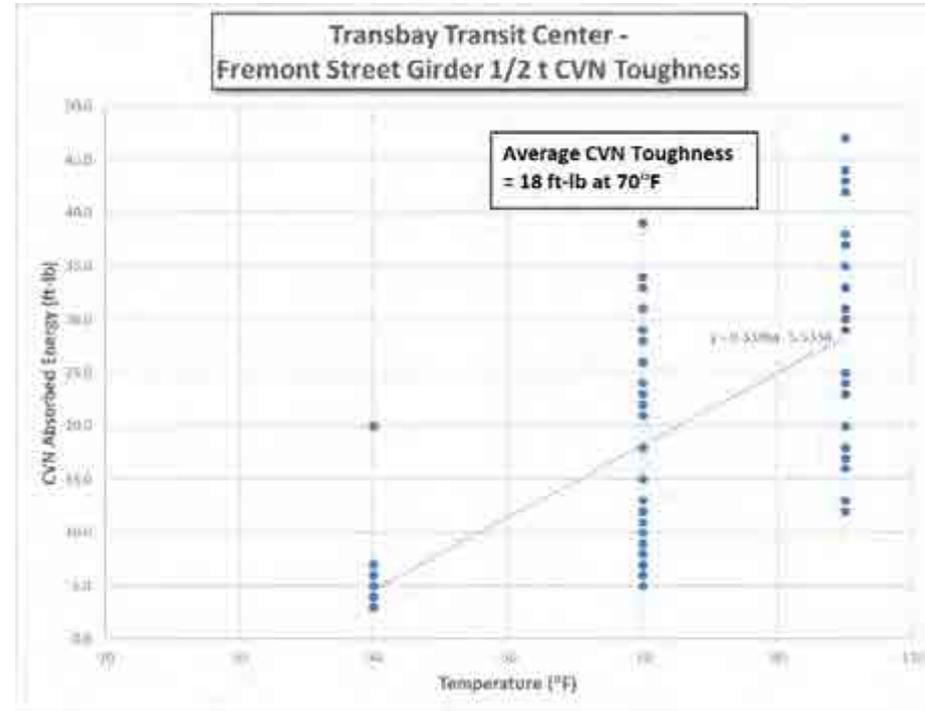
Fremont St CVN Toughness Results

- Toughness measured by CVN testing is an indirect assessment of a material's resistance to brittle, low-energy fracture in the presence of a crack-like flaw such as the observed Pop-in cracks in the Fremont Street girder flange
- CVN toughness, as measured in absorbed energy (ft-lb), is considered to be reasonable at a level of 20 ft-lb and higher

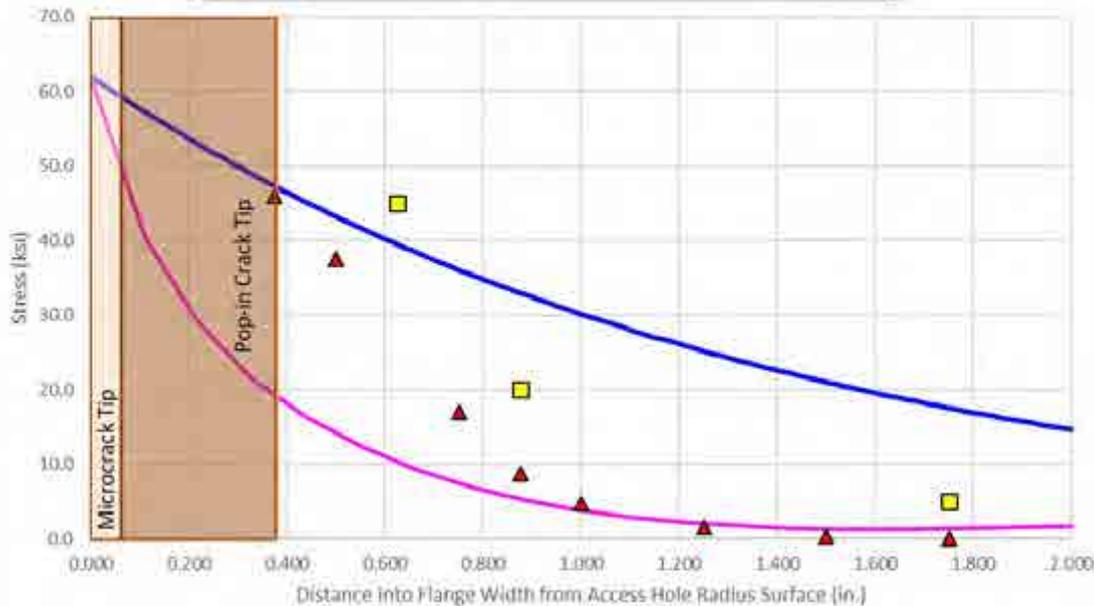
Residual Stress Distribution
Required to Initiate Pop-in Crack from
Microcrack Located at Access Hole Surface

- Initially assumed that the access hole surface stress is subjected to yield strength level residual stress that decreases rapidly with distance into the flange, which is consistent with all reported measured and simulated residual stress analyses
- There is very good agreement between the LPI assumed residual stress distribution (blue curve) required to initiate Pop-in crack from Microcracks and the experimental (EXP) and finite element (FE) results obtained by the US Army Corp of Engineers' research performed in 1992 (Jaeger et. al.) for a comparable joint configuration
- LPI's Thermal FE simulation results (purple curve) of the weld access hole geometry are also in very good agreement with the 1992 US Army Corp of Engineers' research results
- The LPI distribution (blue curve) upper-bounds the results shown and, as such, slightly over estimates the induced stress intensity level (K)

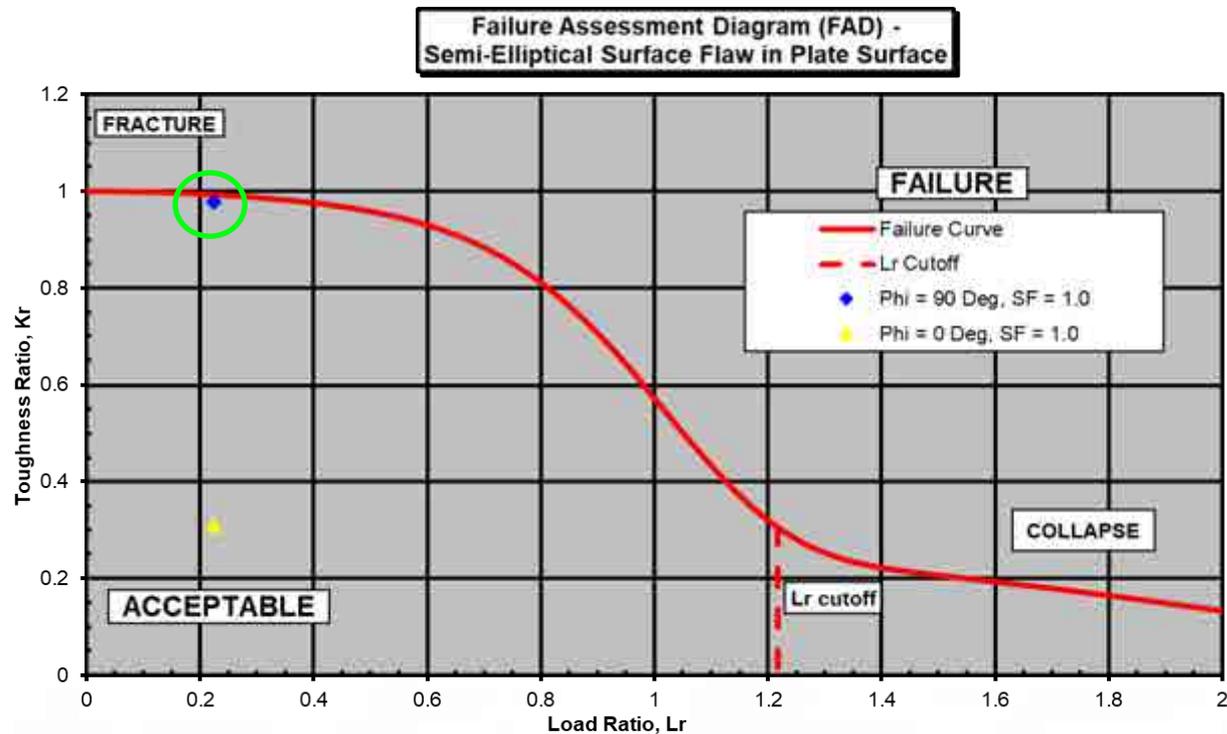
Pop-in crack initiation ○ occurs under the following conditions:

- The residual stress distribution shown in the previous slide
- A Microcrack depth (a) of 0.06 in.
- Fracture toughness (K_{Ic}) of $\sim 30 \text{ ksi}\sqrt{\text{in}}$.

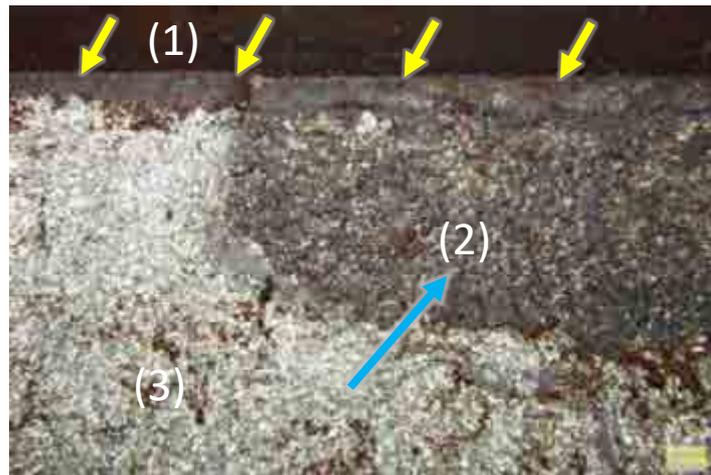
- The only stress present at the time the Pop-in crack arrested was the self-limiting residual stress associated with welding of the CJP butt weld
- Unstable Pop-in crack propagation occurred until the combination crack size, local stress, and fracture toughness were low enough to arrest Pop-in crack extension

- The Pop-in crack was located at mid-thickness ($\frac{1}{2}$ -t) of the flange, where the fracture toughness (K_{1c}) was determined to be approximately 55-60 ksi $\sqrt{\text{in.}}$ at 50°F

- Thus, the Pop-in crack (2) formed during welding of the flange CJP butt weld and attained a maximum depth (a) of 0.38 in. and surface length (2c) of approximately 1.2 in.

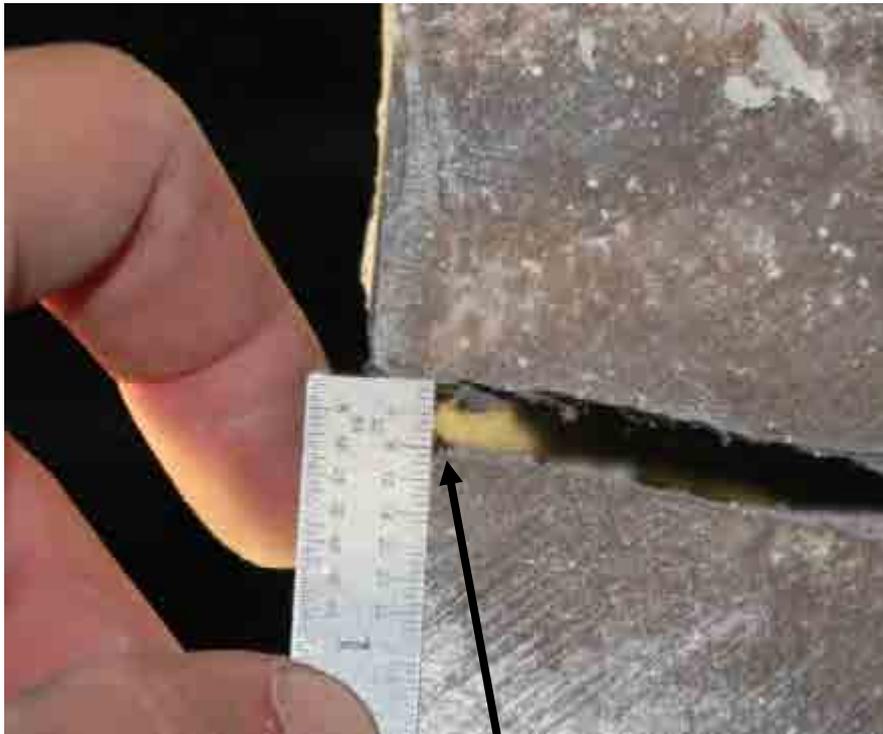
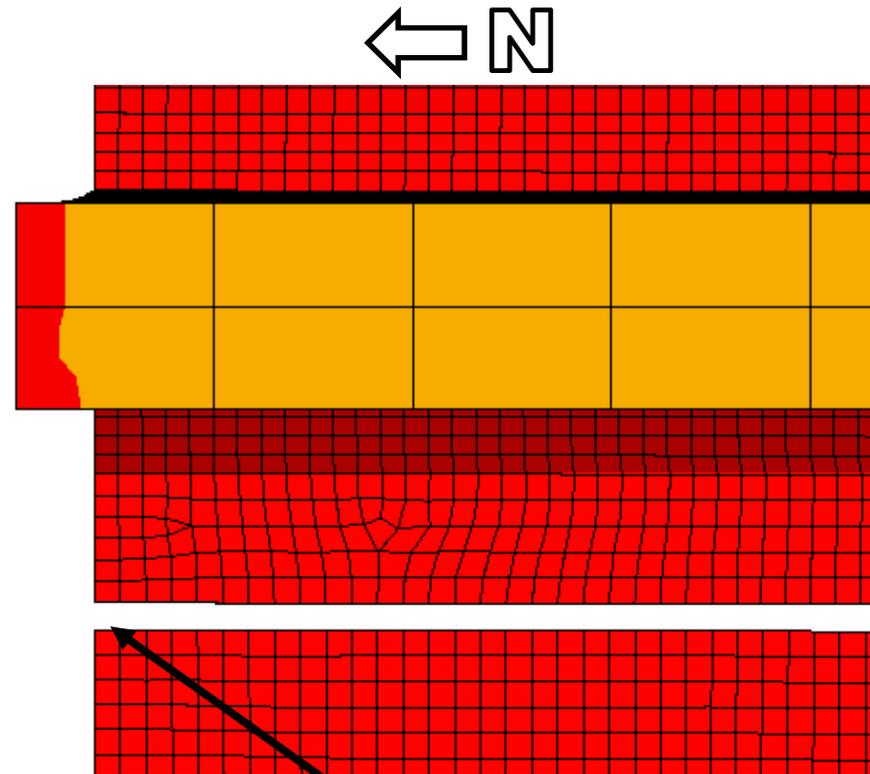
Fremont St Model Validation

Actual Measurement ~ 0.25 in.

NW Fracture

FE Results ~ 0.27 in.

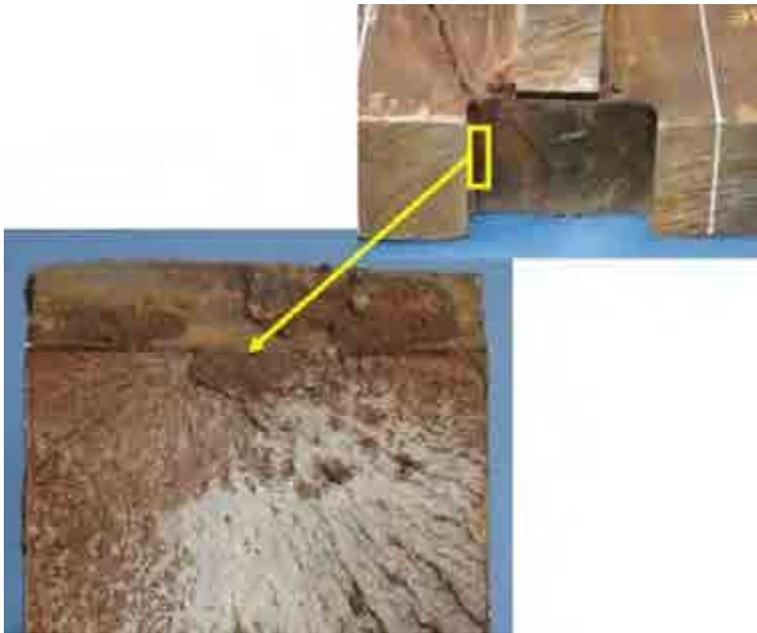
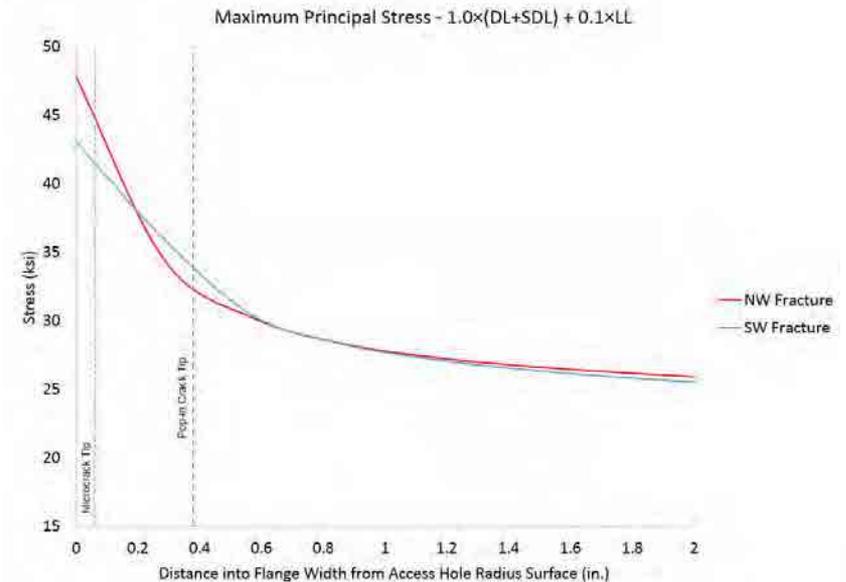
Fremont St Flange Fracture Initiation

- Flange fracture (3) initiated from the Pop-in crack (2) under the combination of normal service-induced stresses and butt weld-induced residual stresses and extended across the width of the flange
- The Pop-in crack was 0.38 in. deep (a) with a surface length (2c) of 1.2 in. and located at mid-thickness ($\frac{1}{2}$ -t) of flange, where the fracture toughness (K_{1c}) was approximately 55-60 ksi $\sqrt{\text{in.}}$.
- Service stresses were those due to 1.0DL + 0.1LL

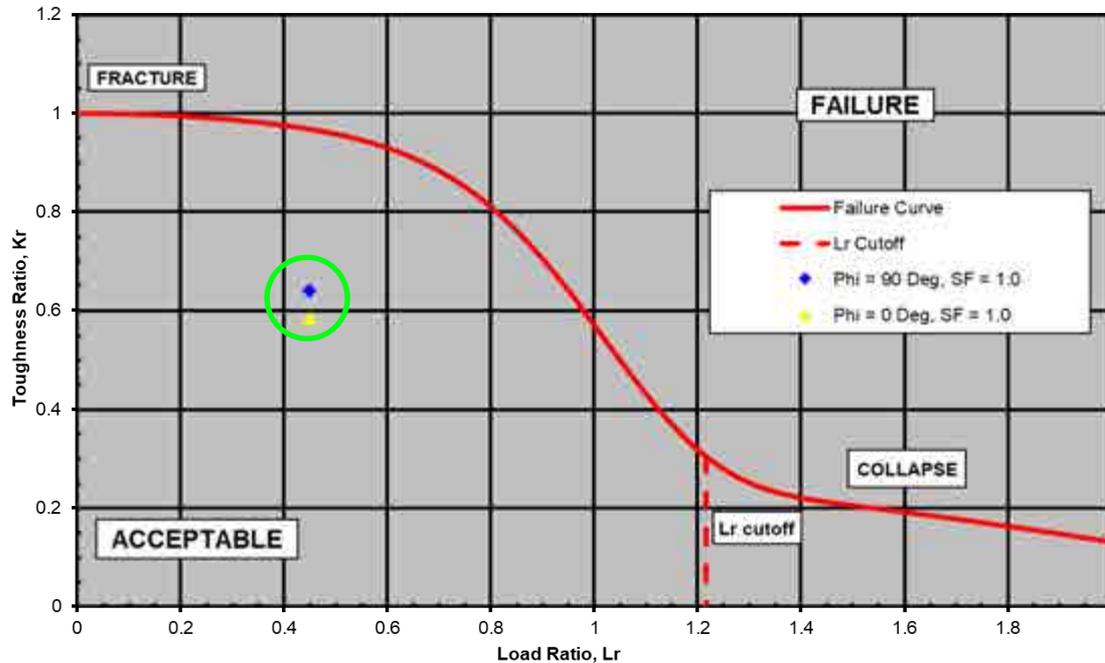
Failure Assessment Diagram (FAD) -
Semi-Elliptical Surface Flaw in Plate Surface

- For a crack 0.38 in. deep (a) x 1.2 long (2c) in., a fracture toughness of $K_{Ic} \sim 55\text{-}60 \text{ ksi}\sqrt{\text{in.}}$, and service stresses only (i.e., no residual stresses), the following Fracture Mechanics (FAD) results were obtained

- From the Fracture Mechanics (FAD) calculations, flange fracture (3) from the Pop-in crack will NOT (○) occur under normal service stresses alone
- As such, a K contribution due to CJP butt weld-induced residual stresses is required to initiate flange fracture
- The contribution of residual stress necessary to initiate flange fracture can be “back-calculated” by incrementally increasing the residual stress K component of the FAD analysis until fracture is indicated by one of the assessment points (▲) intersects the FAD failure curve (left)
- The K due to service stress was 38 ksi√in.
- Accordingly, the minimum additional residual stress-induced K required to initiate flange fracture is approximately 20-22 ksi√in.

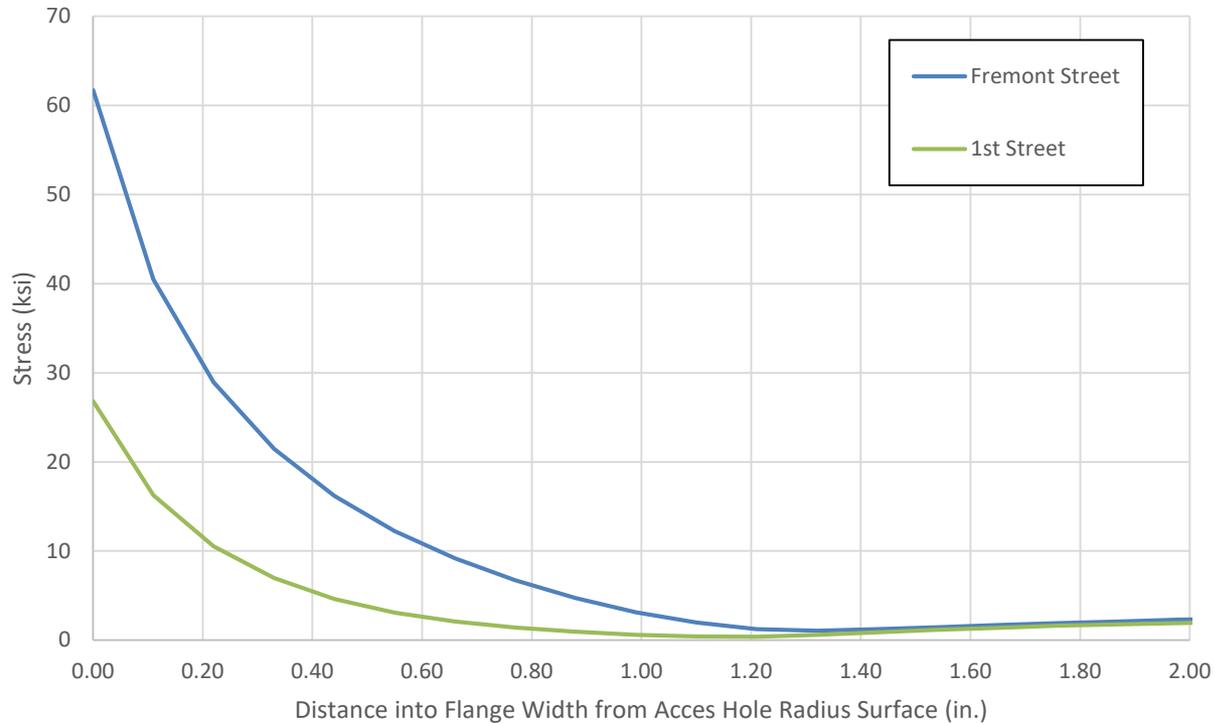
Access Hole Thermal Analyses
Residual Stress

- Yield strength level residual stresses at the weld access hole radius surface (induced by CJP butt welding) were required to initiate the Pop-in crack from the 0.06 in. deep Microcracks

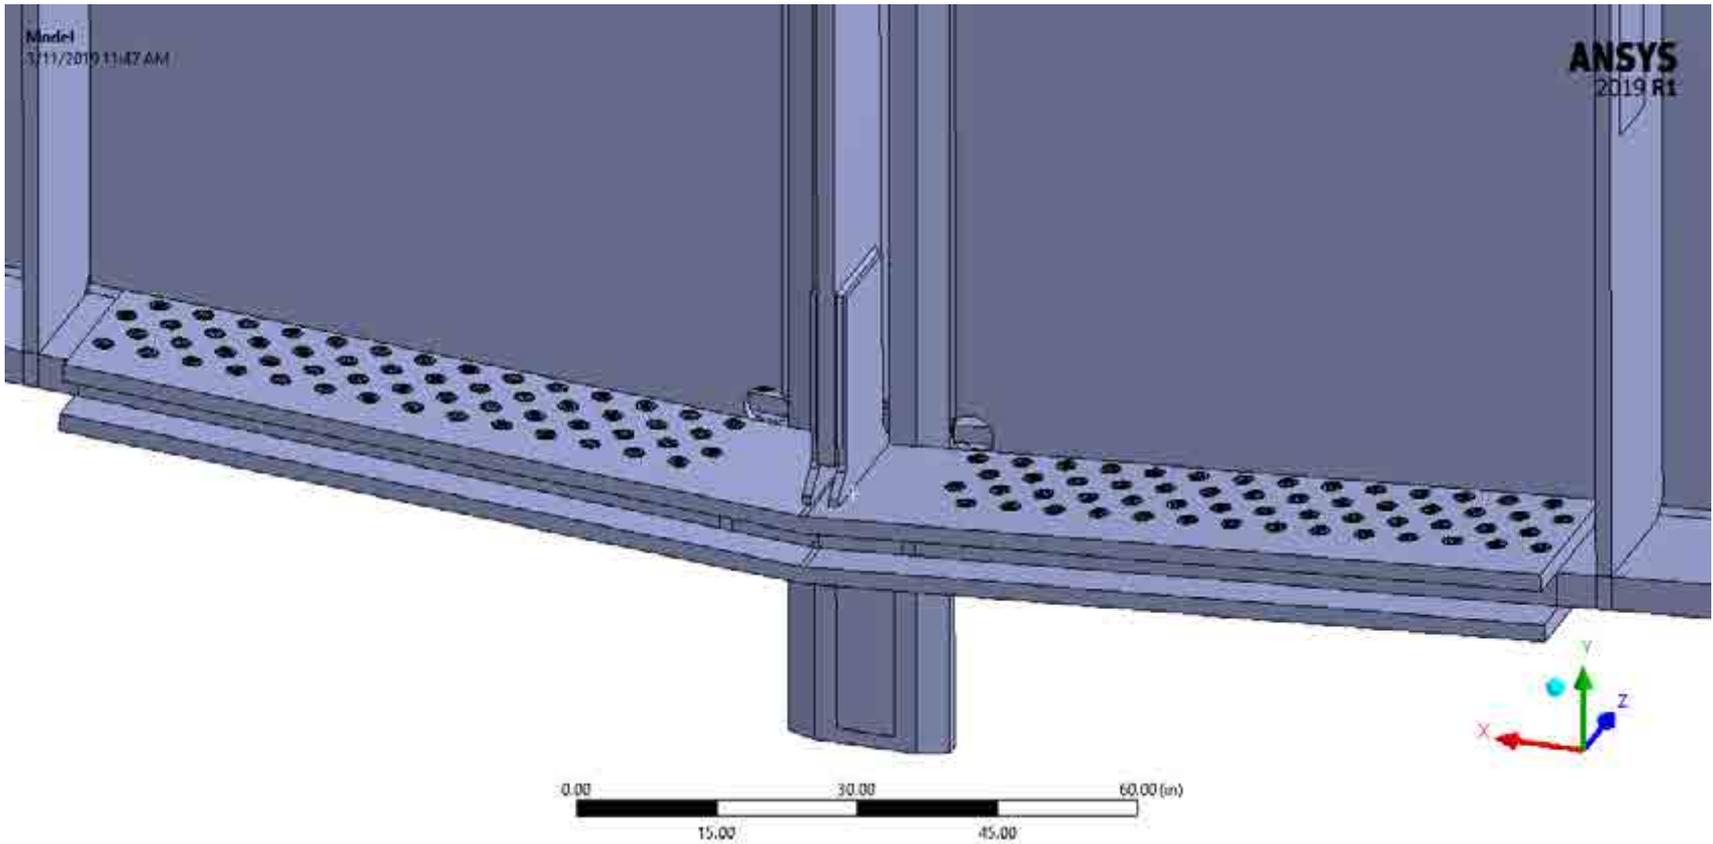
First St Repair

- **Stresses in the First Street girder under the fully factored load state are considered normal and acceptable prior to the bolted repair solution**
- **The bolted repair at First Street provides additional load carrying capacity beyond what is required**
